Research Vessel *Petrel* Baseline Survey of HMAS *AE1*

April 2018

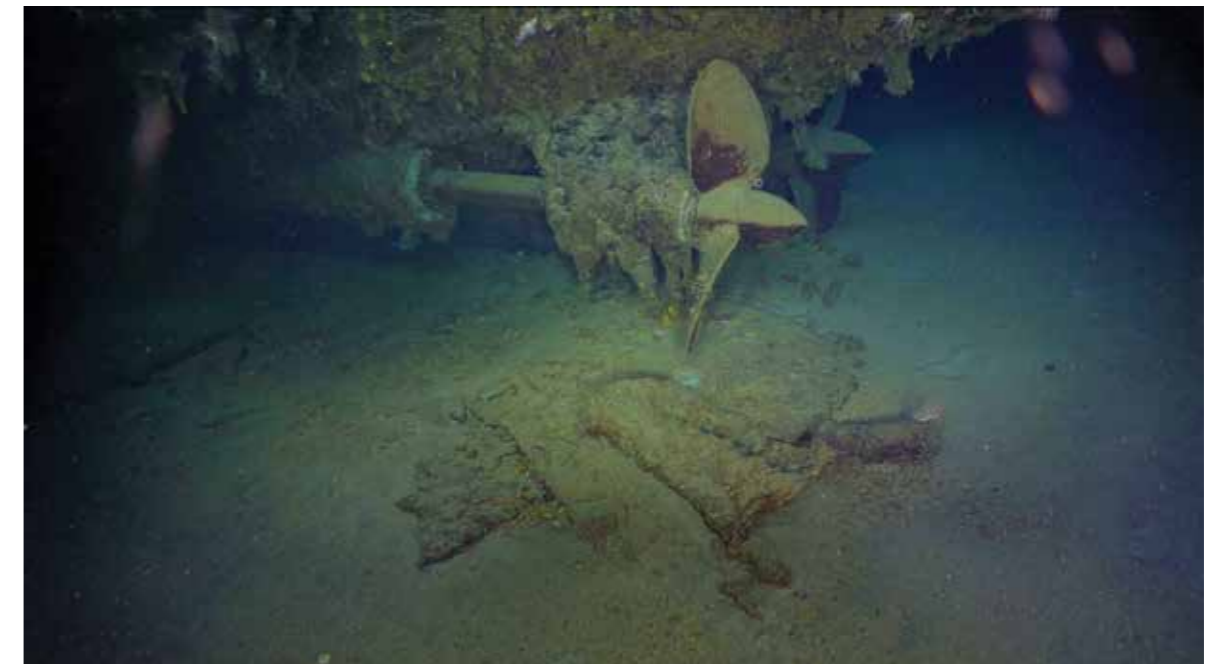
Serial 4 commenced at 0830. On this occasion the current over the wreck was less than on the day before and visibility was excellent. Some time was spent examining the rudder, which has been displaced and is lying under the port propeller, along with its supporting skeg, which has broken off.

Figure 8 – Displaced rudder and supporting skeg lying under port propeller.

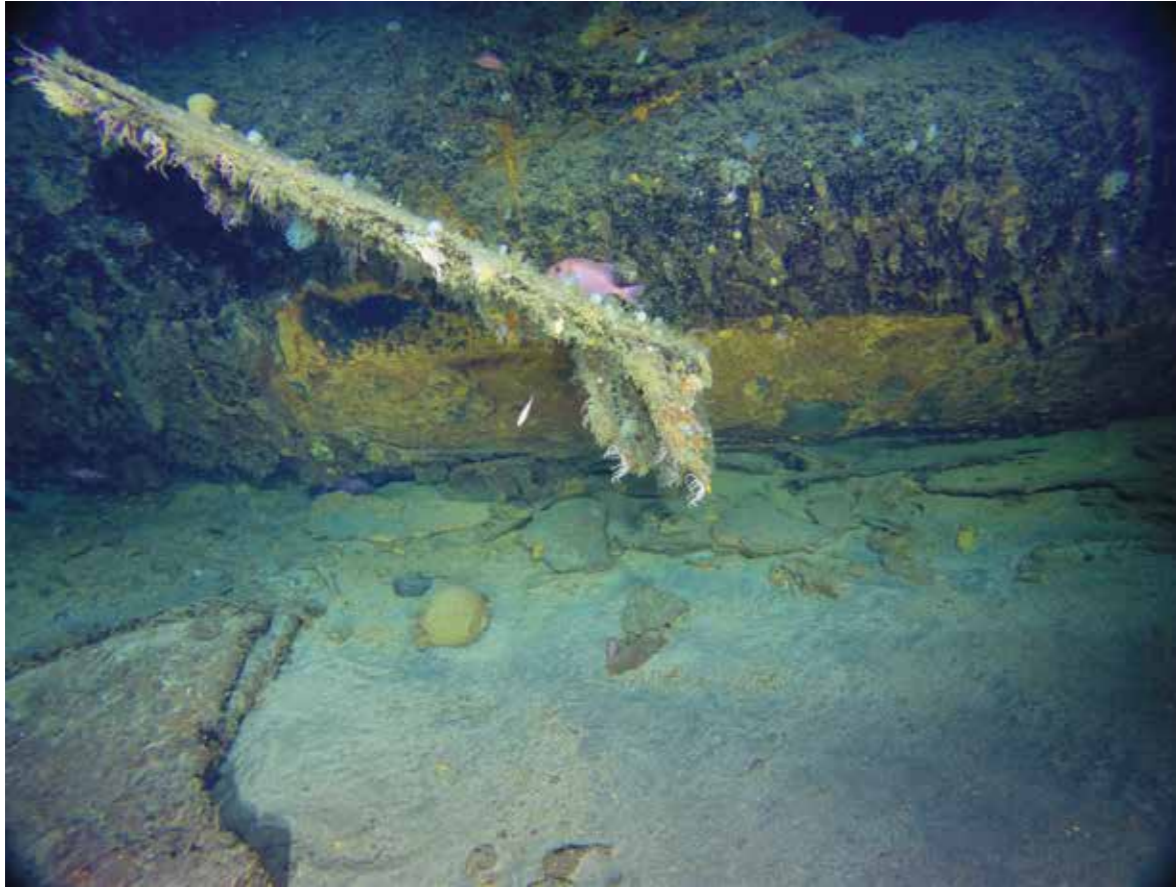
There are several patches where the concretion layer protecting the wreck has dropped away and fresh corrosion is apparent. It is speculated that local seismic activity may be a factor in this situation. Most of the lighter-weight steel plating has disappeared; it is predicted that the wreck will undergo major structural collapse in the next 5–12 years. Further, it is estimated that in 80 years only the conning tower, propellers and shafts and engine bed plates will remain. Additional oceanographic data from the wreck site is required to enable these predictions to be refined. These issues are discussed in detail in Annexes B (see page 47) and D (see page 102).

Figure 11 – Pressure hull near starboard after hydroplane, showing concretion delamination.
Image courtesy of Paul G Allen, Find AE1 Ltd, Australian National Maritime Museum and Curtin University. © Navigea Ltd

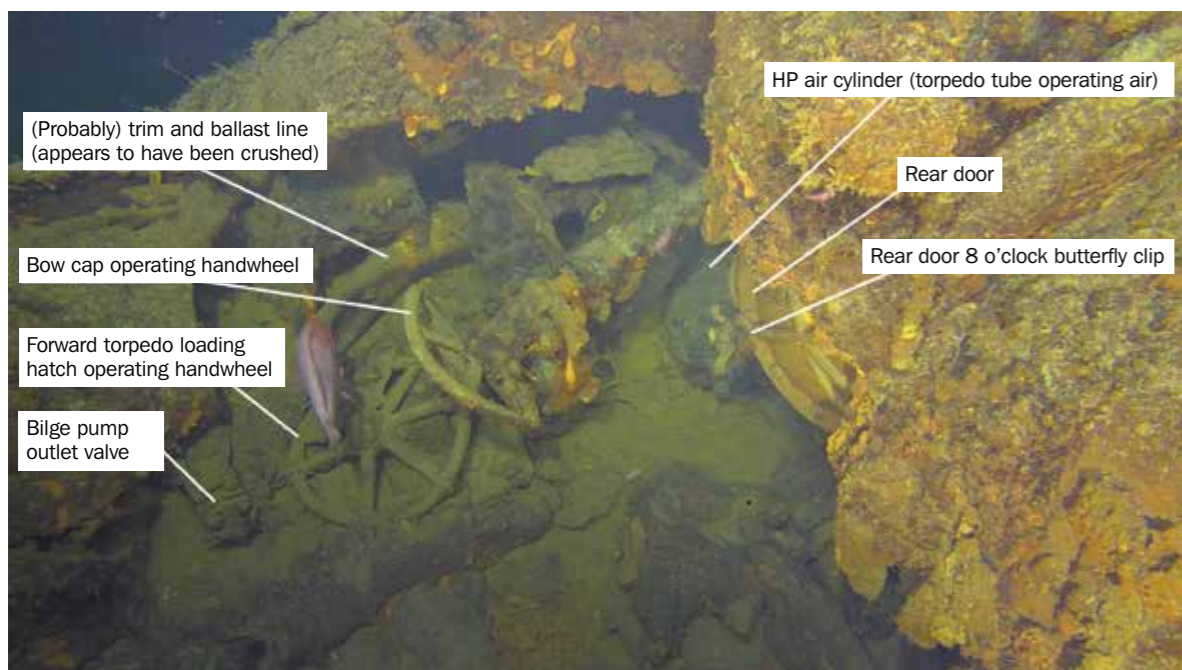
Figure 19 – Forward torpedo tube rear door butterfly clip, open view from starboard.
Image courtesy of Paul G Allen, Find AE1 Ltd, Australian National Maritime Museum and Curtin University. © Navigea Ltd

We do not think this was part of the accident sequence; the rear door remains shut, indicating that it was not the source of any flooding. This is corroborated by the implosion over this compartment as flooding would have tended to equalise the external water pressure, making implosion less likely if the compartment had flooded through the forward torpedo tube.

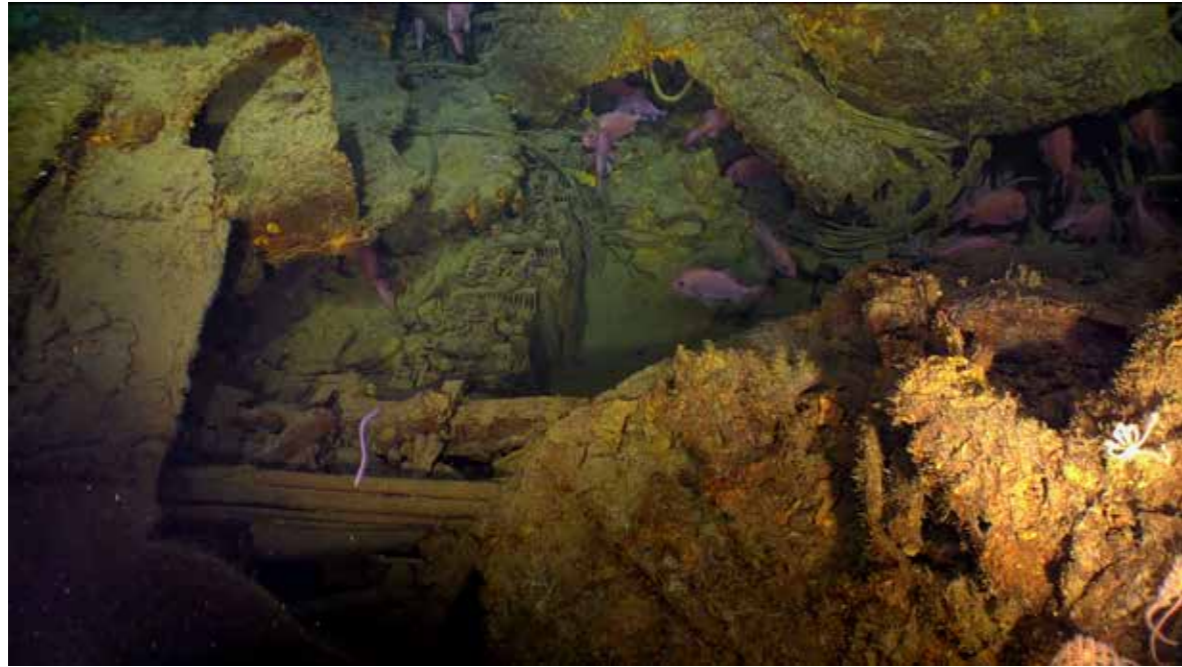
A portion of the forward main battery is visible. This was unexpected. The batteries were secured in a waterproof metal tank with a top cover made up of a double layer of teak boards in turn covered with two layers of painted canvas so as to be waterproof, and was tested to 3 psi (20.68 kilopascals) air pressure to check that it was sealed.¹² These arrangements have obviously broken down with the passage of time. Why only a portion of the battery is visible and there is no sign of the after section of the battery is not known.

Figure 21 – Battery cells visible in the control room.
Image courtesy of Paul G Allen, Find AE1 Ltd, Australian National Maritime Museum and Curtin University. © Navigea Ltd

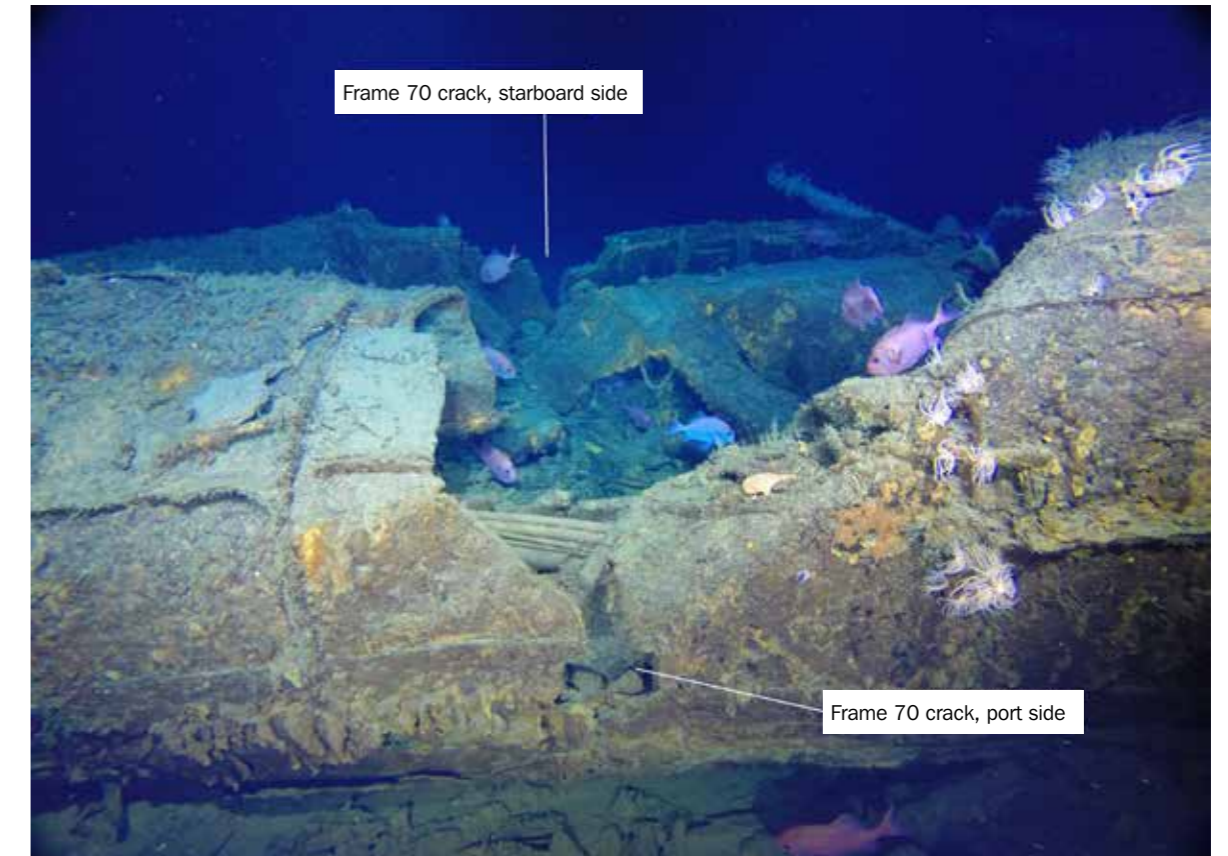
It would appear that the keel and pressure hull have broken in the vicinity of frame 70¹³ and this could explain why one battery section is visible and one has dropped from sight. The apparent split in the pressure hull/keel will be considered further in discussing the sinking process below.

Figure 22 – Pressure hull split at frame 70.
Image courtesy of Paul G Allen, Find AE1 Ltd, Australian National Maritime Museum and Curtin University. © Navigea Ltd

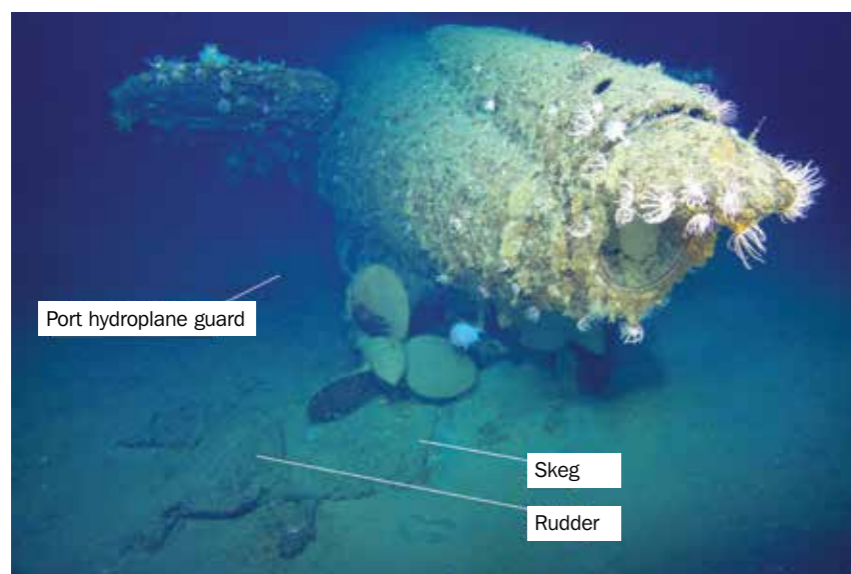
The skeg has broken away from the pressure hull and the rudder has been displaced; both are lying on the sea floor in the vicinity of the port propeller.

Figure 24 – Rudder and skeg lying on the sea floor. Image courtesy of Paul G Allen, Find AE1 Ltd, Australian National Maritime Museum and Curtin University. © Navigea Ltd

Significant force would be required to break the skeg and displace the rudder. This damage is consistent with the initial and major impact of a stern-first grounding. This will be considered in greater detail in the section dealing with the sinking process.

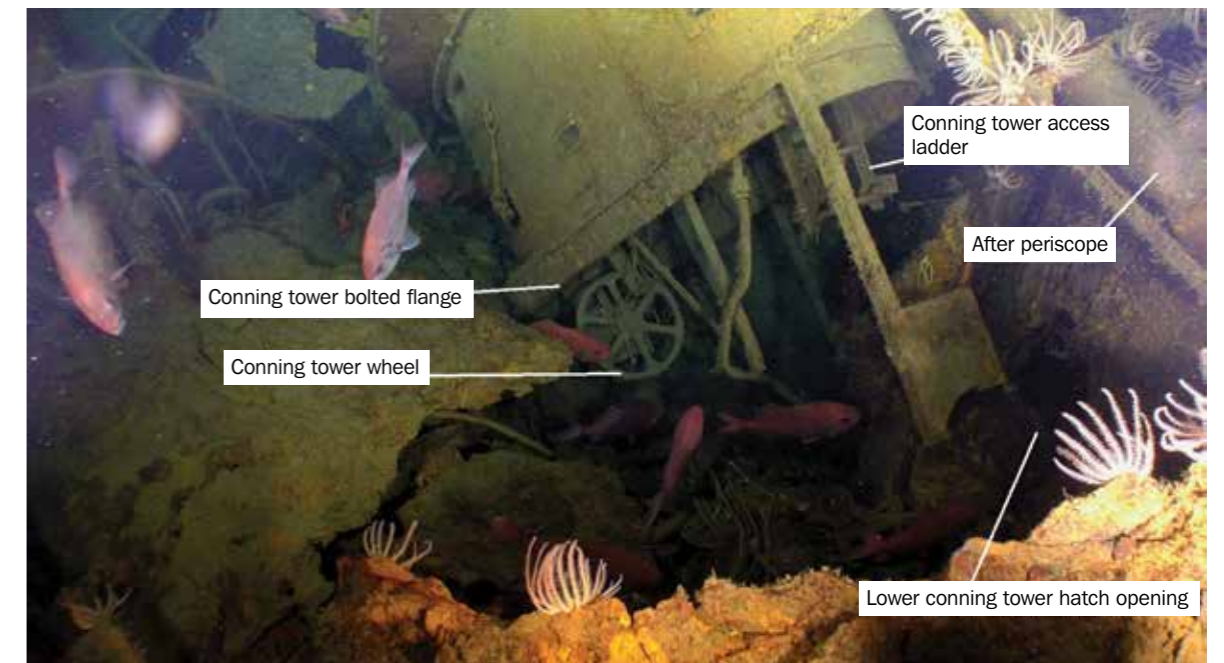
The opening in the pressure hull for the conning tower lower hatch has been identified because it is in a portion of the pressure hull on which the after periscope is mounted. The coaming and hatch are missing; just the opening remains. This is another unexplained puzzle and is discussed further in Annex C (see page 59).

Figure 25 – Conning tower lower hatch opening. Image courtesy of Paul G Allen, Find AE1 Ltd, Australian National Maritime Museum and Curtin University. © Navigea Ltd

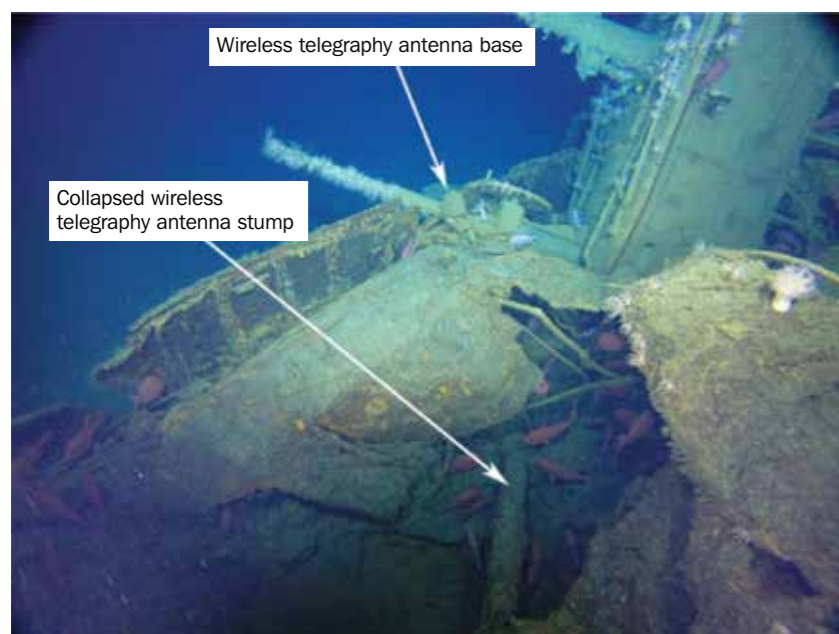
Figure 2 – Remnants of *AE1*'s devastated control room, showing the locations of the collapsed wireless telegraphy antenna and its base, which remains *in situ*. The collapsed fin is visible in the background. Image courtesy of Paul G Allen, Find *AE1* Ltd, Australian National Maritime Museum and Curtin University. © Navigea Ltd

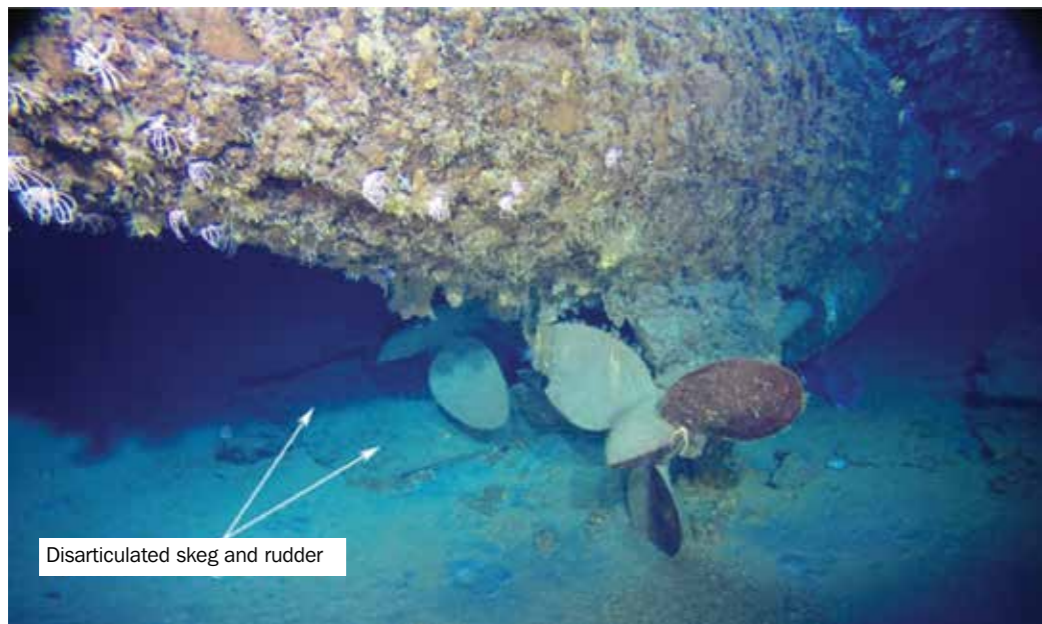
Figure 4 – AE1's disarticulated skeg and rudder are lying flat on the seabed beneath the stern. Note the relatively undamaged condition of the propellers. Image courtesy of Paul G Allen, Find AE1 Ltd, Australian National Maritime Museum and Curtin University. © Navigea Ltd

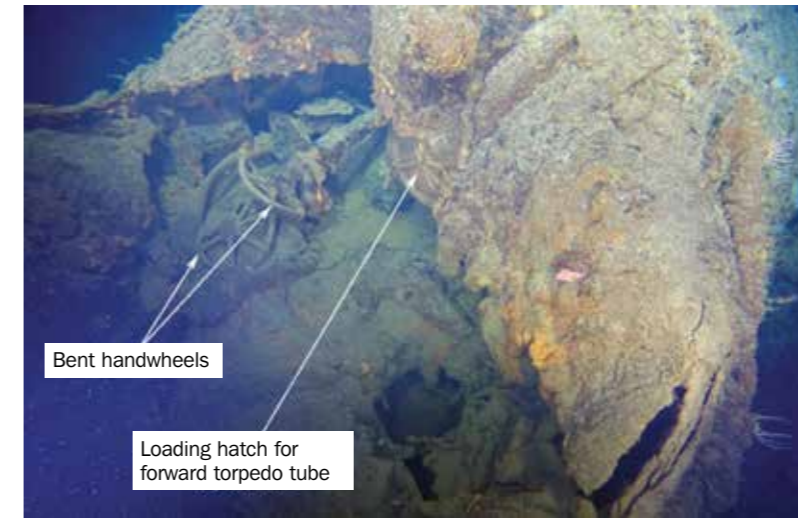
Figure 6 – AE1's devastated forward torpedo compartment, showing folded hull plating and the damage to handwheels wrought by the implosion event. Image courtesy of Paul G Allen, Find AE1 Ltd, Australian National Maritime Museum and Curtin University. © Navigea Ltd

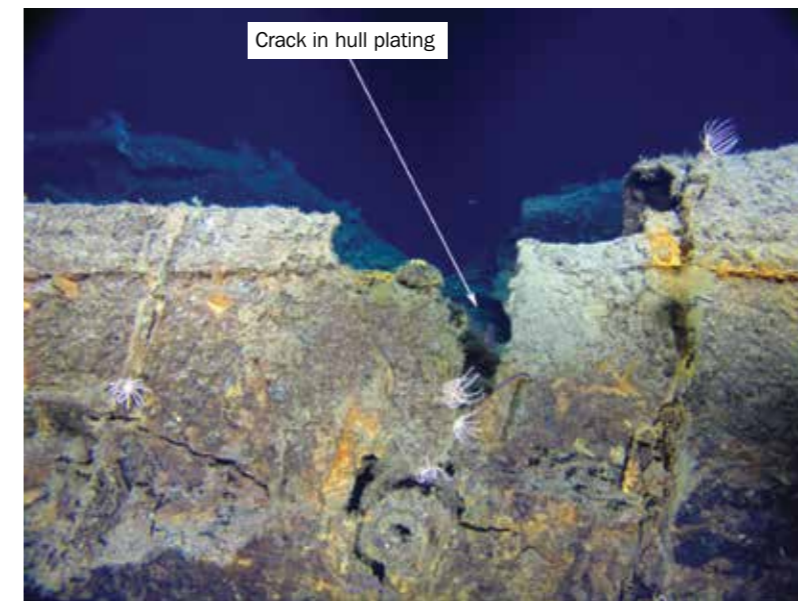
Figure 7 – Vertical fissure in AE1's port side pressure hull at Frame 70. Image courtesy of Paul G Allen, Find AE1 Ltd, Australian National Maritime Museum and Curtin University. © Navigea Ltd

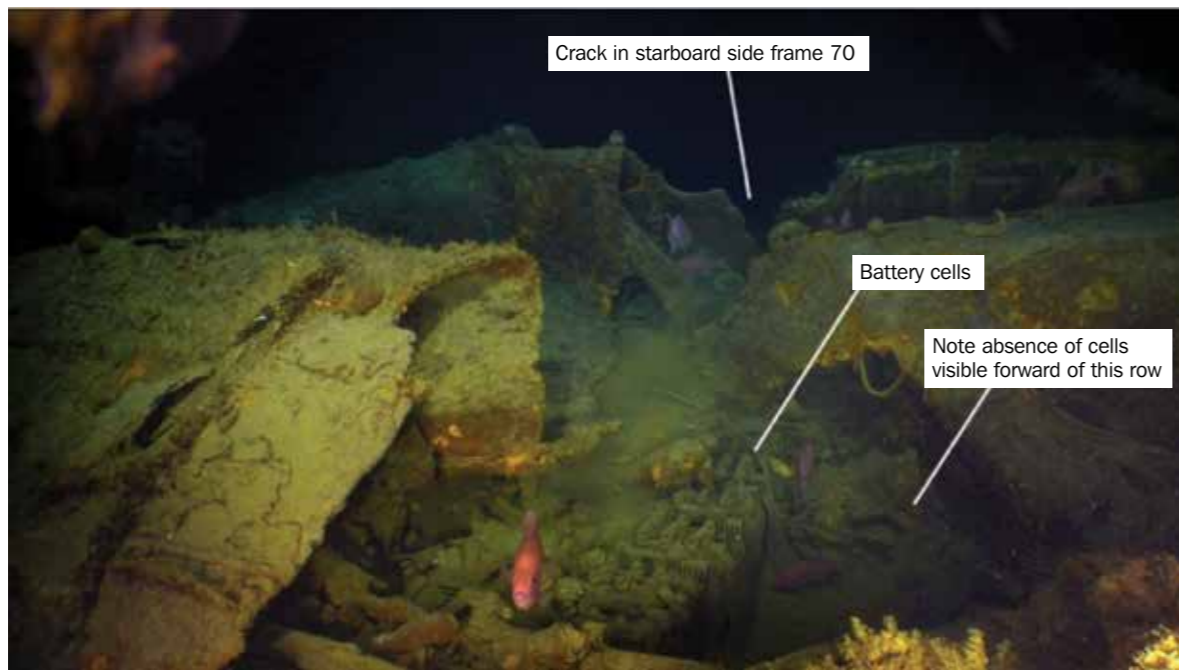
Figure 6 – Control room implosion area and Frame 70 crack in pressure hull.
Image courtesy of Paul G Allen, Find AE1, Australian National Maritime Museum and Curtin University. © Navigea Ltd

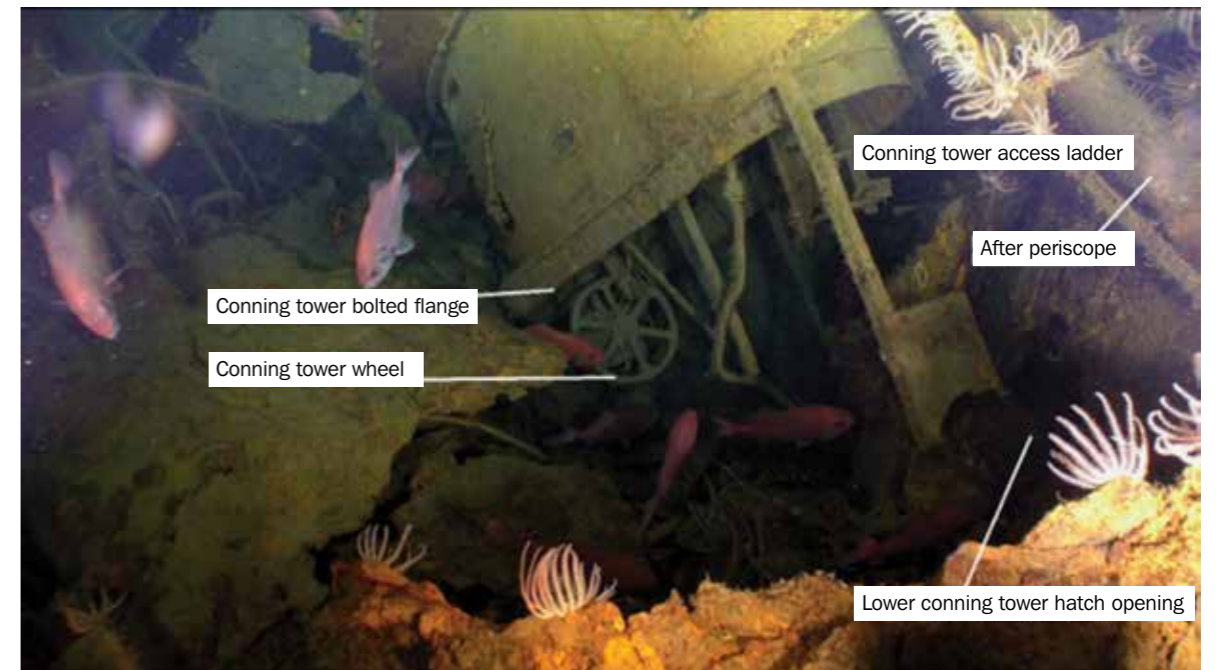
Figure 8 – Fin from port. Note absence of conning tower lower section.
Image courtesy of Paul G Allen, Find AE1, Australian National Maritime Museum and Curtin University. © Navigea Ltd

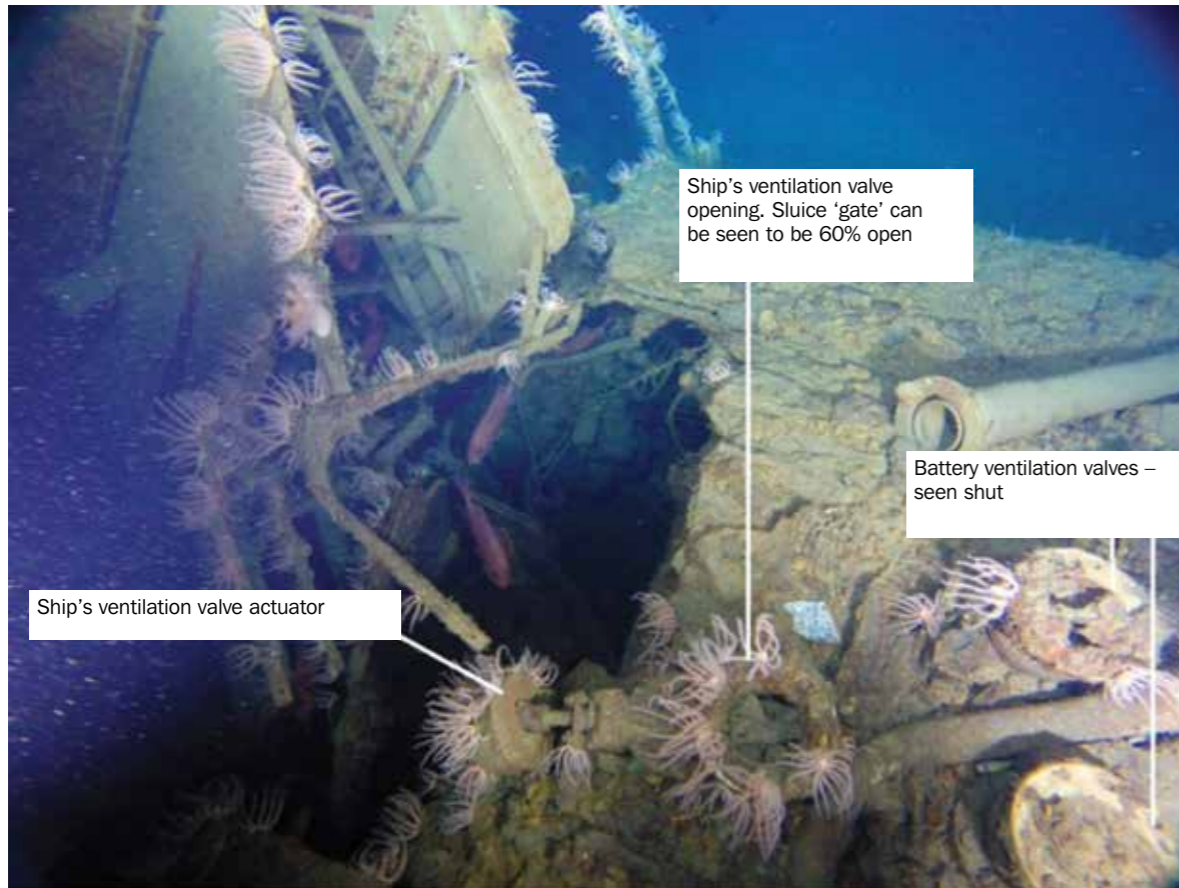
The ship's ventilation hull valve has been found 60% open; this may have initiated a sequence that led to the flooding of the after end of the submarine, causing it to sink, out of control, past its crush depth, leading to an implosion that would have killed the crew instantaneously. The submarine then appears to have sunk stern first to the bottom. We don't know why the valve was not shut prior to diving.

It is considered likely that the normal state of the quick-acting valve when on the surface (that is, prior to diving) would be open. In this case, with the quick-acting valve open (or not fitted), or if the trunking failed to hold the pressure build-up, then water could have entered the after end of the submarine immediately on diving. The water could quickly make its way to the lower section of the after end of the submarine containing the after main battery and vital systems supplying power, lighting and the port main propulsion motor. The additional water would also cause a loss of buoyancy, causing *AE1* to sink faster. As it sank deeper the volume of water entering the submarine would increase dramatically.¹¹ The combined effect would be a rapid loss of control and the depth excursion that caused the fatal implosion.

Figure 24 – Ship's ventilation hull valve.
Image courtesy of Paul G Allen, Find AE1, Australian National Maritime Museum and Curtin University. © Navigea Ltd

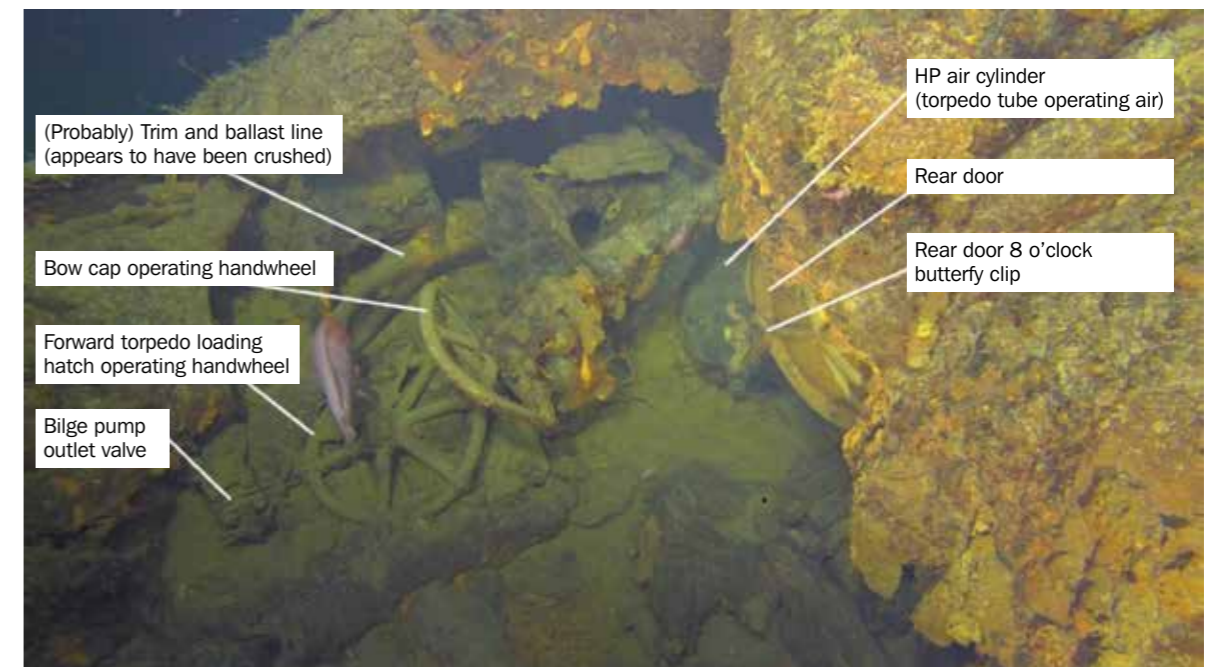
Figure 31 – Forward torpedo compartment implosion area (see also Figure 4, page 67).
Image courtesy of Paul G Allen, Find AE1, Australian National Maritime Museum and Curtin University. © Navigea Ltd

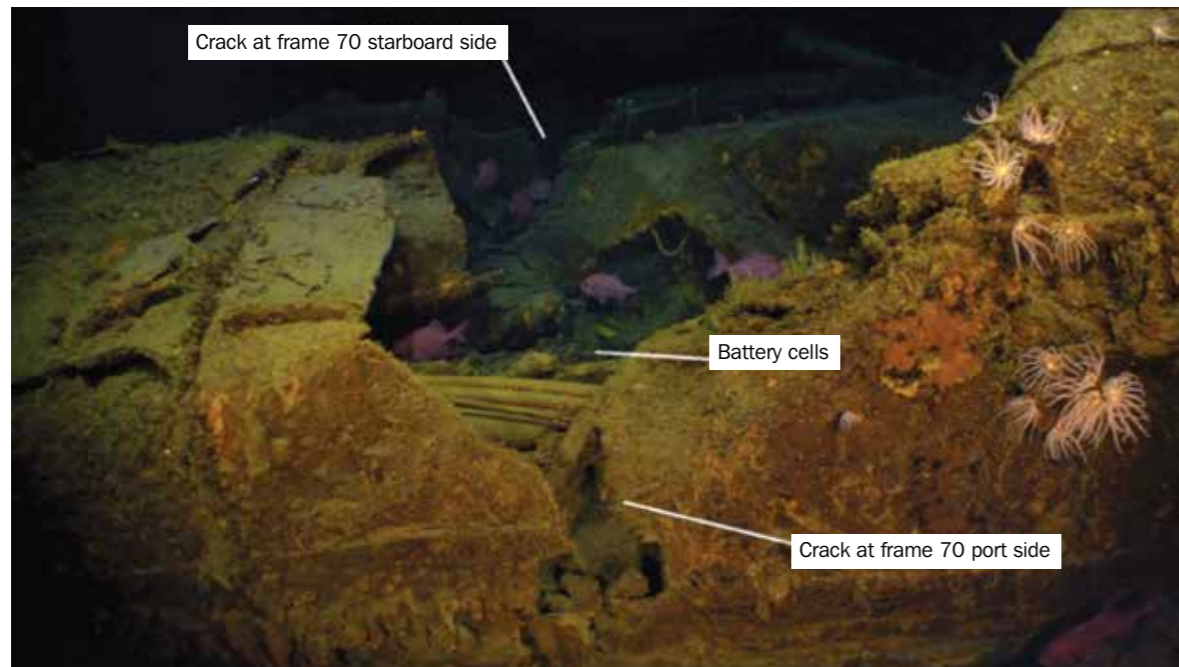
Figure 32 – Side-on view of Frame 70 pressure hull crack.
Image courtesy of Paul G Allen, Find AE1, Australian National Maritime Museum and Curtin University. © Navigea Ltd

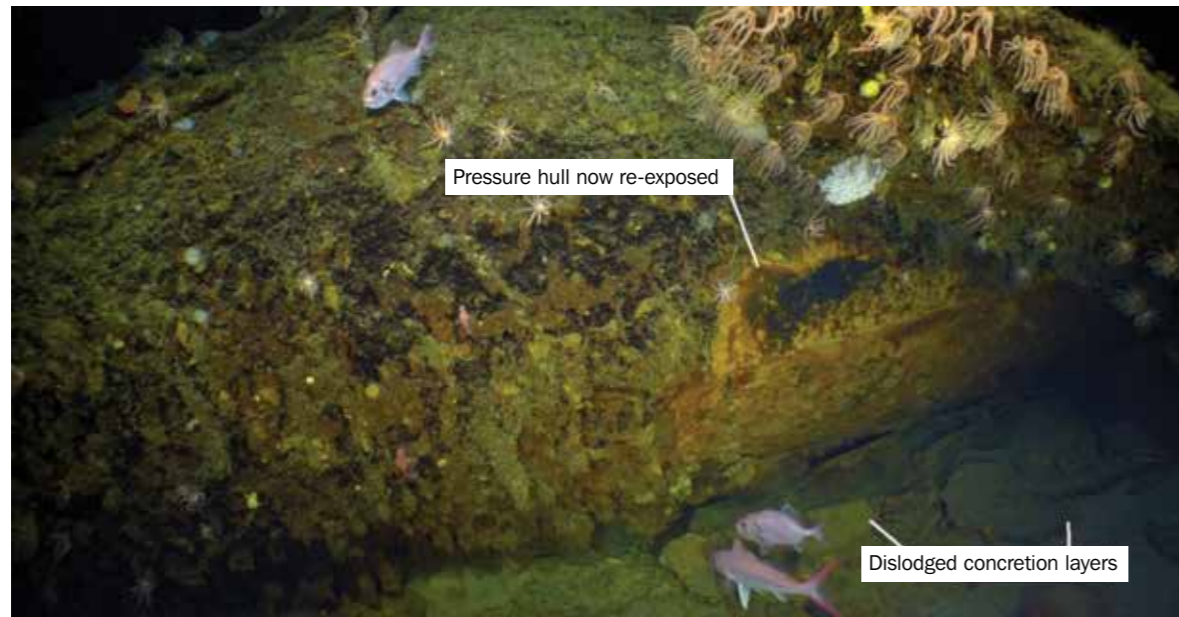
Figure 47 – Example of concrete delamination under foreplane. Image courtesy of Paul G Allen, Find AE1, Australian National Maritime Museum and Curtin University. © Navigea Ltd

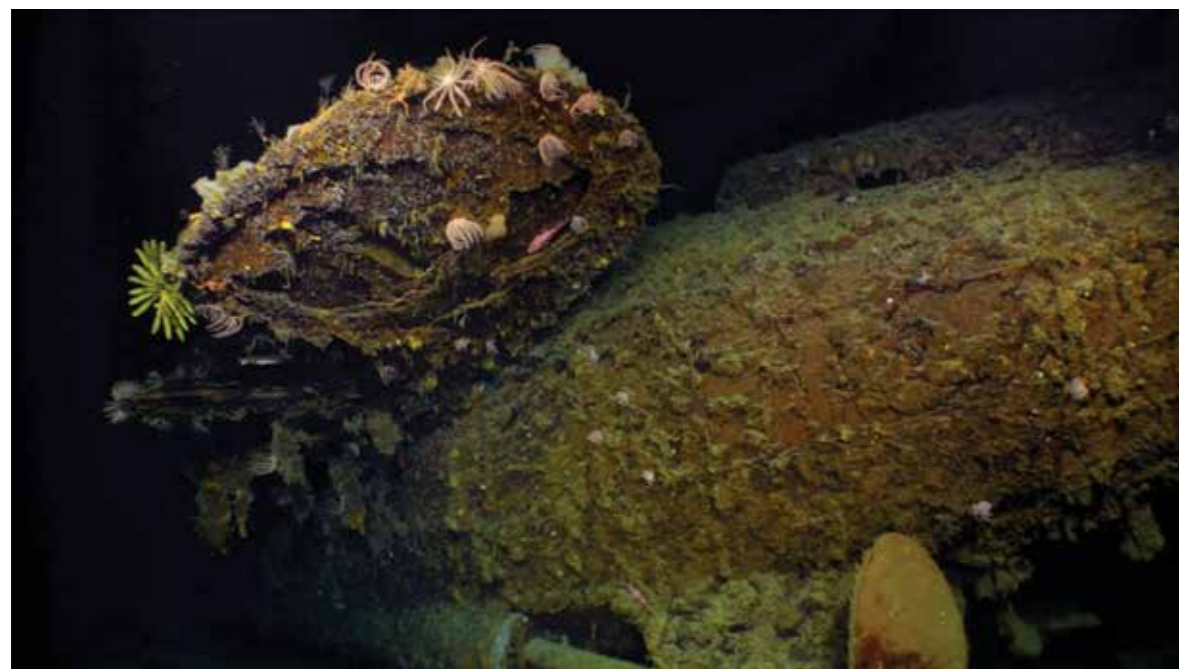
Figure 48 – Example of plate corrosion under port afterplane. Image courtesy of Paul G Allen, Find AE1, Australian National Maritime Museum and Curtin University. © Navigea Ltd

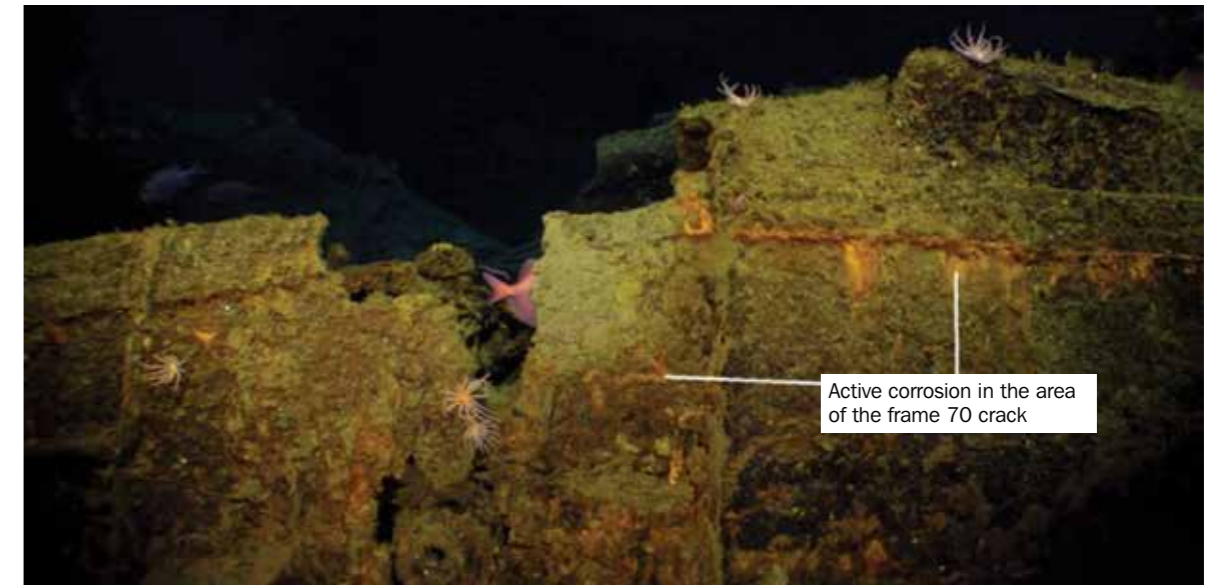
Figure 49 – Examples of (the many) areas of active corrosion. Image courtesy of Paul G Allen, Find AE1, Australian National Maritime Museum and Curtin University. © Navigea Ltd

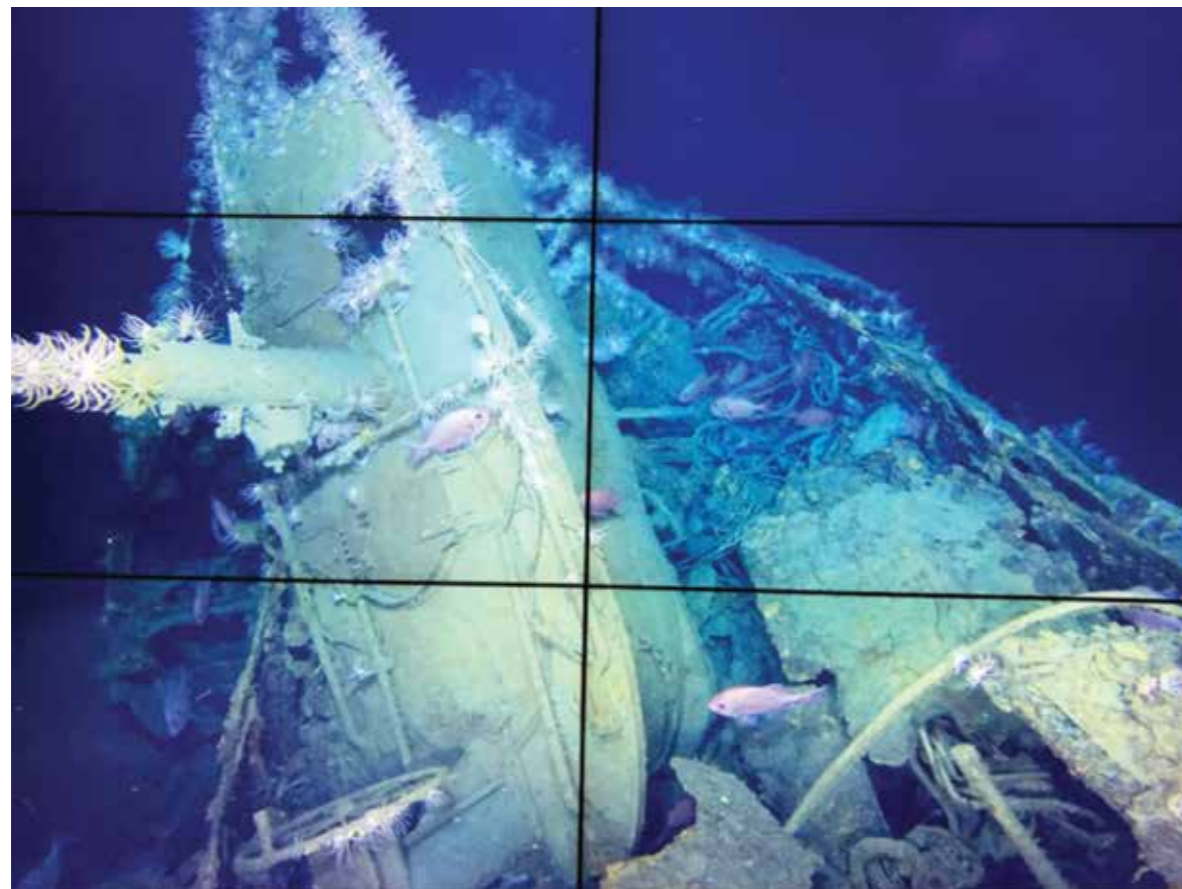
View of the fin and residual pressure hull showing implosion damage.
 Image courtesy of Paul G Allen, Find AE1 Ltd, Australian National Maritime Museum and Curtin University. © Navigea Ltd

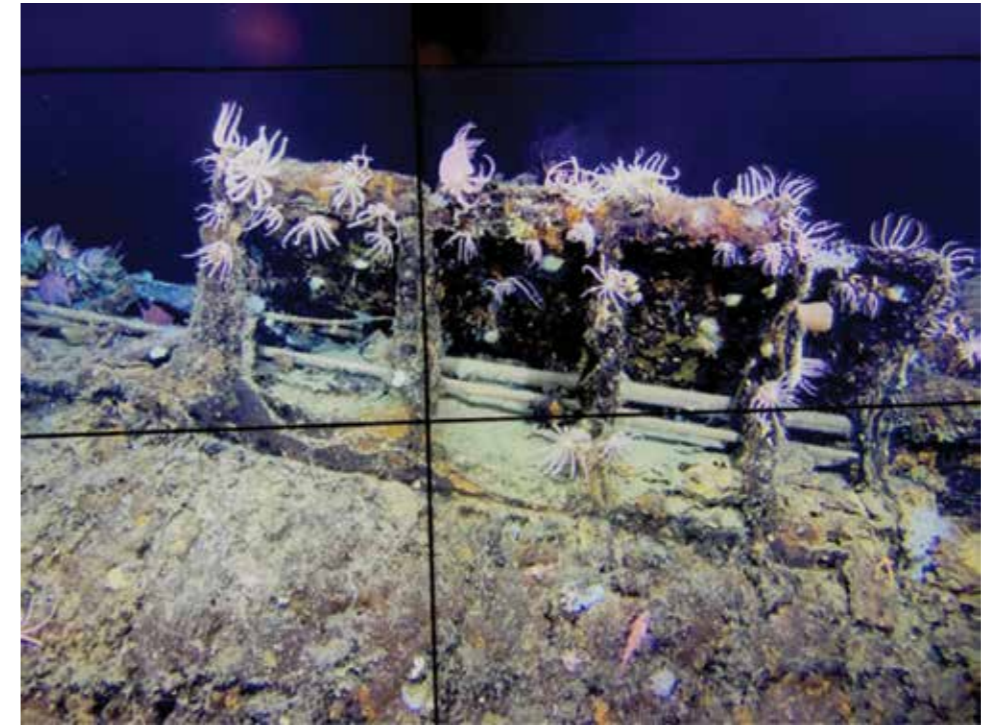
Figure 4 – A few metres aft of the bow the 17-pound (10.6 mm) plate of the forward firing tank has corroded away leaving the frames in a half-corroded state.

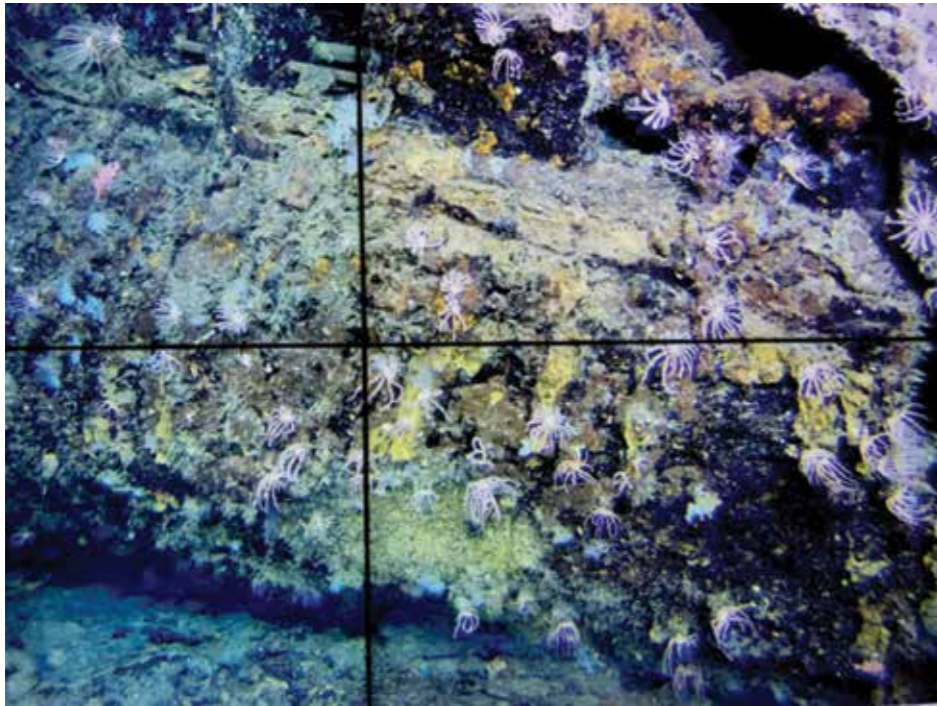
Figure 5 – Some weeping rusticles on port side and apparent separation of hull plates.
Image courtesy of Paul G Allen, Find AE1 Ltd, Australian National Maritime Museum and Curtin University. © Navigea Ltd

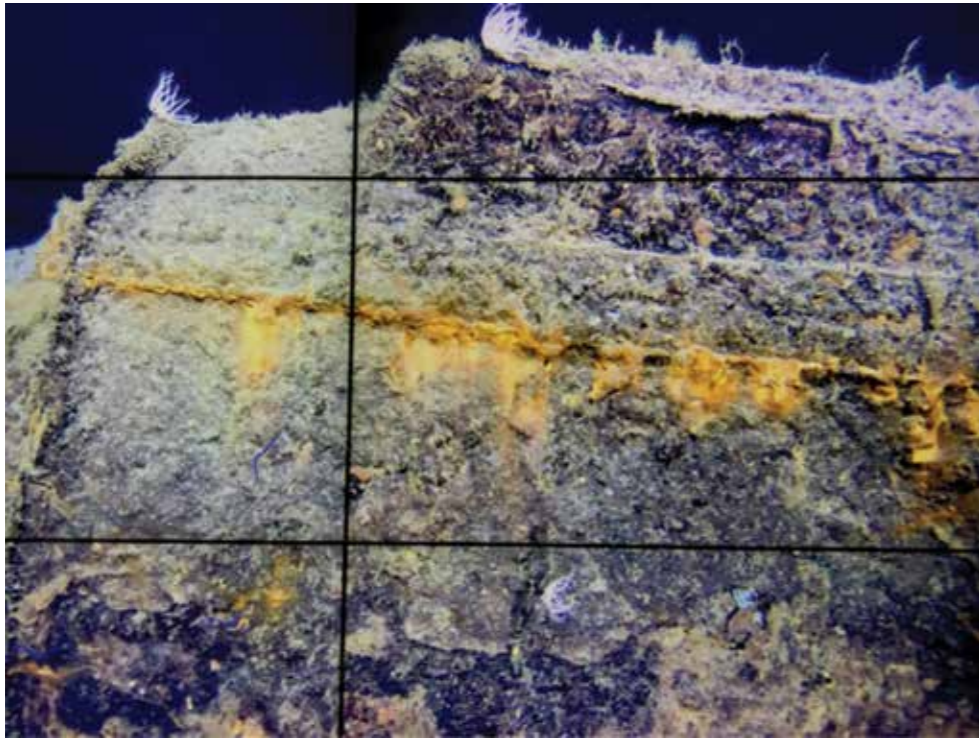
Figure 7 – Image 90-16134, showing corrosion at the join between plates below a doubling line. Image courtesy of Paul G Allen, Find AE1 Ltd, Australian National Maritime Museum and Curtin University. © Navigea Ltd

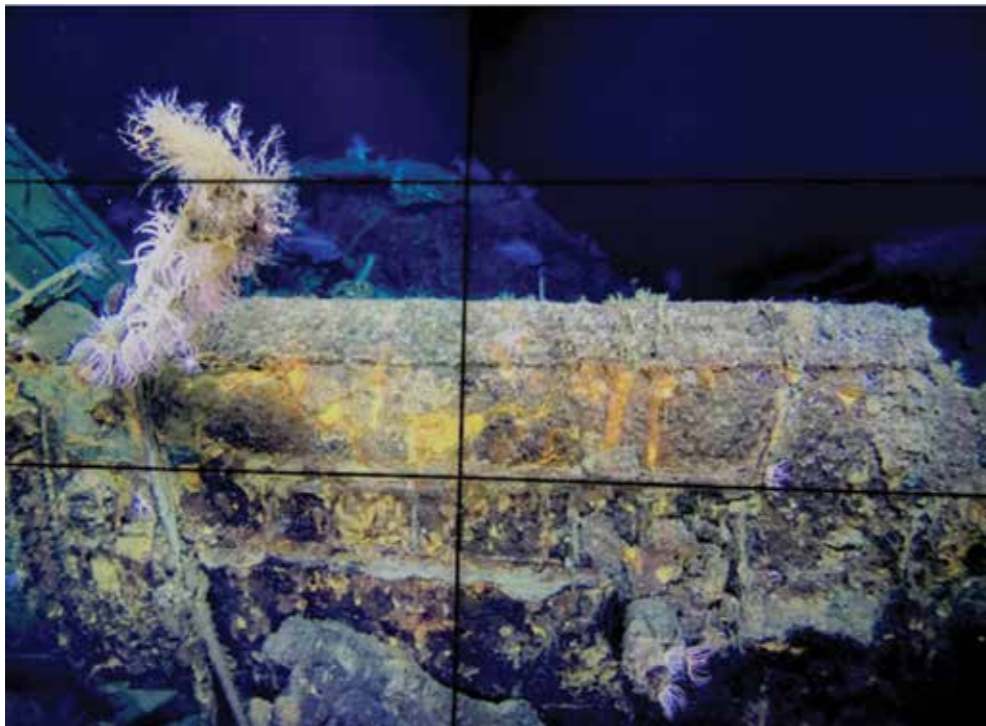
Figure 8 – Upper section of the submarine (starboard side of control room) showing weeping corrosion lines from the horizontal seam. Image courtesy of Paul G Allen, Find AE1 Ltd, Australian National Maritime Museum, and Curtin University. © Navigea Ltd

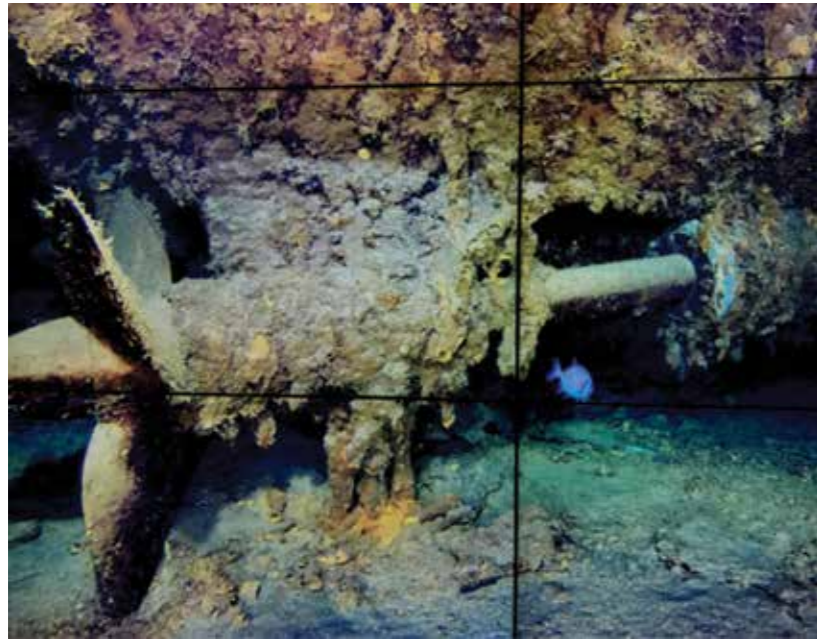
Figure 11 – Image 91-76390, showing starboard propeller and rusticles flowing from the A bracket.
Image courtesy of Paul G Allen, Find AE1 Ltd, Australian National Maritime Museum and Curtin University. © Navigea Ltd

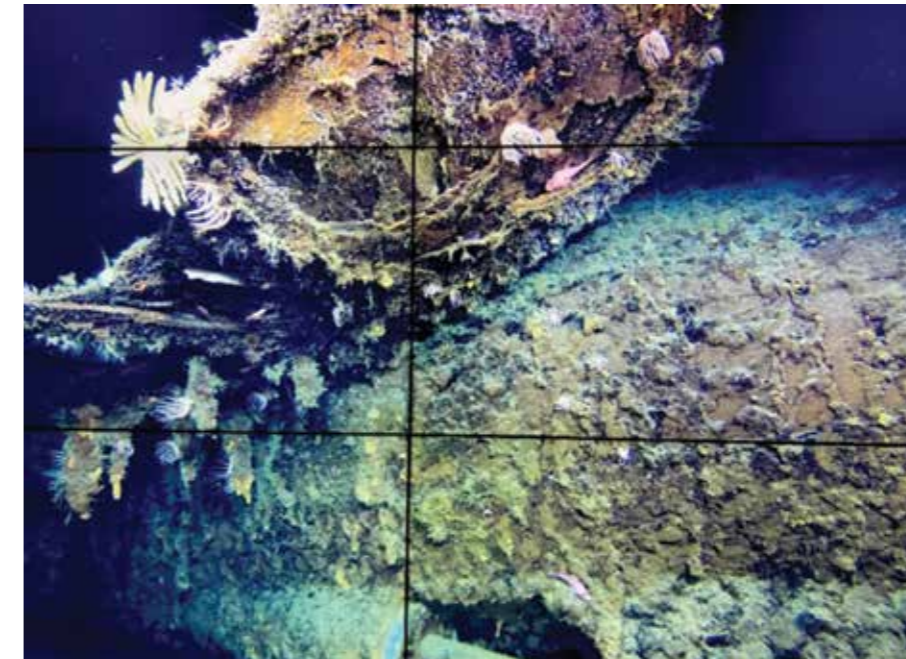
Figure 13 – Image 91-76463 of the port aft hydroplane, showing partial skin loss.
Image courtesy of Paul G Allen, Find AE1 Ltd, Australian National Maritime Museum and Curtin University. © Navigea Ltd
