# Locating HM Bark *Endeavour*

Archaeological identification  
of shipwreck site RI 2394 in  
Newport Harbor, Rhode Island, USA

Kieran Hosty  
James Hunter

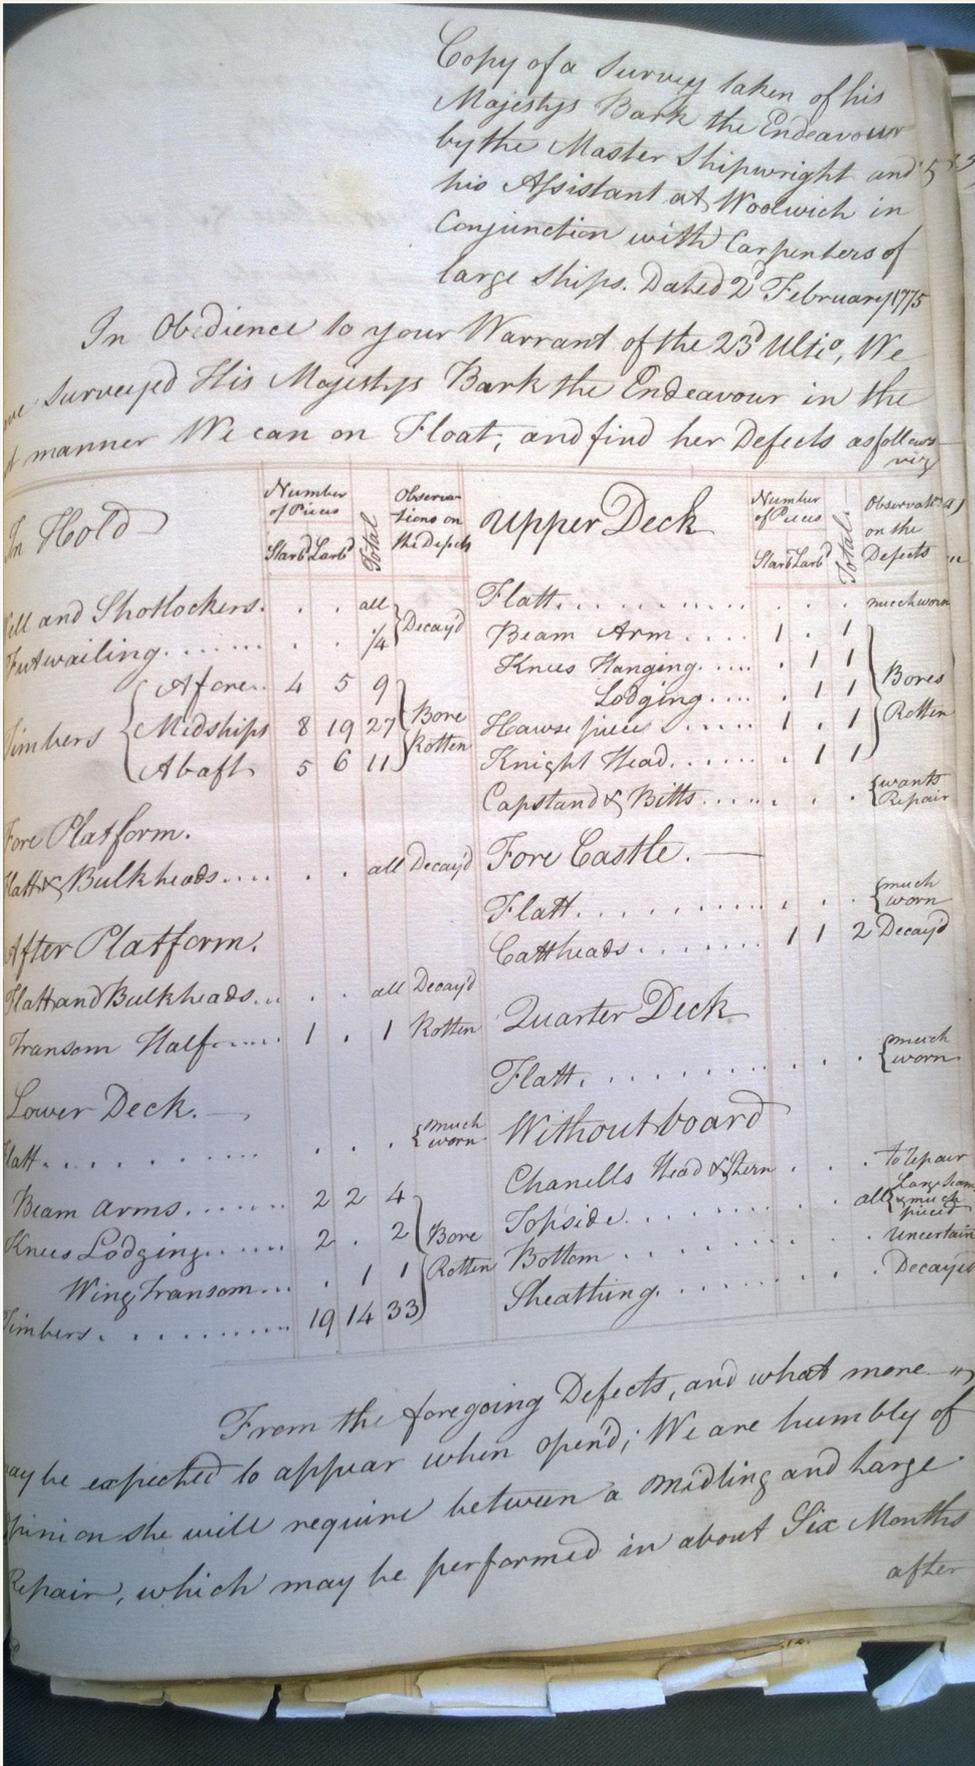
Figure 1. Report to the Admiralty noting significant repairs required in 1775 to keep Endeavour operational and seaworthy (ADM 354/189/330 Navy Board: Bound Out-Letters: Woolwich; National Archives, Kew). Photograph: Nigel Erskine/ANMM

ship's frames and 33 of the transom (stern) timbers were rotten, could not be repaired, and needed to be replaced.<sup>2</sup> All decks were described as 'much worn', the sheathing 'decayed', and the state of the ship's lower hull 'uncertain' (Erskine 2017: 61).

2 ADM 354/189/330 notes the following timbers were rotten and needed to be replaced: In the bow, four timbers (frames) on the starboard side and nine timbers on the larboard (port) side; at midships, eight timbers on the starboard side and 19 timbers on the larboard side; and at the stern, five timbers on the starboard side and six timbers on the larboard side. This constituted 47 timbers in total, or around 36% of the lower hull.

The master shipwright at Woolwich stated *Endeavour* required 'large repairs' that would take around six months to complete and cost approximately £3,420. Upon receiving the report, the Navy Board recommended the vessel be sold out of service, and in March 1775 master mariner George Brodrick purchased it for £645 (Erskine 2017: 59–61; Knight 1933: 299–300). The 1776 edition of *Lloyds Register* states *Endeavour*, a ship-rigged vessel of 350 tons built at Whitby in 1764, is 'Now the *Lord Sandwich*; owner James Mather; Blanchard – Master, sailed from Archangel (Russia) for London' (Erskine 2017: 61–3).

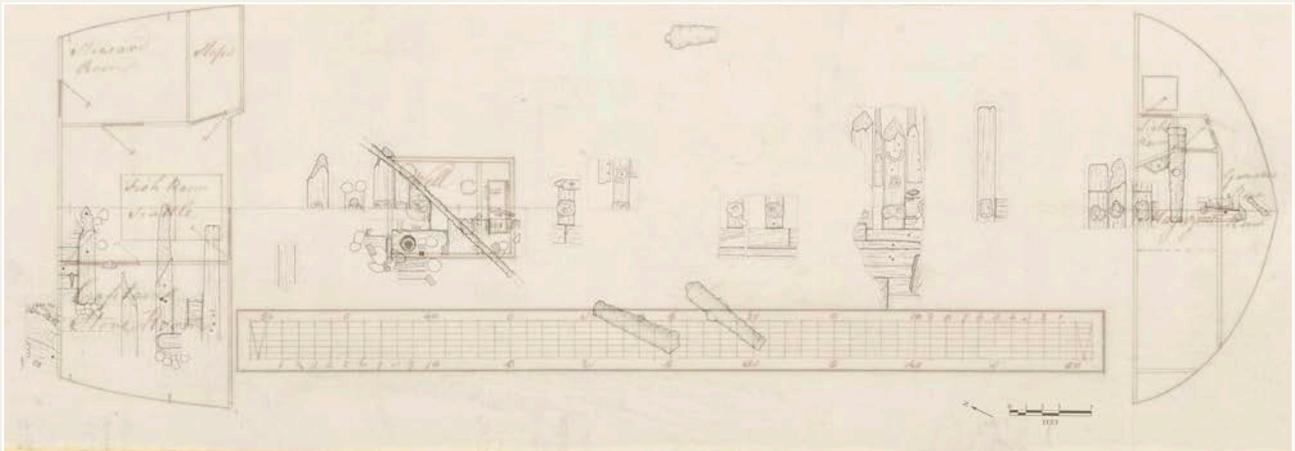
**Figure 9.** 2019–21 site plan overlaid with *Endeavour*'s 1768 survey draught, showing relative positions of site features such as the pump well compared with those on the archival plan. Image: Royal Museums Greenwich; James Hunter/ANMM.

the mainmast in the hull's midships section, the positive identification of the shaft stump provided a reference for position fixing within the vessel's surviving hull. An archaeological site plan generated from hull recording during the 2019 and 2020 investigations was scaled to the same size and superimposed with the 1768 Admiralty plan of *Endeavour* (Figure 9). The positions of the surviving bilge pump shaft, pump well bulkheads, and centreline keel bolts correlate exactly to the positions of these features on the 1768 plan of *Endeavour*'s lower hold (ADM 3814b, March 1768; Marquardt 2010: 40–1).

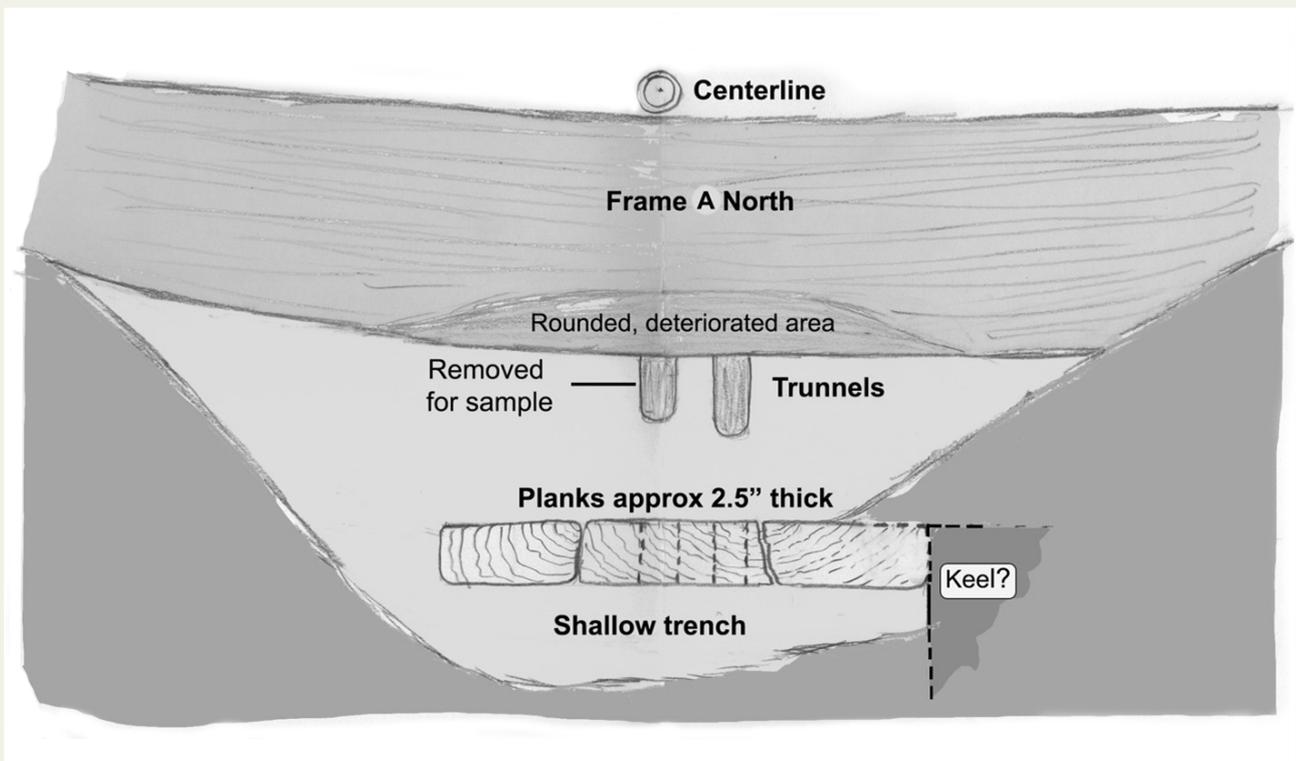
Figure 11. Cross-section through TP6N southern extension, at Frame A North (FU7), facing south, showing outer planking pulled free from Frame B North. Also shown is the possible keel, located on the last dive. Scale approximate (John D. Broadwater).

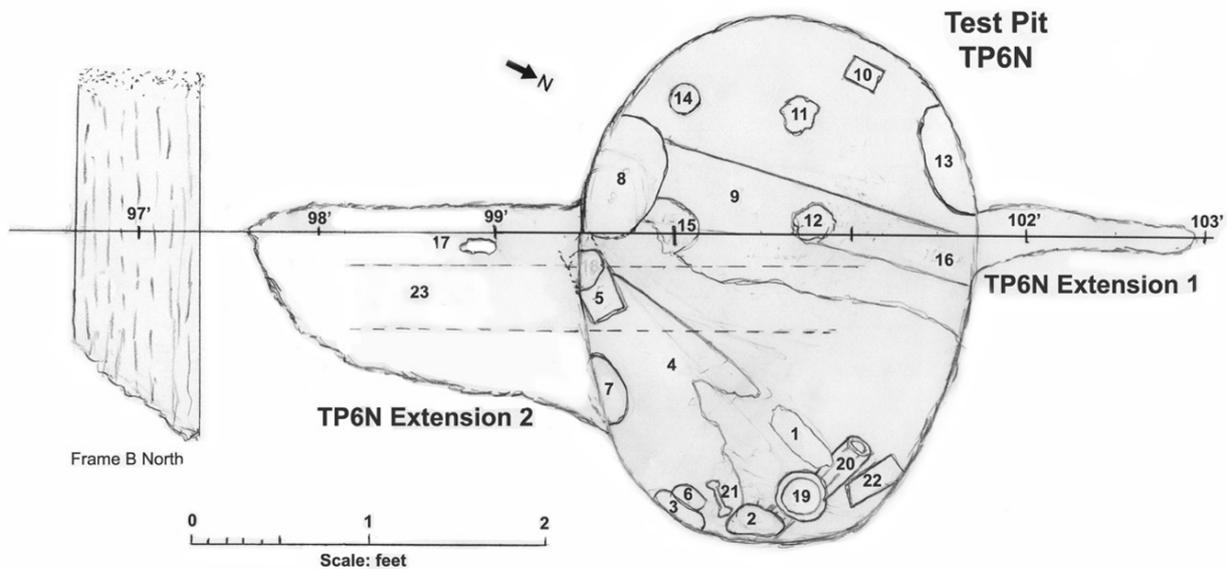
Several planks run fore and aft through TP6N on a roughly north-south orientation and are located at a depth of approximately 1 foot (0.3 metres) below grade. Those encountered beneath Frame A North were identified as runs of hull planking that had become disarticulated from the frame. Additional planks were encountered in TP6N, and some are believed to be contiguous with the hull planking beneath Frame A North. All are approximately 1 foot (0.3 metres) below grade. Their relatively shallow burial depth, as well as that of the two frames, suggests hull preservation is very poor in this part of the site. This

Figure 12. RI 2394: Details of test pit TP6N (John D. Broadwater).

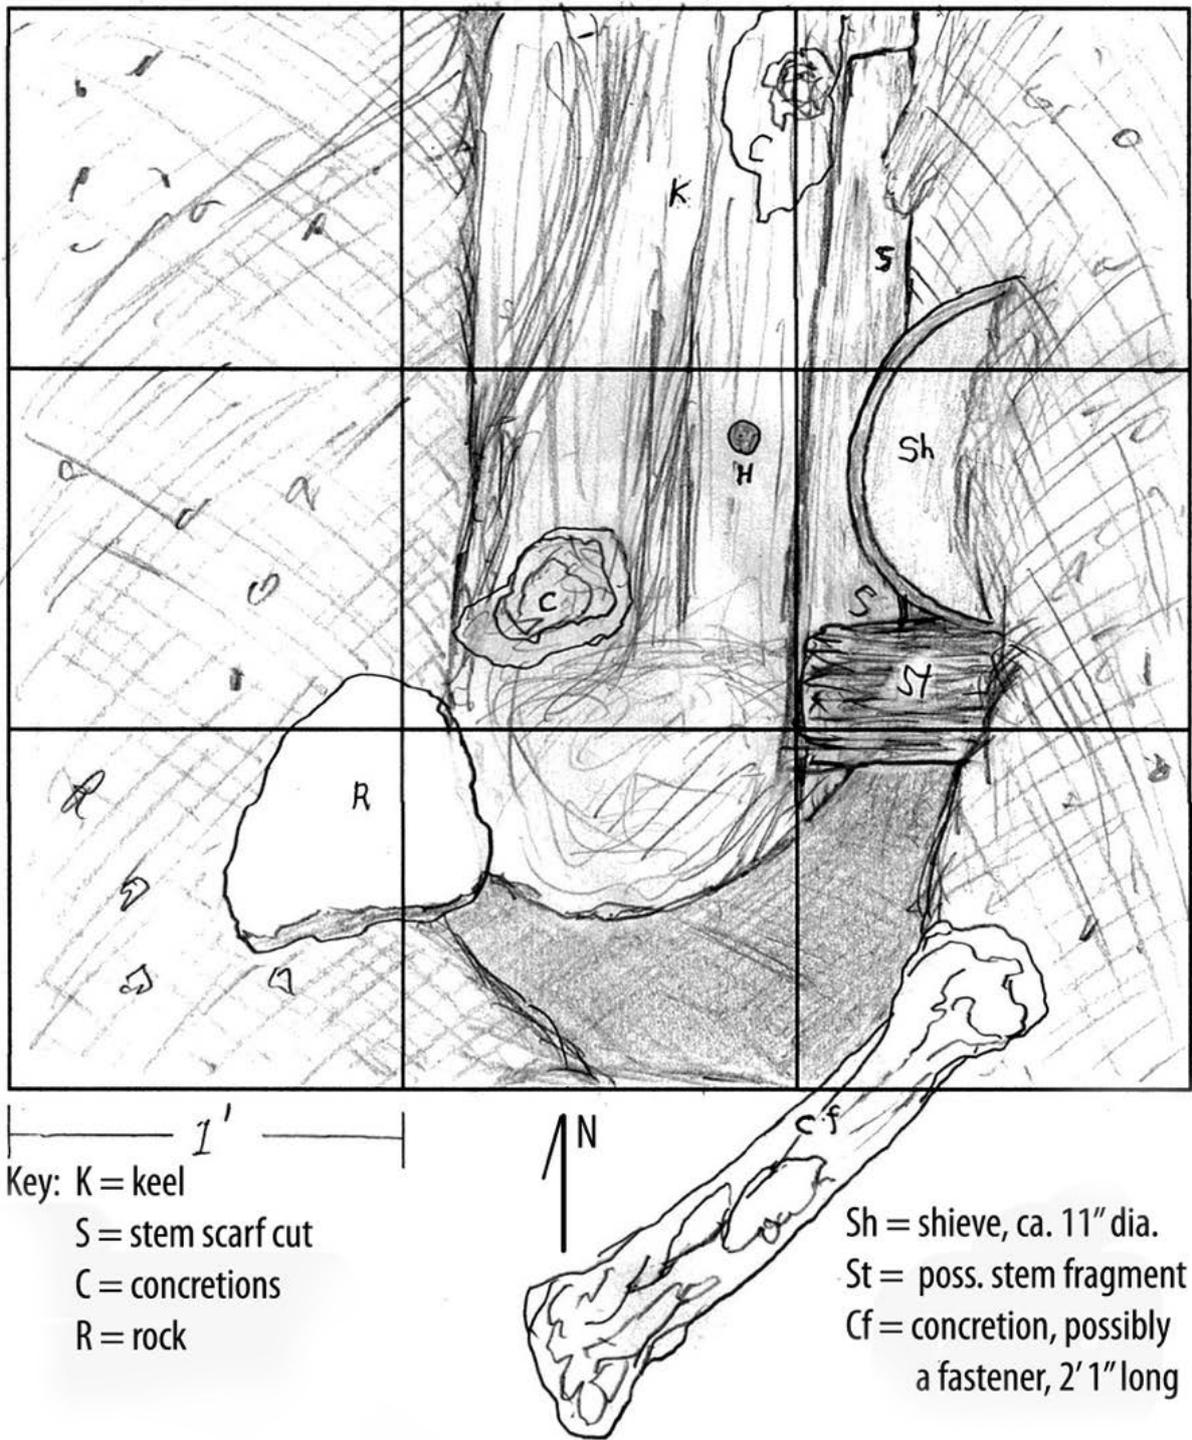
The use of a half-lap scarph joint like the one observed on RI 2394 seems unusual, as it superficially does not appear to be a particularly strong method for fastening the keel to the stem. However, as the area occupied by the two timbers where they overlap is significant (more than 0.33 metres of

Figure 13. South end of keel, showing stem-keel scarph in plan view (John D. Broadwater).

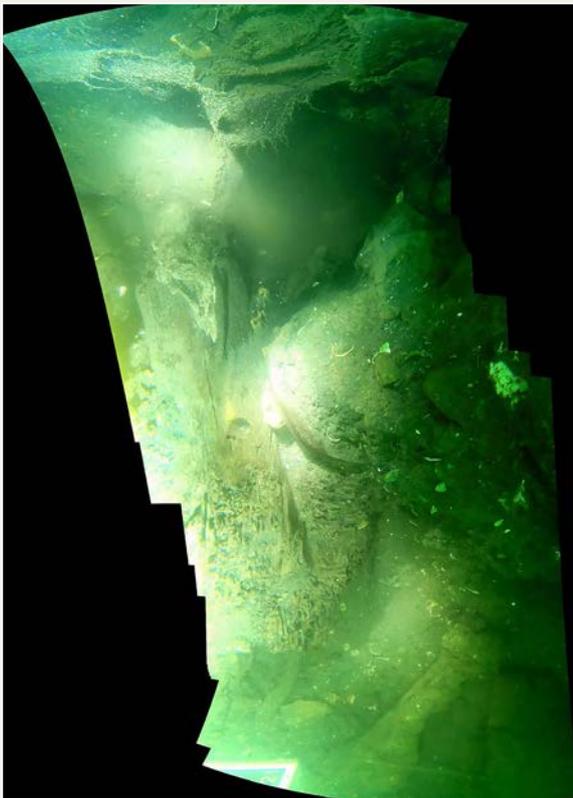
**Figure 14.** Photomosaic of keel's southern terminus, showing scarp for the stem (beneath wooden sheave at image centre). Note that north is up (John D. Broadwater and Joshua Daniel).

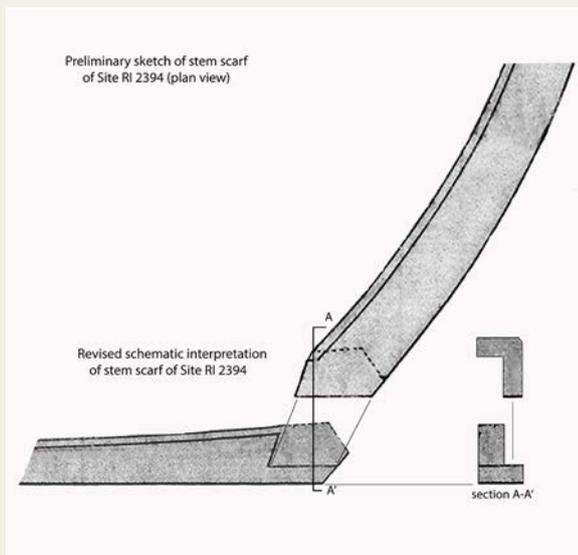
**Figure 15.** Reconstruction of RI 2394's keel-stem scarp (John D. Broadwater).

3.5 square feet,) it would have provided a large, flat surface for the insertion of several large connecting fasteners. It should be noted the surface area listed above does not include the upper, aft and lower surfaces of each timber, which also likely would have accommodated several large fasteners. When fayed together, the keel and stem would have formed a combined joint measuring 18 inches (0.46 metres) sided. Finally, the stem sat directly atop the keel, which would have helped to support the entire structure, as well as the bow deadwood immediately above it. It also permitted the stem to have a near-vertical rake, an absolute necessity for a vessel requiring the broad, bluff bow typical of a Whitby collier (Broadwater and Daniel 2021: 7-10).

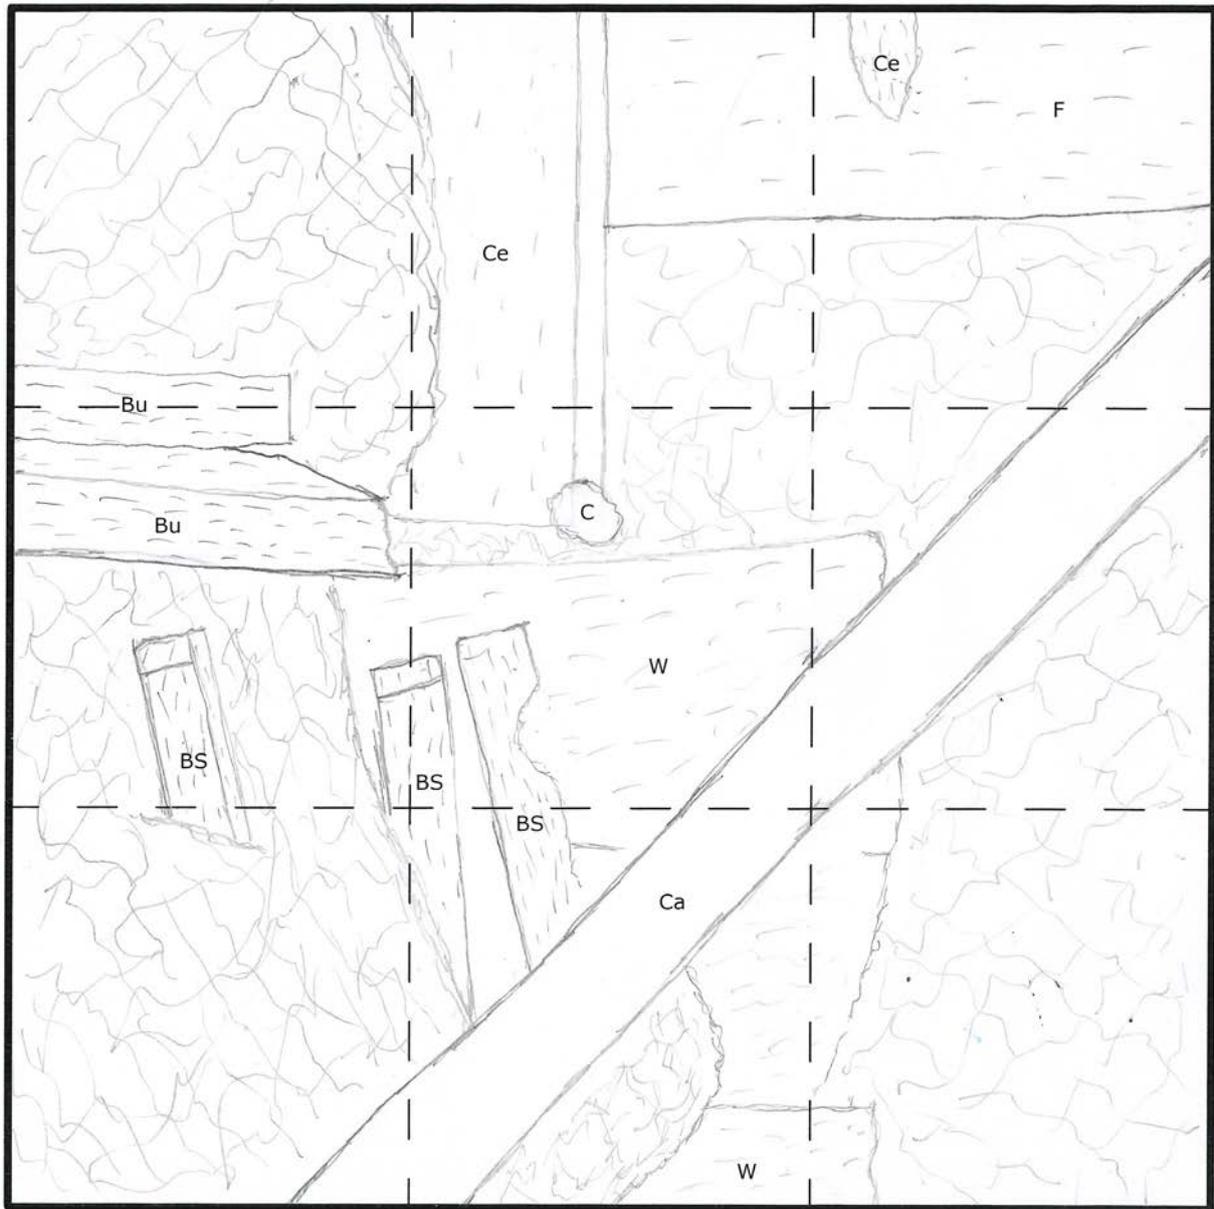
It is possible further excavation could reveal holes cut in the ceiling to accommodate the suction tubes or a pump sieve – also referred to as a 'basket' (ADM 3814b; Marquardt 1995: 71). However, further excavation of the pump well was discontinued, as exposing a larger and deeper area was thought to exceed the terms of the RIHPHC permit (Broadwater and Daniel 2021: 10). A large area within and forward of the pump well was exposed and carefully mapped (Figures 16 and 17). Scaled plan-view sketches, drawn with a 3-foot by 3-foot mapping grid, added more detail to the overall site plan and provide a starting point for future excavations in this area.

Figure 16. Pump well test pit, north section (Joshua Daniel).

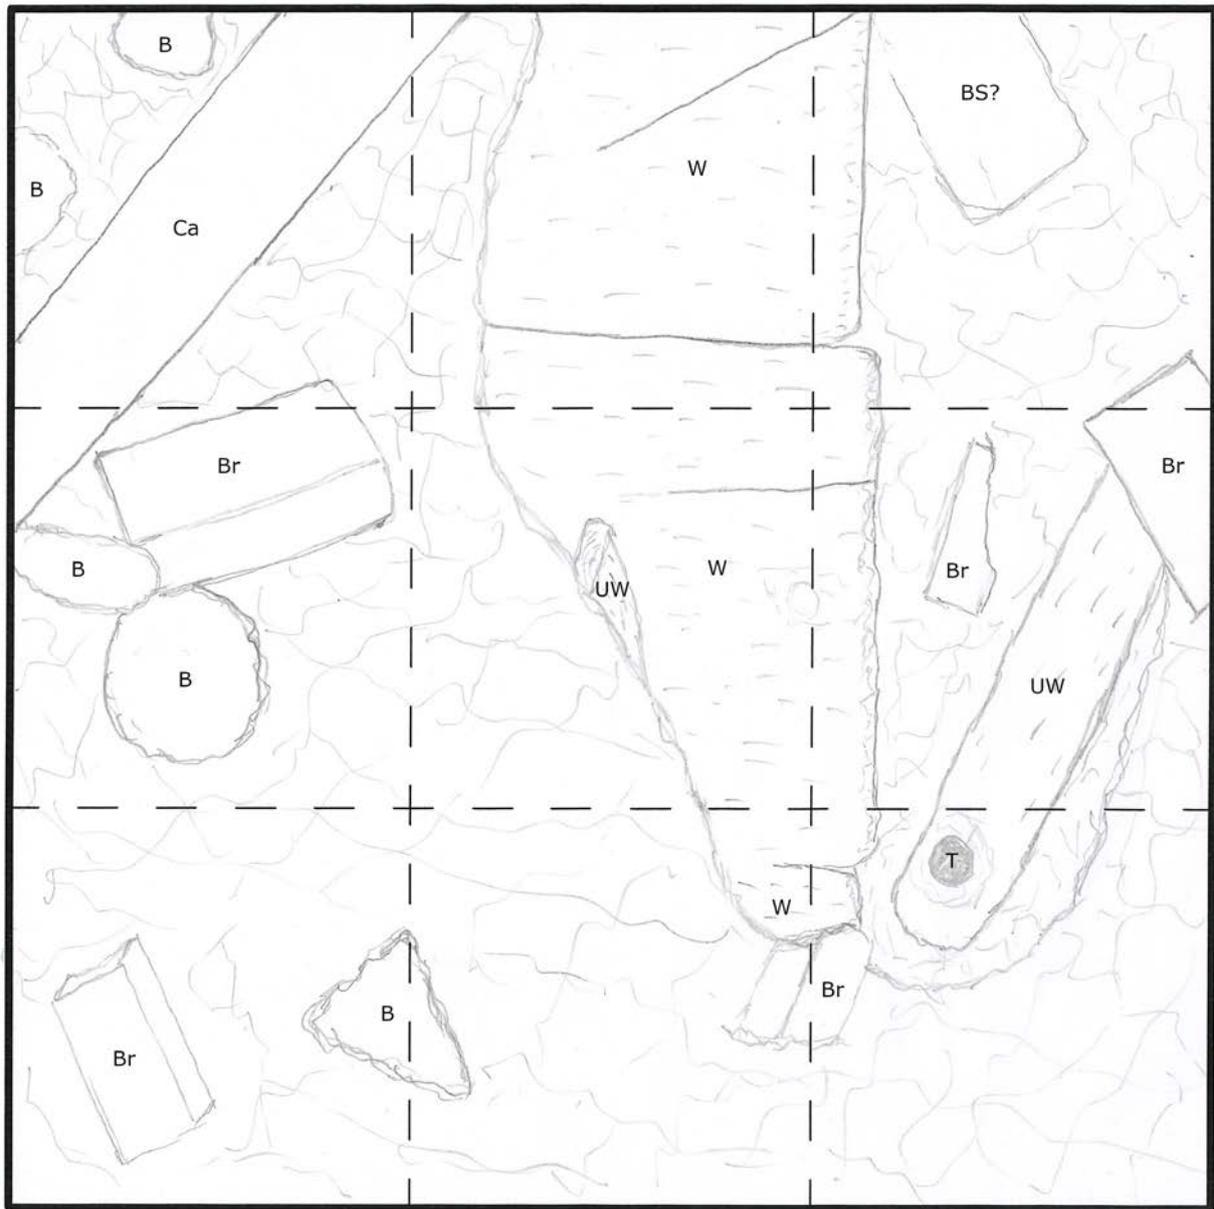
Figure 17. Pump well test pit, south section (Joshua Daniel).

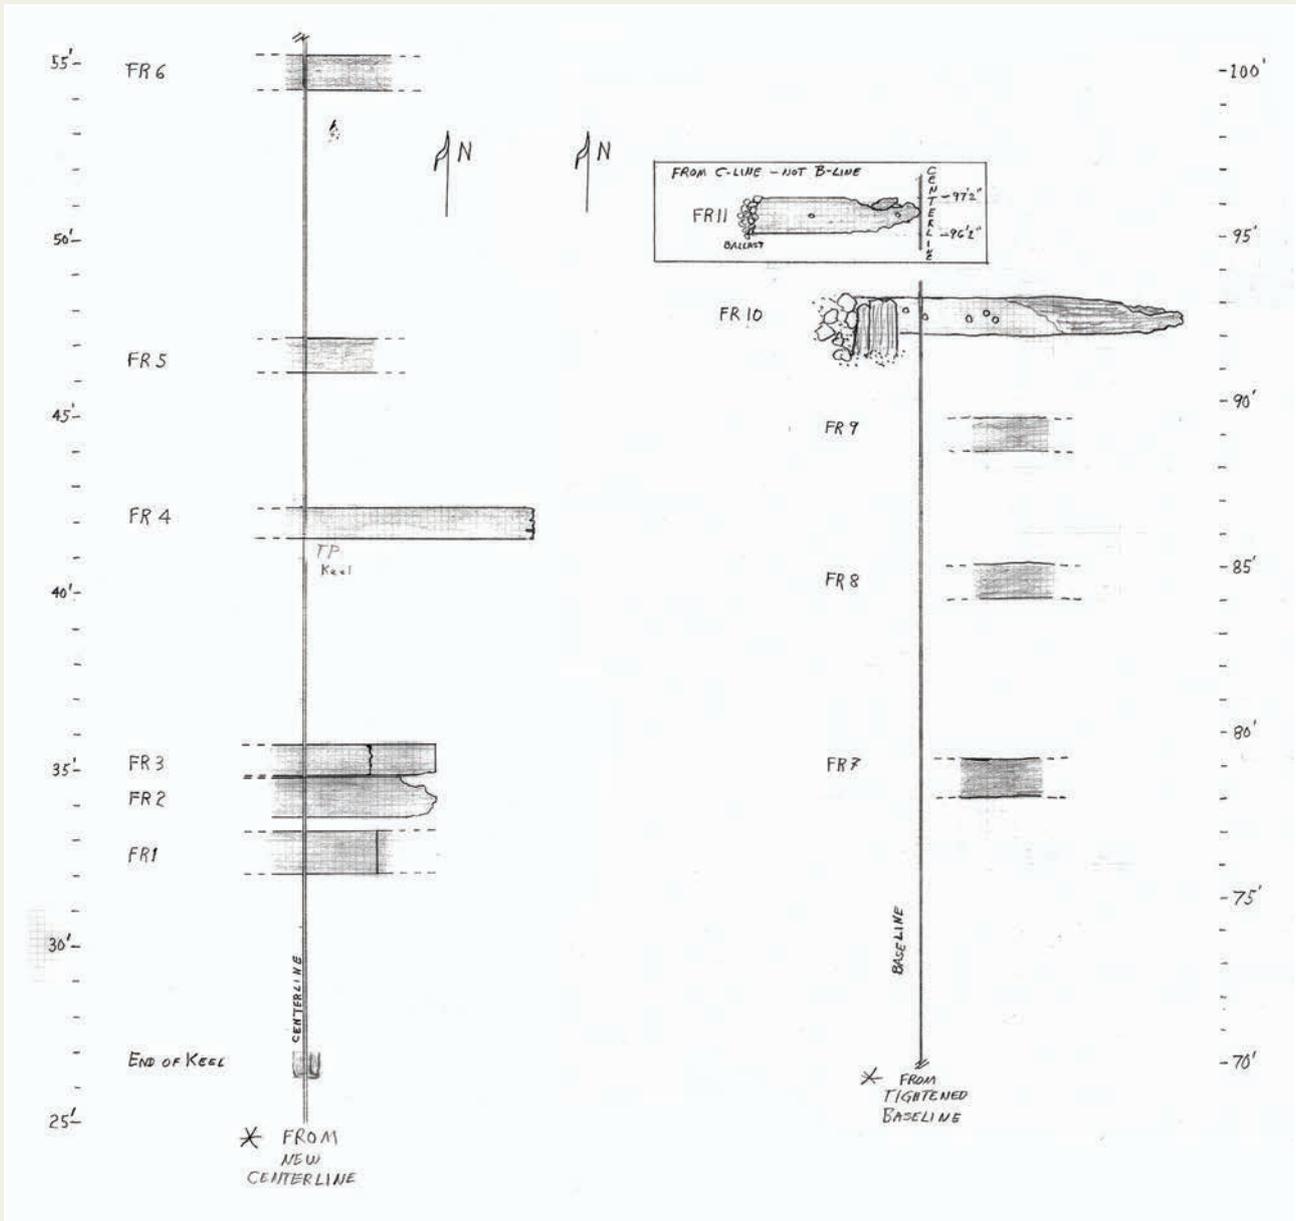
Figure 18. Locations of exposed frames in the bow section (left) and at the extent of the site's surviving stern (right) (John D. Broadwater).

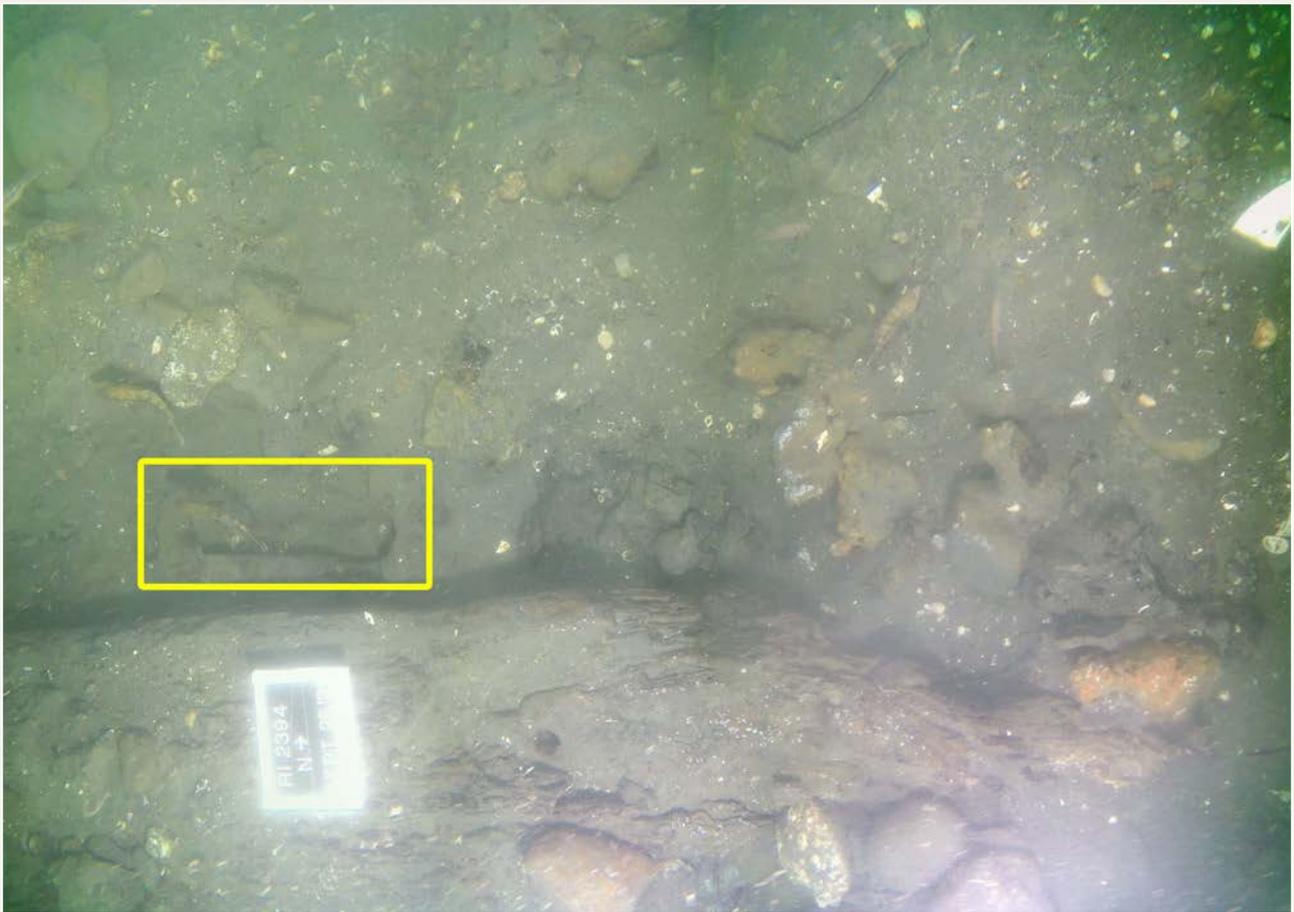
Figure 19. Mosaic showing frame and scuttling hole beneath letter board, north is at bottom of image (John D. Broadwater).

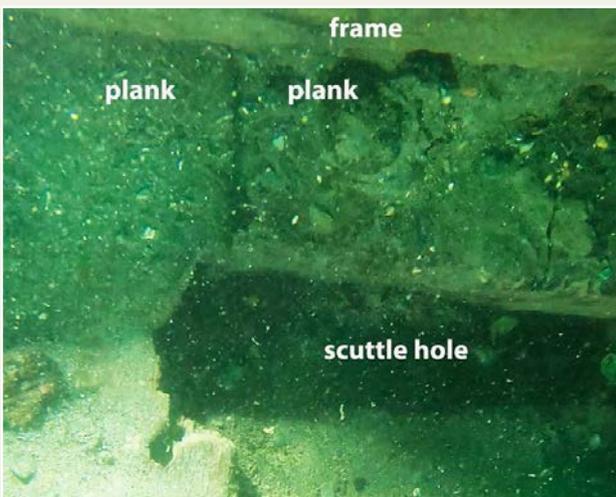
Figure 20. Close-up image of scuttling hole on the north side of the frame (John D. Broadwater).

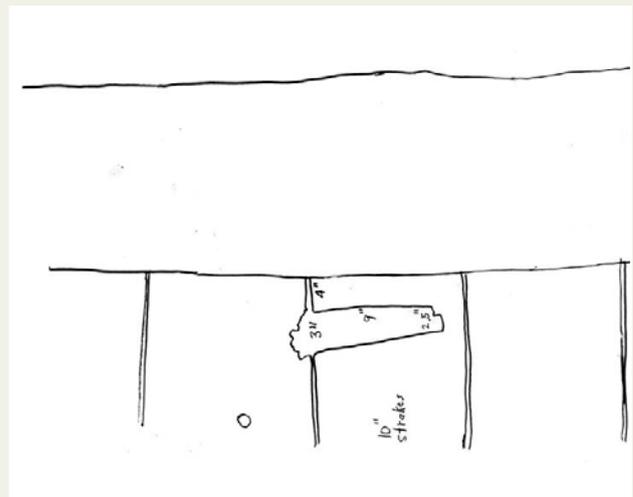
Figure 21. Sketch of scuttling hole (plan view, north is at bottom of image) (John D. Broadwater).

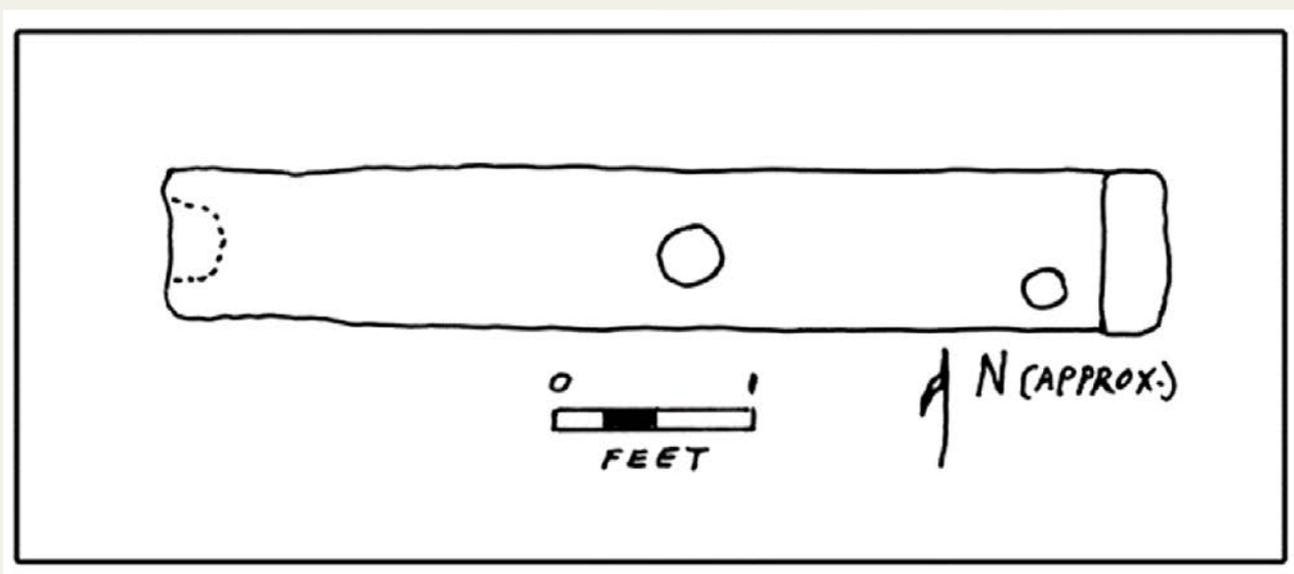
Figure 28: Sketch of Cannon 4 (John D. Broadwater).
