# Locating HM Bark *Endeavour*

Archaeological identification  
of shipwreck site RI 2394 in  
Newport Harbor, Rhode Island, USA

**Kieran Hosty**  
**James Hunter**

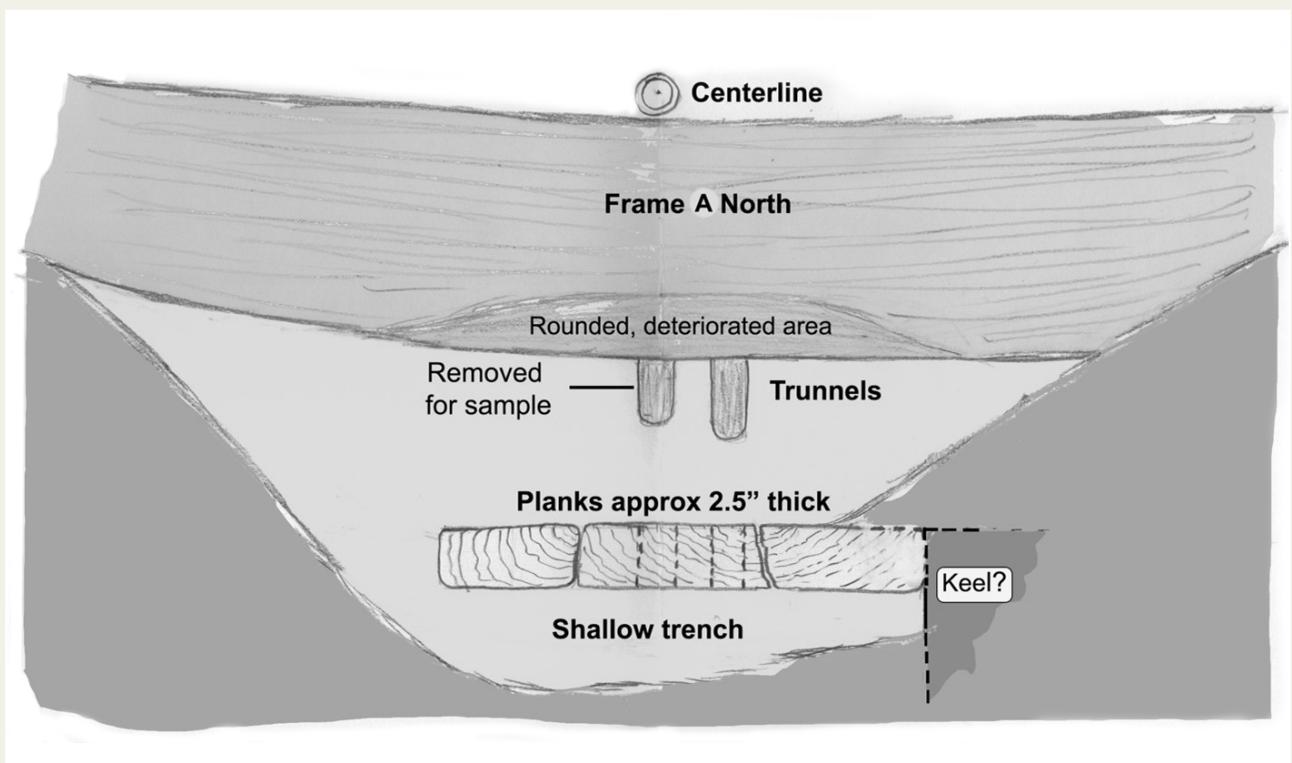
Figure 11. Cross-section through TP6N southern extension, at Frame A North (FU7), facing south, showing outer planking pulled free from Frame B North. Also shown is the possible keel, located on the last dive. Scale approximate (John D. Broadwater).

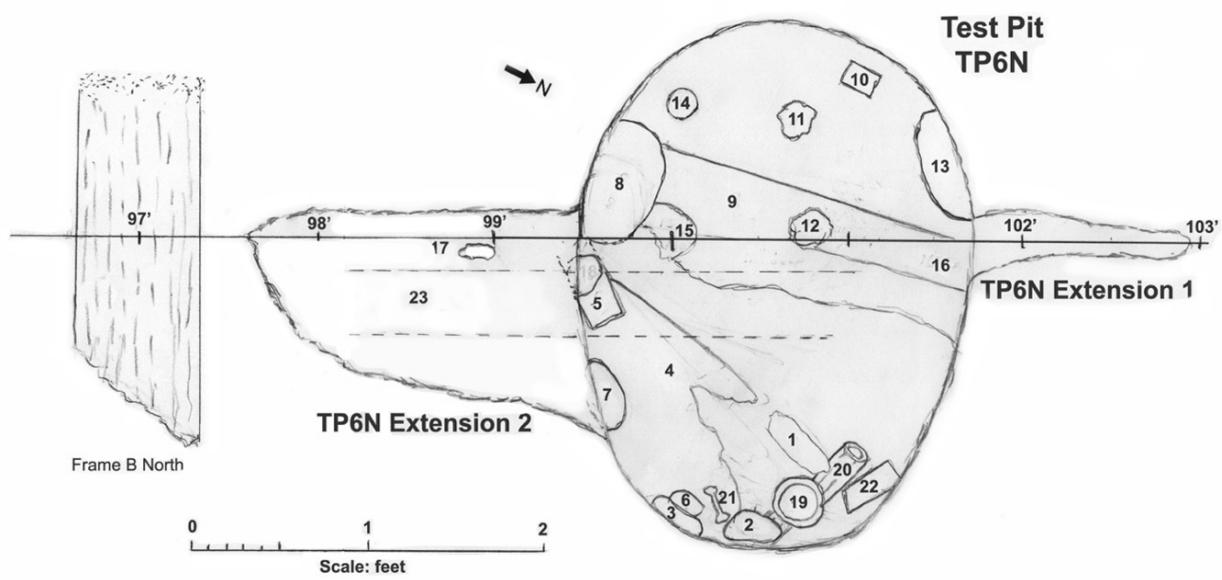
Figure 12. RI 2394: Details of test pit TP6N (John D. Broadwater).

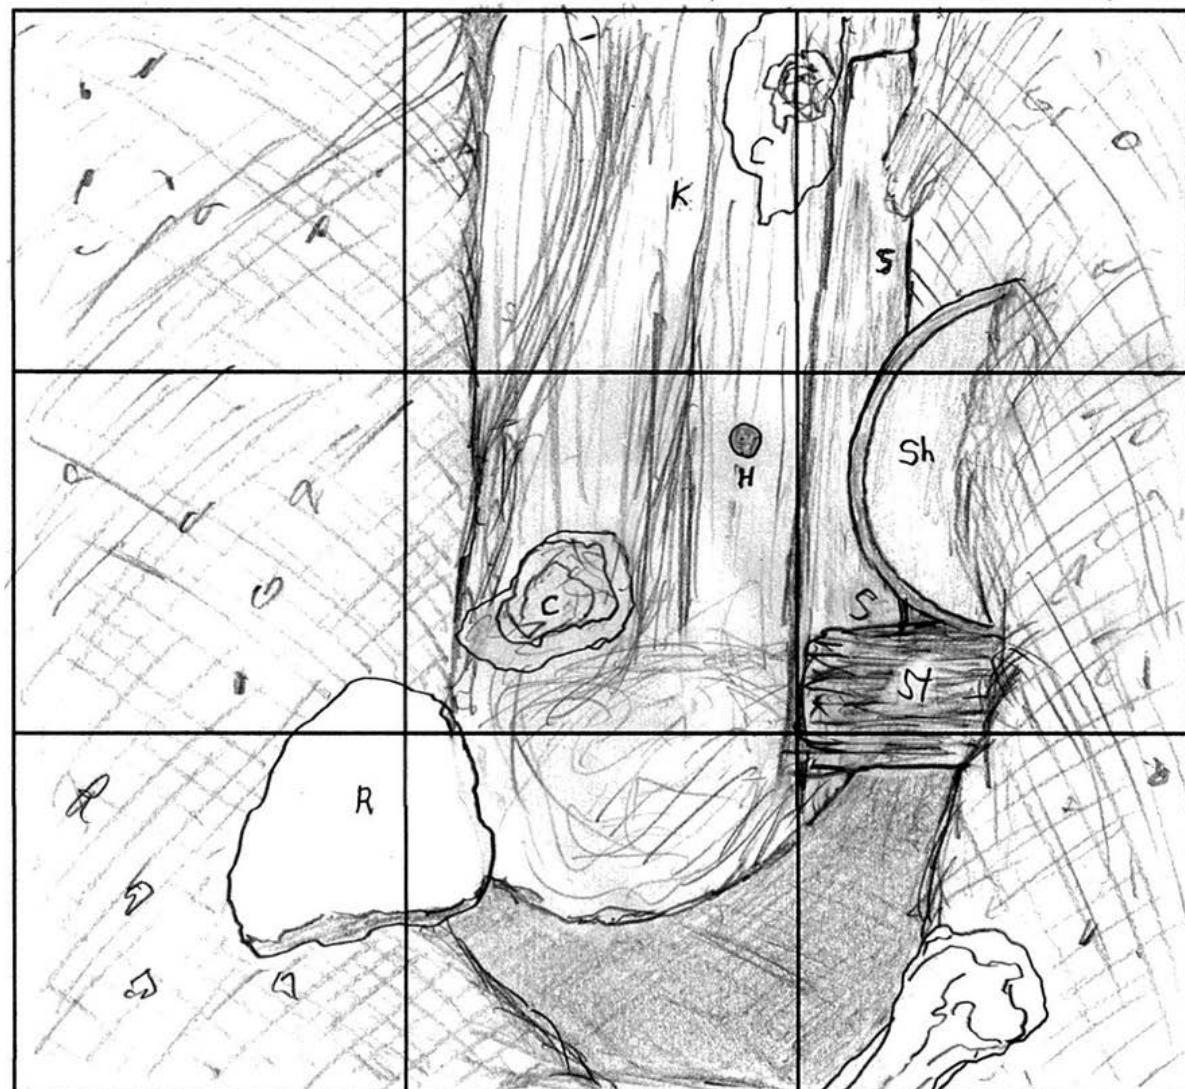
Figure 13. South end of keel, showing stem-keel scarf in plan view (John D. Broadwater).

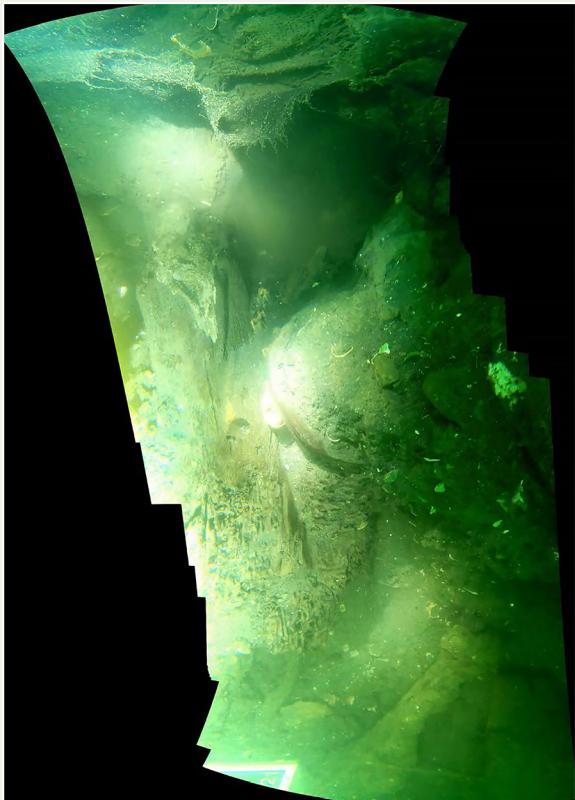
**Figure 14.** Photomosaic of keel's southern terminus, showing scarf for the stem (beneath wooden sheave at image centre). Note that north is up (John D. Broadwater and Joshua Daniel).

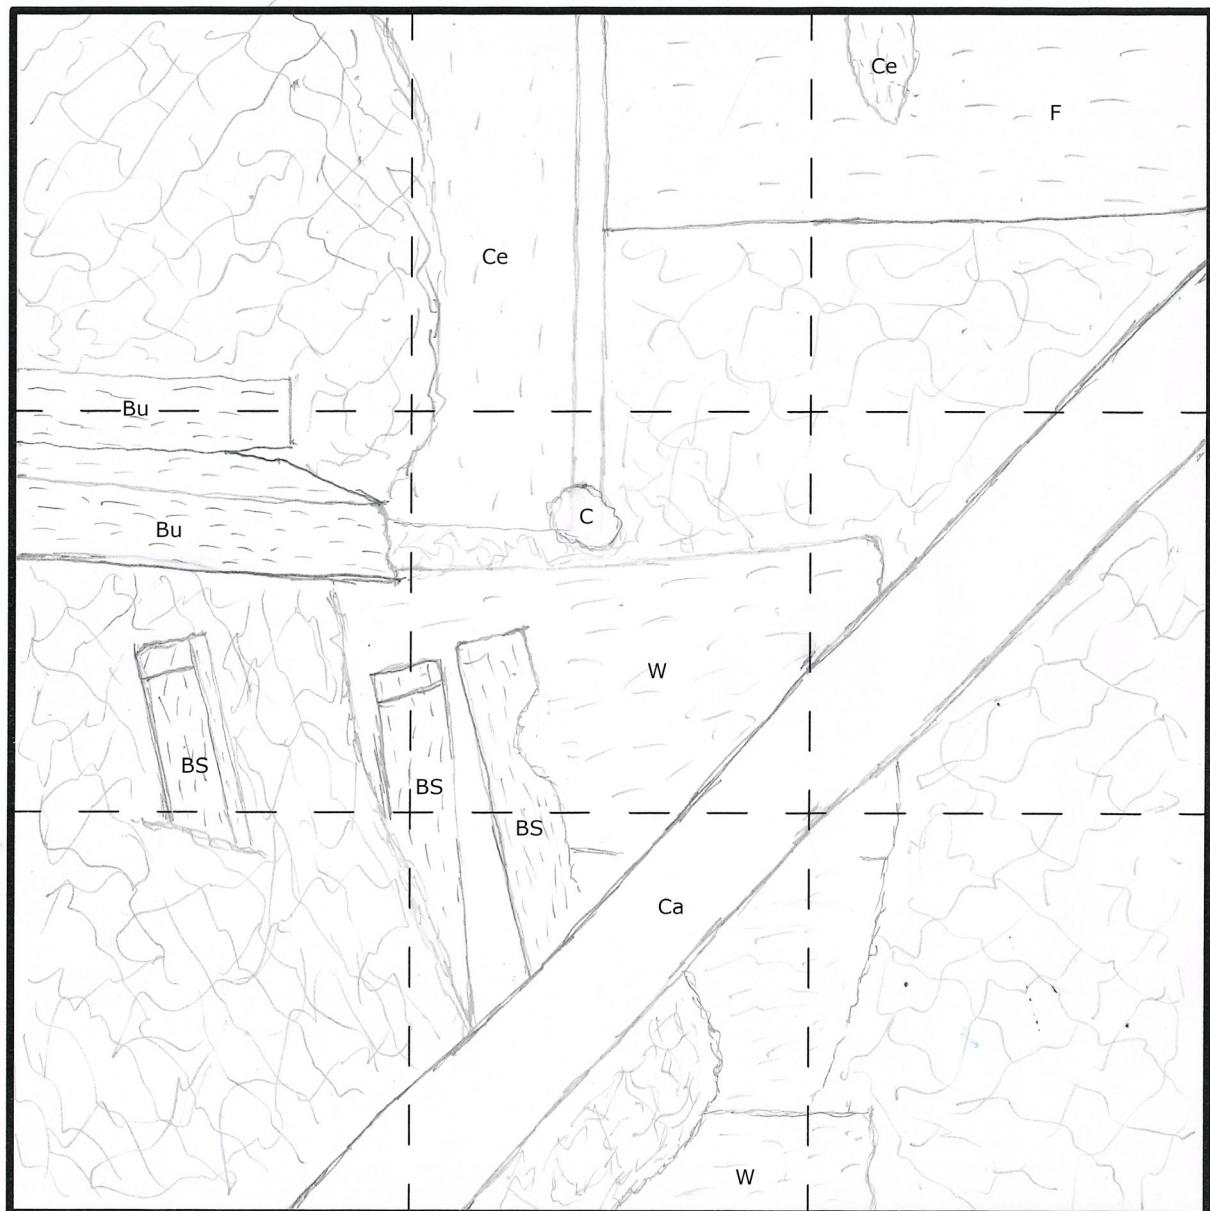
Figure 16. Pump well test pit, north section (Joshua Daniel).

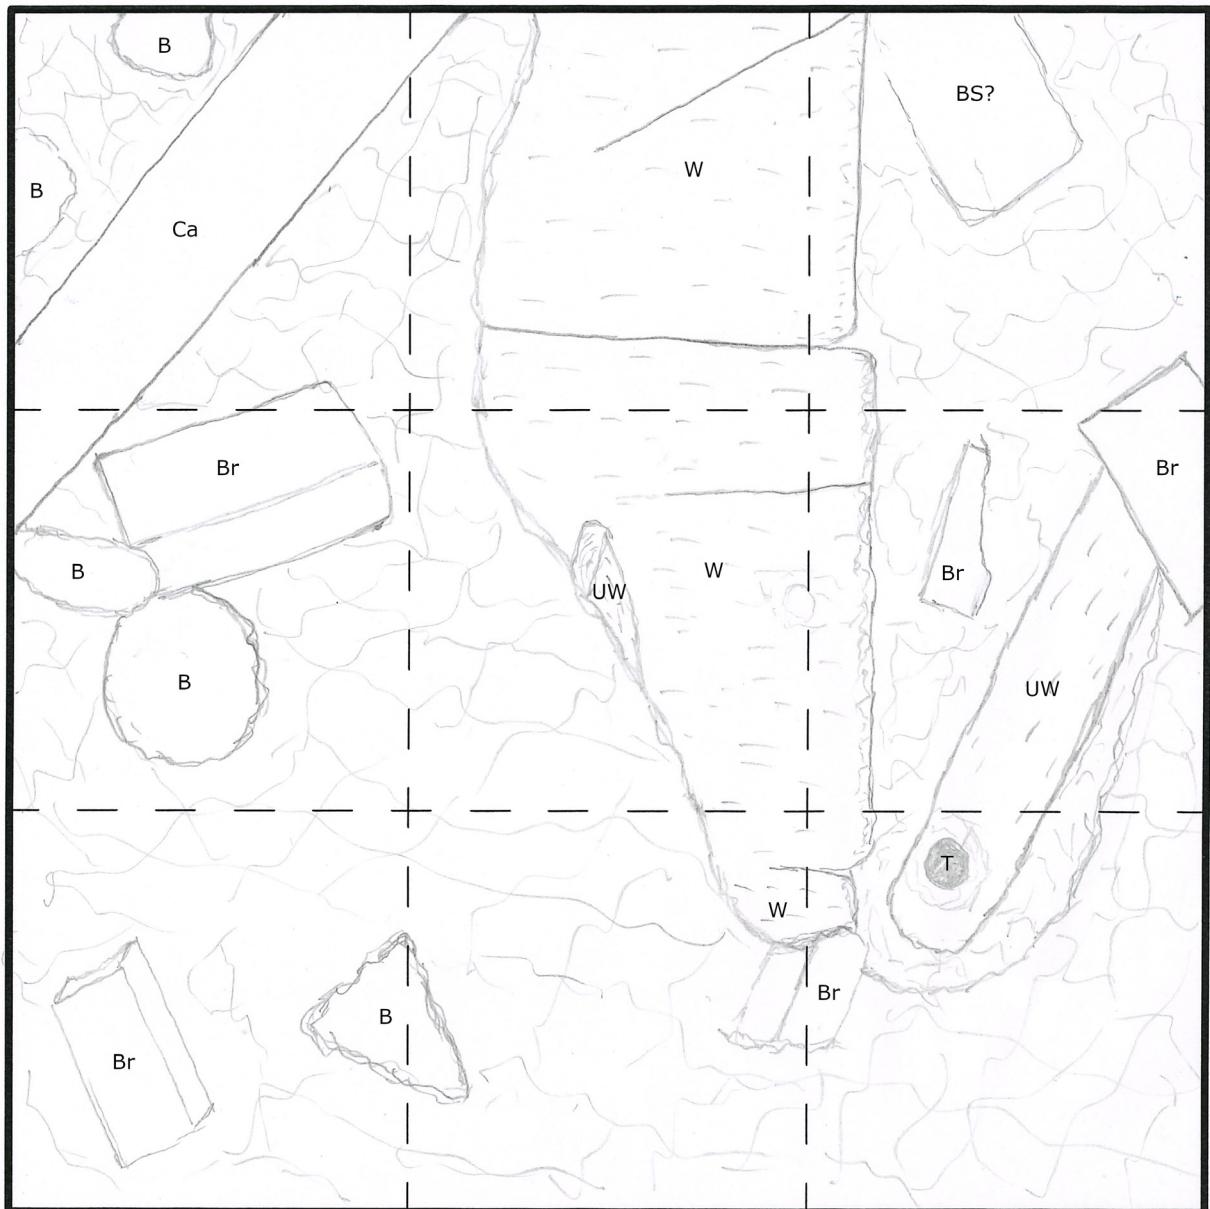
Figure 17. Pump well test pit, south section (Joshua Daniel).

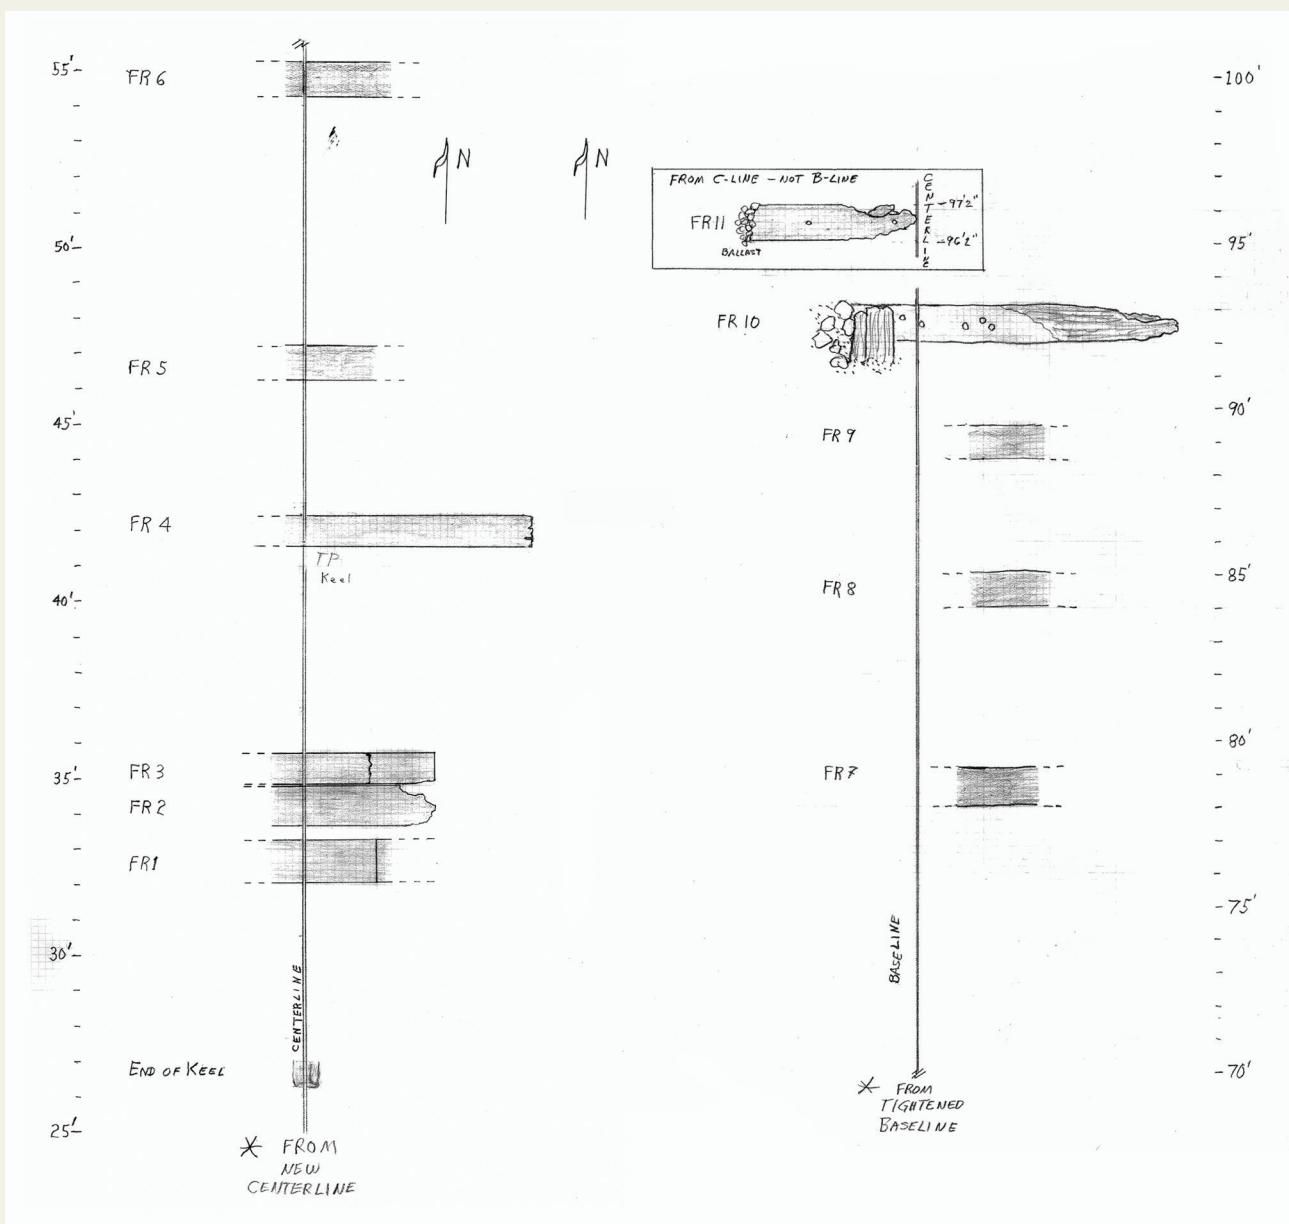
Figure 18. Locations of exposed frames in the bow section (left) and at the extent of the site's surviving stern (right) (John D. Broadwater).

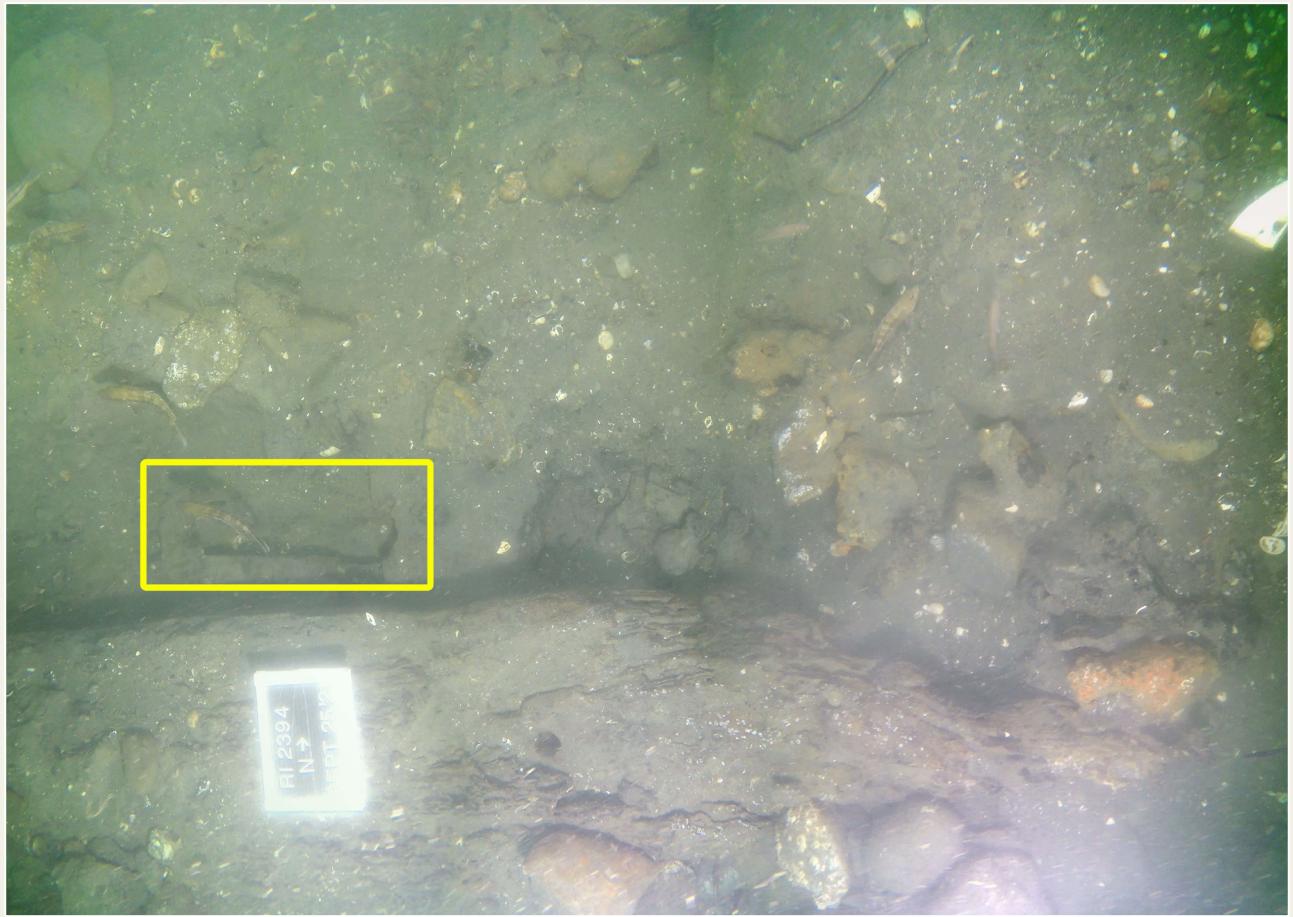
Figure 19. Mosaic showing frame and scuttling hole beneath letter board, north is at bottom of image (John D. Broadwater).

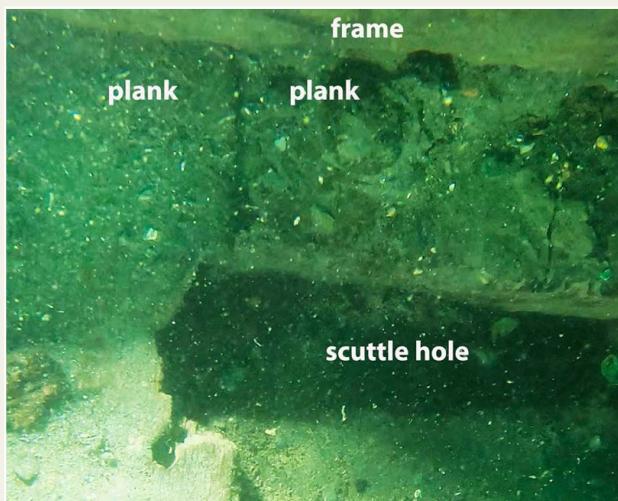
Figure 20. Close-up image of scuttling hole on the north side of the frame (John D. Broadwater).

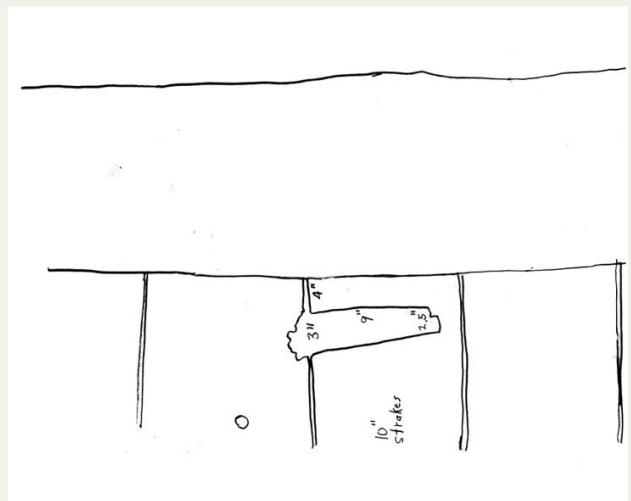
Figure 21. Sketch of scuttling hole (plan view, north is at bottom of image) (John D. Broadwater).
