Research Vessel *Petrel* Baseline Survey of HMAS *AE1*

April 2018

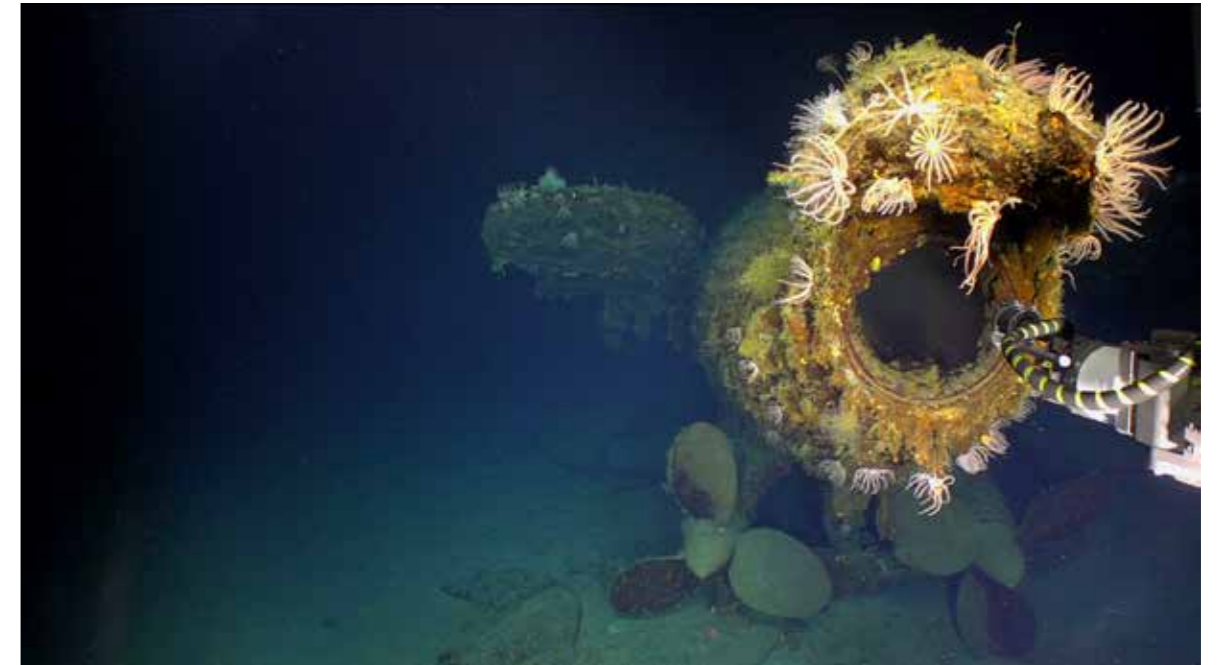
Figure 7 – Examining the after torpedo tube sluice valve.

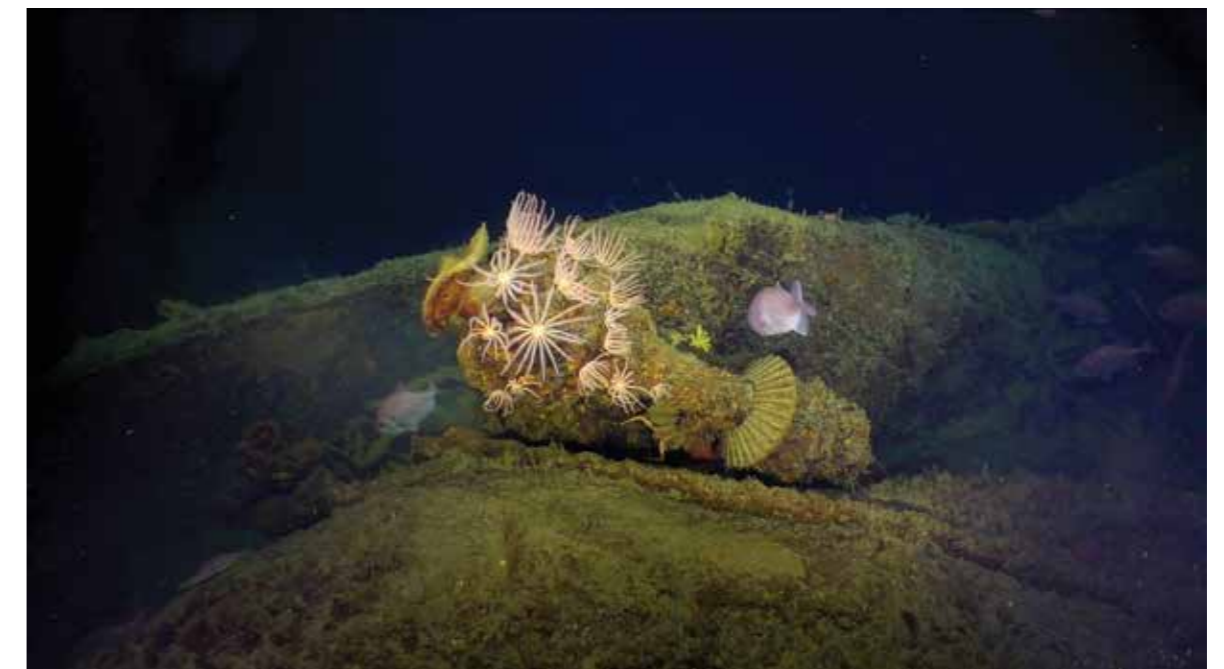
Figure 10 – Marine growth on the windlass.
Image courtesy of Paul G Allen, Find AE1 Ltd, Australian National Maritime Museum and Curtin University. © Navigea Ltd

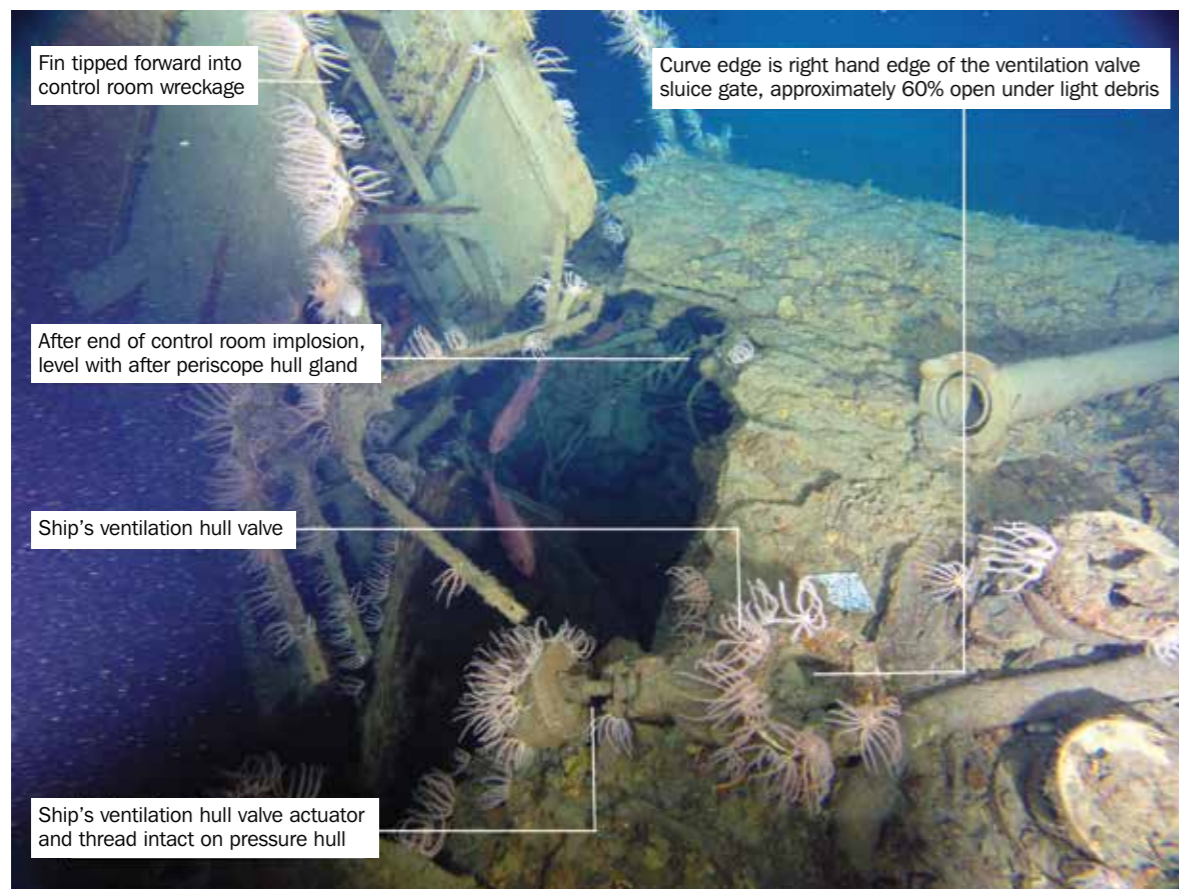
This is the most significant observation: the ship's ventilation system hull valve is ~60% open. The valve is a large, 6-inch (~152-millimetre) opening. It is one of five ventilation hull valves situated at the after end of the fin and now exposed to view by the displacement of the fin; the remaining four are associated with the battery ventilation system. The ship's ventilation system was designed to supply sufficient air to the engine room to allow the diesel engines to be run at reduced power while on the surface, presumably in a situation when the conning tower upper hatch had to be shut due to rough weather.¹⁰

The valve is a sluice or gate valve construction, external to the hull and operated by a handwheel, driving through a rod gearing to turn a thread on the valve shaft, in order to drive the sluice across the opening. The thread actuator remains intact and attached to the pressure hull and therefore we think it most unlikely that the valve has been pulled open by the force of the implosion. In the image below, the curved leading edge of the sluice valve is clearly visible beneath some light debris – it is ~60% open.

Figure 14 – The open ship's ventilation hull valve.

It is considered likely that the normal state of the quick-acting valve when on the surface (that is, prior to diving) would be open. In this case, with the quick-acting valve open (or not fitted), or if the trunking failed to hold the pressure build-up, then water could have entered the after end of the submarine immediately on diving. The water could quickly make its way to the lower section of the after end of the submarine containing the after main battery and vital systems supplying power, lighting and the port main propulsion motor. The additional water would also cause a loss of buoyancy, causing *AE1* to sink faster. As it sank deeper the volume of water entering the submarine would increase dramatically.¹¹ The combined effect would be a rapid loss of control and the depth excursion that caused the fatal implosion.

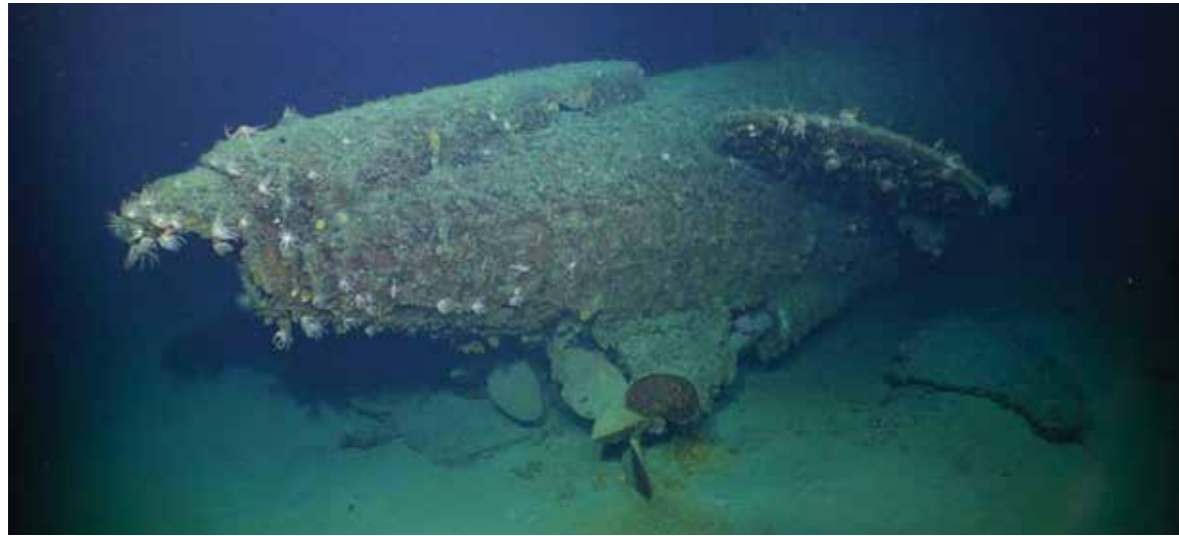
The stern cap on the after torpedo tube is open. This was unexpected. Some technical details follow:

- The stern cap is the outer opening on the after torpedo tube.
- It is backed up by a sluice valve in the tube positioned about 2 metres forward of the stern cap.
- The torpedo is stowed forward of this, with a rear door giving access to the tube inside the after torpedo compartment.
- The stern cap is opened by a handwheel operated from the after torpedo compartment, driving through a rod gearing to an external worm gearing arrangement to open the stern cap.
- The whole arrangement is shielded by a casing external to the pressure hull.
 - This casing is intact.
 - The gearing arrangement would have been very resistant to opening caused by the sinking process.

Figure 15 – Protective casing over stern cap operating rod.
Image courtesy of Paul G Allen, Find AE1 Ltd, Australian National Maritime Museum and Curtin University. © Navigea Ltd

It is therefore considered highly likely that the stern cap was opened as a result of deliberate action by the crew. Why would this step be taken?

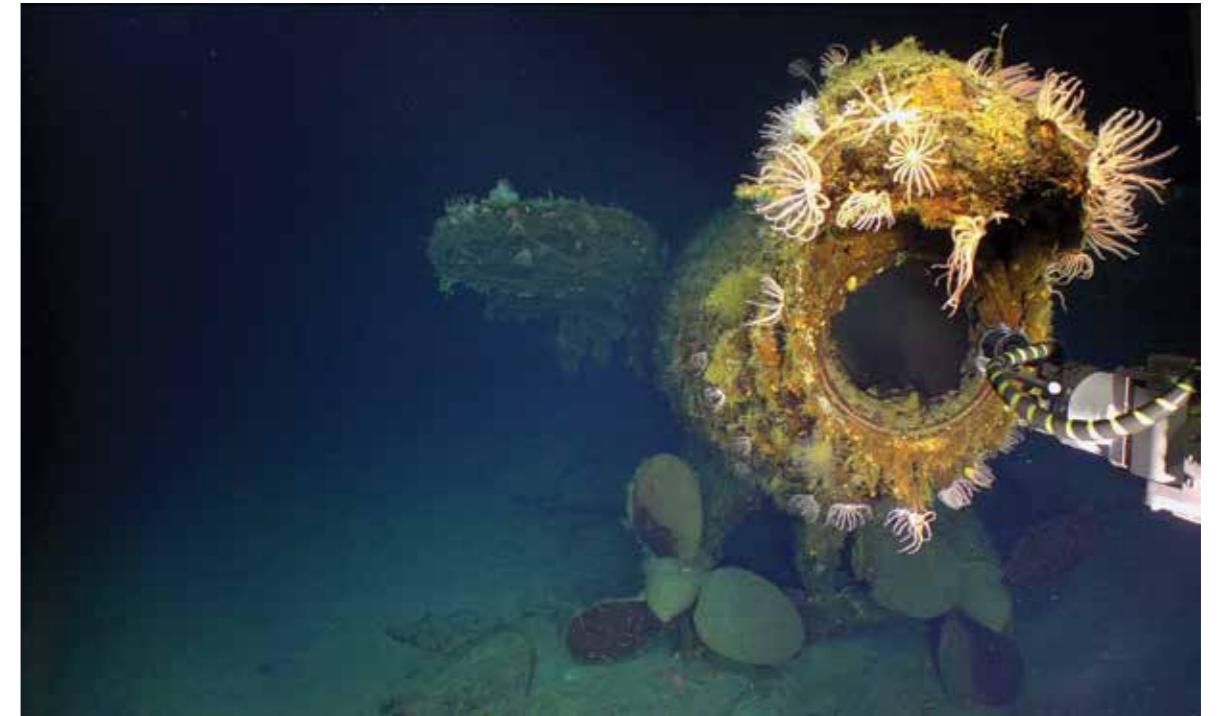
- Possibly a precautionary step to prepare the tube for action in anticipation of locating the German steamer, which we believe caused the commanding officer to divert to the Duke of York Islands.
- The after torpedo tube's sluice valve has been sighted shut using the ROV manipulator camera.
 - We assume the torpedo remains unfired in the torpedo tube on the other side of the sluice valve.
- Why start to prepare the after torpedo tube?
 - This initial step does not expose the torpedo to seawater and could be simply executed as the bow and stern caps were at the waterline and partially under water on the surface.
 - The after tube would have been less vulnerable to damage from flotsam or the wash compared to the bow tube, enabling the stern cap to be fully opened with little risk of damage.
- Alternatively, it could have been opened as a training drill.

Figure 16 – Examining the after torpedo tube using the ROV manipulator arm camera.
Image courtesy of Paul G Allen, Find AE1 Ltd, Australian National Maritime Museum and Curtin University. © Navigea Ltd

Given the flooding scenario set out above there would have been no time to open the stern cap after diving. It is therefore considered most likely that the stern cap was opened prior to the dive, possibly some time earlier in the day, and that it played no part in the accident sequence.

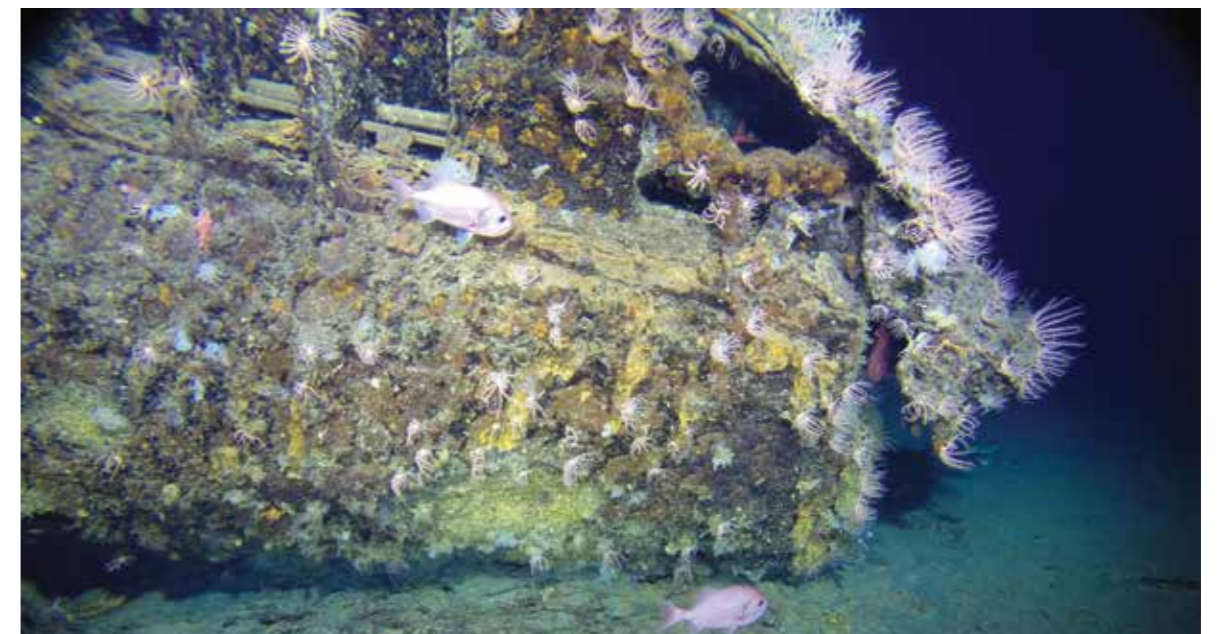
The bow cap on the forward torpedo tube is partially opened, say 20–25 degrees of the 90 degrees necessary to be fully opened.

Figure 17 – Partially open bow cap.
Image courtesy of Paul G Allen, Find AE1 Ltd, Australian National Maritime Museum and Curtin University. © Navigea Ltd

It is possible that the bow cap was also opened as a precaution, to reduce the time necessary to prepare the tube for firing at the same time and for the same reasons as the stern cap. In this case the bow cap was only partially opened to protect the bow cap operating arrangement from damage from the bow wave or flotsam as the submarine moved around on the surface. Alternatively, it could also have been opened as part of a training drill.

We have considered the possibility that the sinking process could have distorted the rod gearing and worm gearing opening arrangements sufficiently to partially open the bow cap, but on balance think the absence of significant impact damage to the bow militates against this explanation.

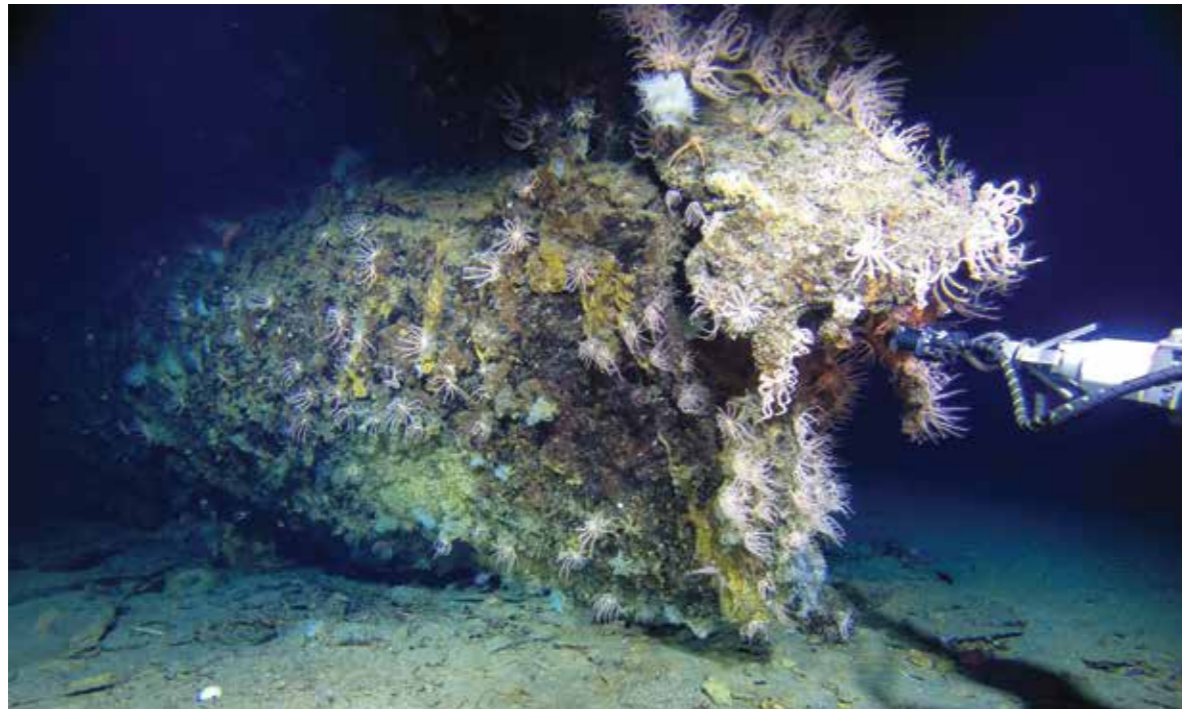
We were unable to inspect the forward torpedo tube sluice valve due to the bow cap obstructing access.

Figure 18 – Failed attempt to inspect bow torpedo tube.
Image courtesy of Paul G Allen, Find AE1 Ltd, Australian National Maritime Museum and Curtin University. © Navigea Ltd

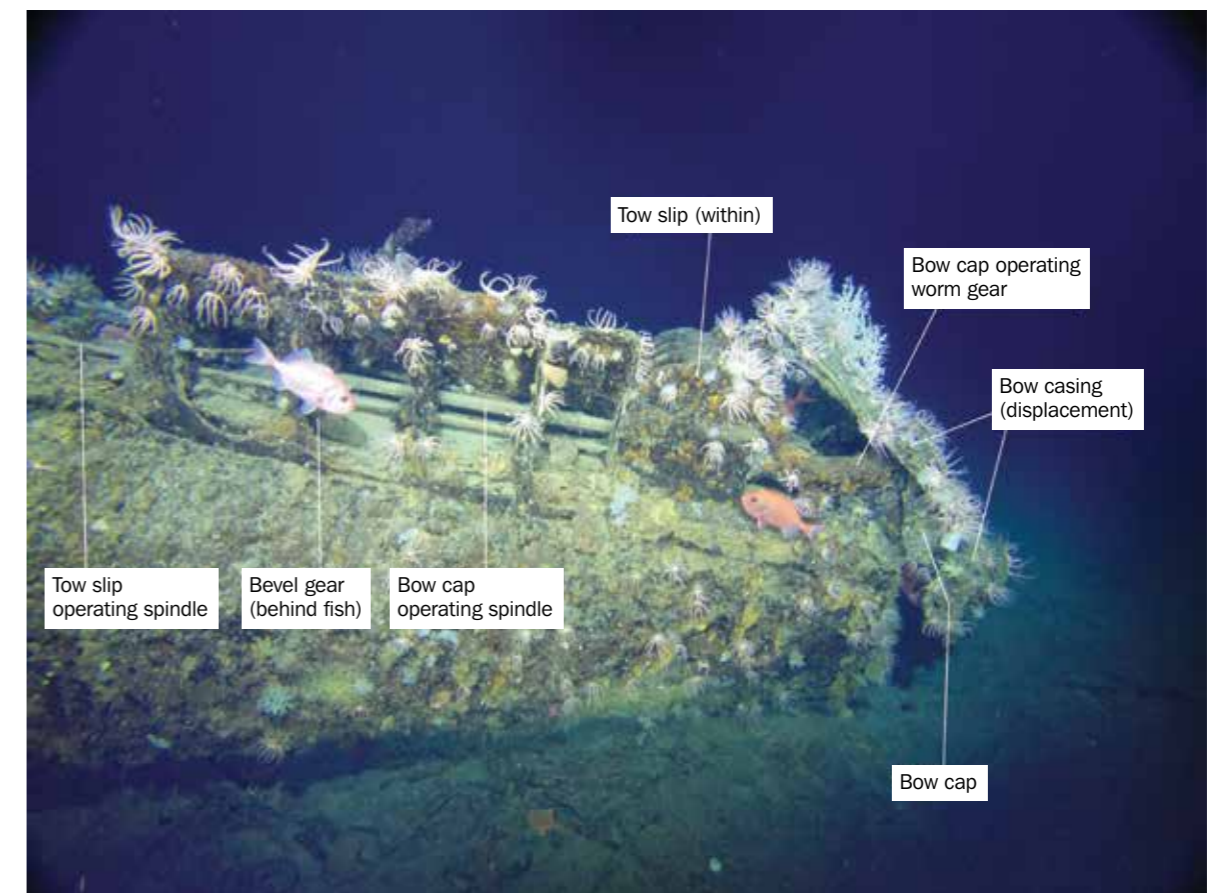
Figure 20 – Bow cap operating arrangements.
Image courtesy of Paul G Allen, Find AE1 Ltd, Australian National Maritime Museum and Curtin University. © Navigea Ltd

In summary: we do not know why the bow cap is partially open. We think it was most likely done prior to diving and do not think it was part of the accident sequence leading to the loss of the submarine.

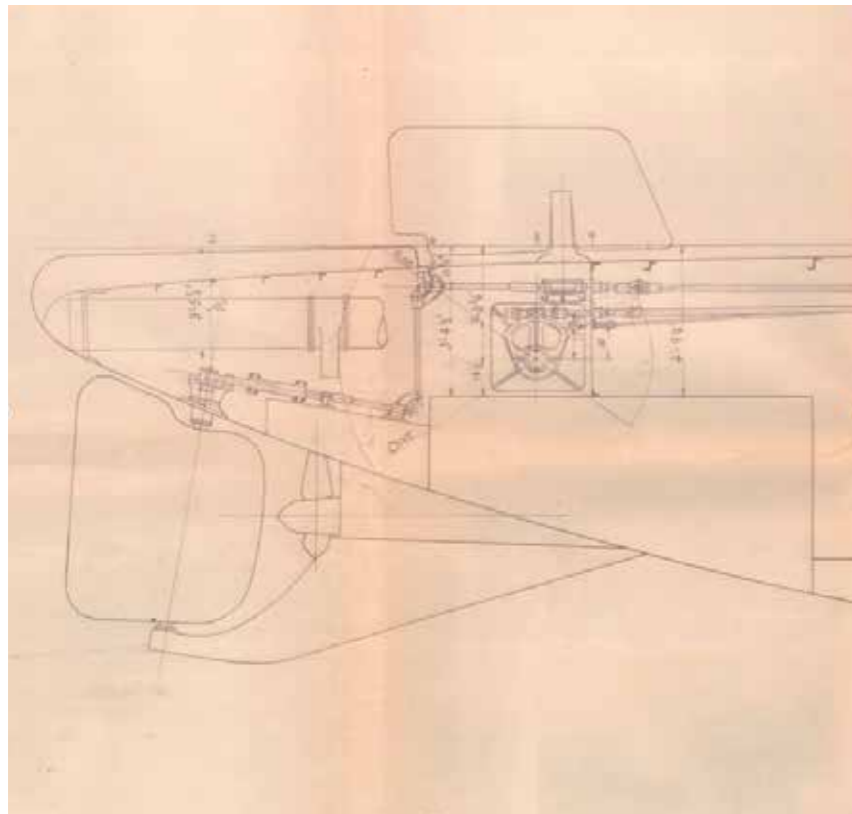
Figure 23 – Rudder and skeg arrangement, from as built drawings. Image courtesy of National Archives of Australia

The skeg has broken away from the pressure hull and the rudder has been displaced; both are lying on the sea floor in the vicinity of the port propeller.

Significant force would be required to break the skeg and displace the rudder. This damage is consistent with the initial and major impact of a stern-first grounding. This will be considered in greater detail in the section dealing with the sinking process.

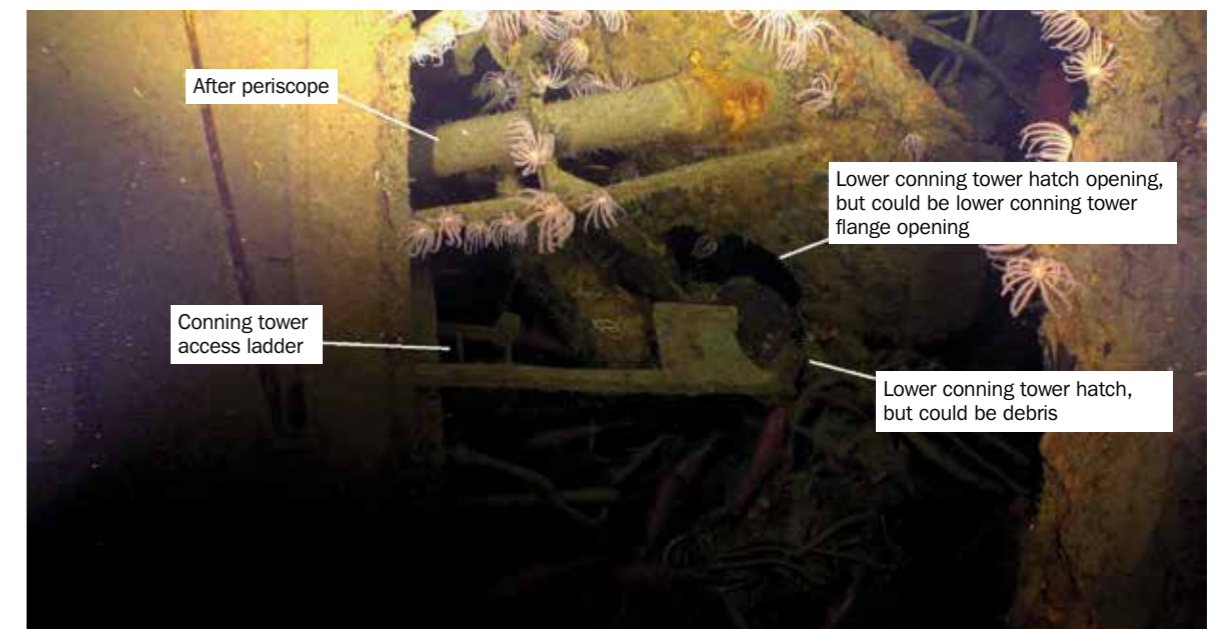
The opening in the pressure hull for the conning tower lower hatch has been identified because it is in a portion of the pressure hull on which the after periscope is mounted. The coaming and hatch are missing; just the opening remains. This is another unexplained puzzle and is discussed further in Annex C (see page 59).

Figure 26 – Possibly the lower conning tower hatch. Image courtesy of Paul G Allen, Find AE1 Ltd, Australian National Maritime Museum and Curtin University. © Navigea Ltd

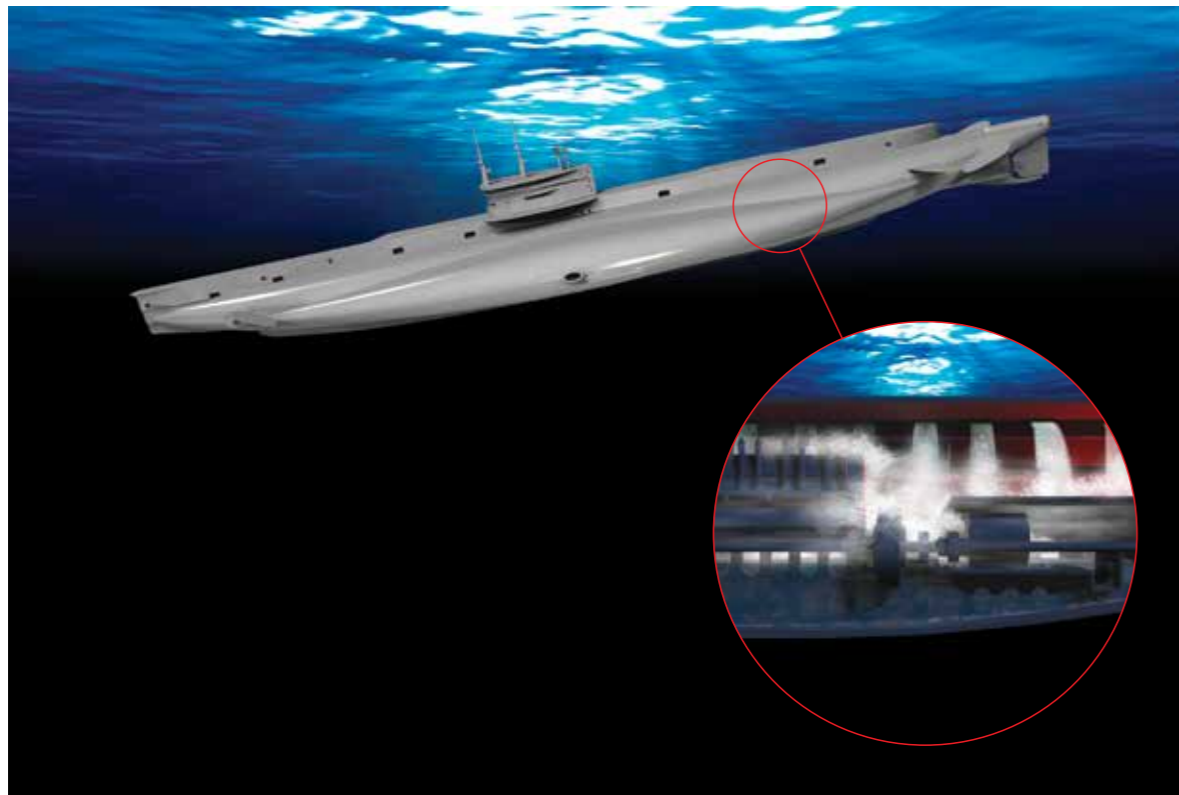
- From these clues we believe it is likely that the submarine began to flood through the ship's ventilation system shortly after diving.
- The ventilation system directed water into the after section of the hull, causing a loss of buoyancy aft (in submarine trim terminology, making the submarine heavy overall and heavy aft).
- The submarine began to sink stern first.
- As the flooding progressed the submarine became progressively more negatively buoyant (heavier).
- The influx increased dramatically as the submarine sank deeper.
- Propulsion would have been lost once the flood waters reached any or all of the after main battery, port propulsion motor or their associated power supply arrangements.
- Note, we believe that only the port main motor was available when the boat was dived, due to a defect on the starboard main engine clutch.¹⁴

Figure 27 – Artist's impression of the situation on diving. Grant Gittus for Find AE1 Ltd

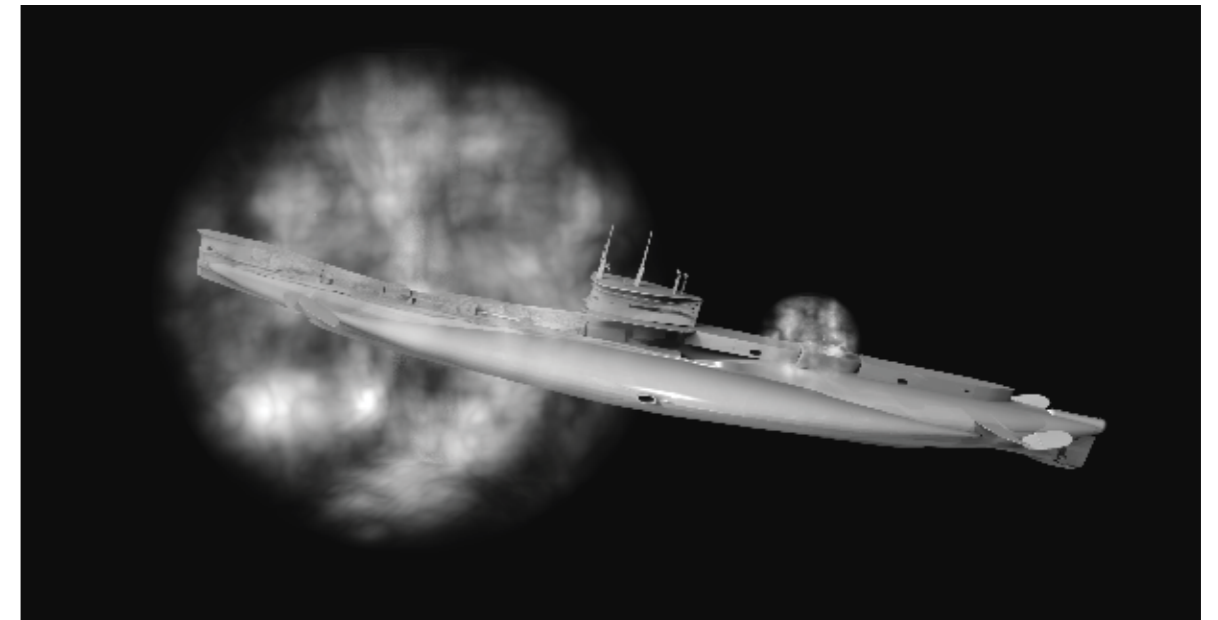
The submarine exceeded its crush depth (~90–120 metres) and the pressure hull imploded over the control room and forward torpedo compartment. The after end of the submarine, by then substantially flooded, did not implode; however, the shock wave from the implosion of the forward compartments blew off the engine room hatch.

Figure 28 – Artist's impression of the implosion. Grant Gittus for Find AE1 Ltd

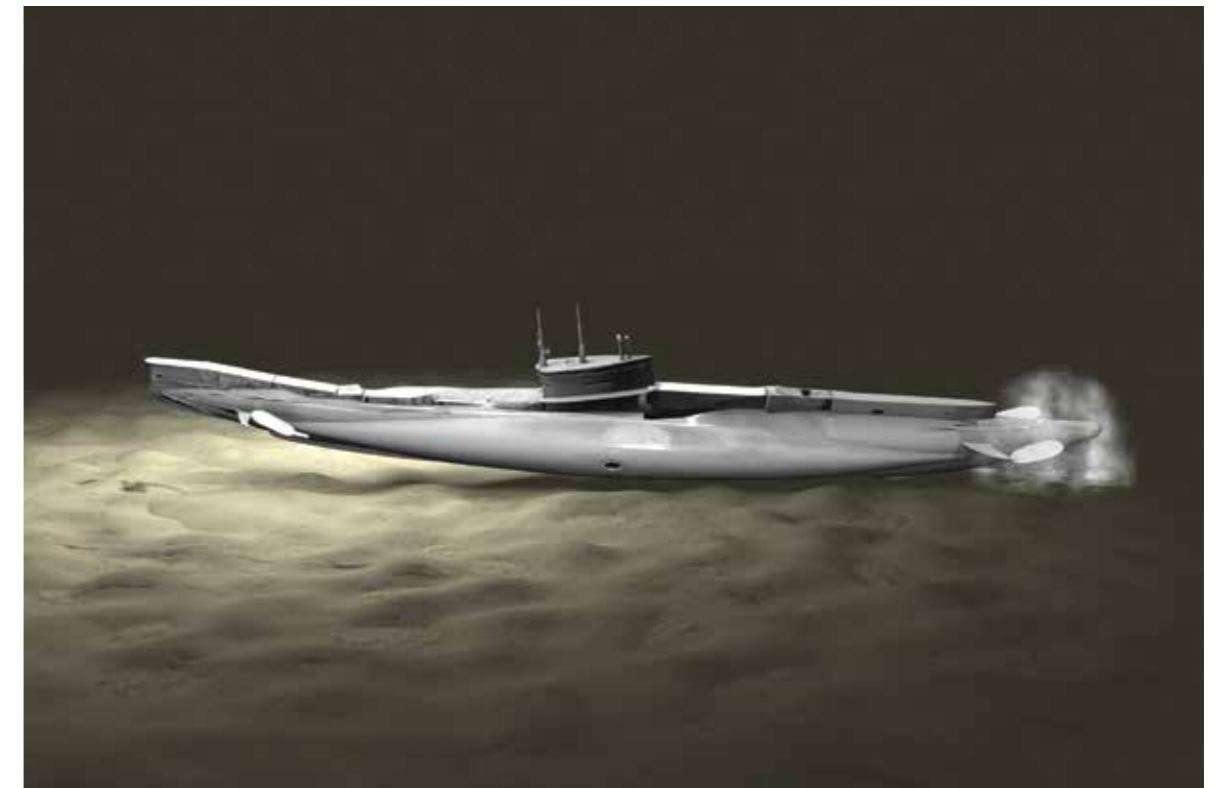
The rudder and skeg absorbed the main impact as the submarine struck the bottom with a slightly stern down angle and little or no headway, snapping off the skeg and displacing the rudder. The first impact may have caused the after hydroplane guards to break away and drop to the bottom, close to their normal positions on the hull.

Figure 29 – Artist's impression of the first impact on rudder and skeg. Grant Gittus for Find AE1 Ltd

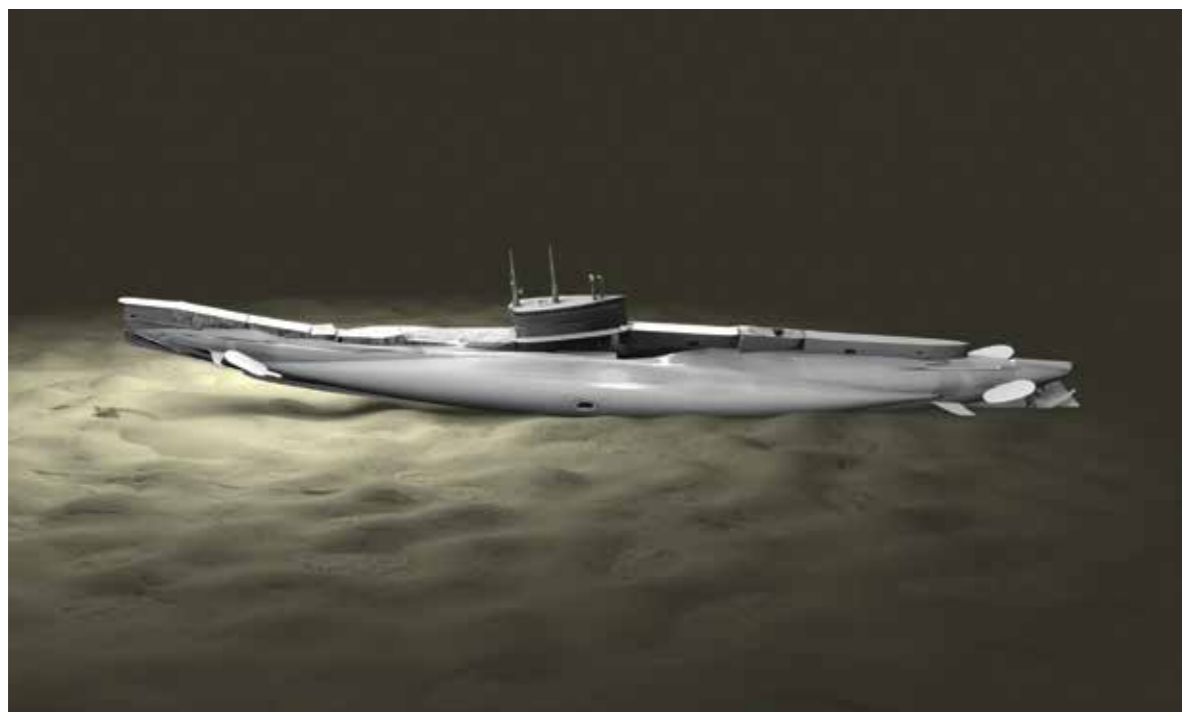
The submarine then pitched forward to land on its keel. The second impact may have also contributed to unseating the fin, already weakened by the implosion damage to its footings, causing it to start its movement forward into the wreckage over the control room. The location of the toilet bowl shards in the fin suggest that the fin movement may have taken some time, slowly settling forward, as a higher-energy event could be expected to shatter the bowl and scatter the remnants.

Figure 30 – Artist's impression of second impact: landing on the keel. Grant Gittus for Find AE1 Ltd

The whiplash effect from the second impact on the forward, unsupported length of the pressure hull in front of the keel appears to have split the pressure hull at frame 70 (see Figure 22, page 27).

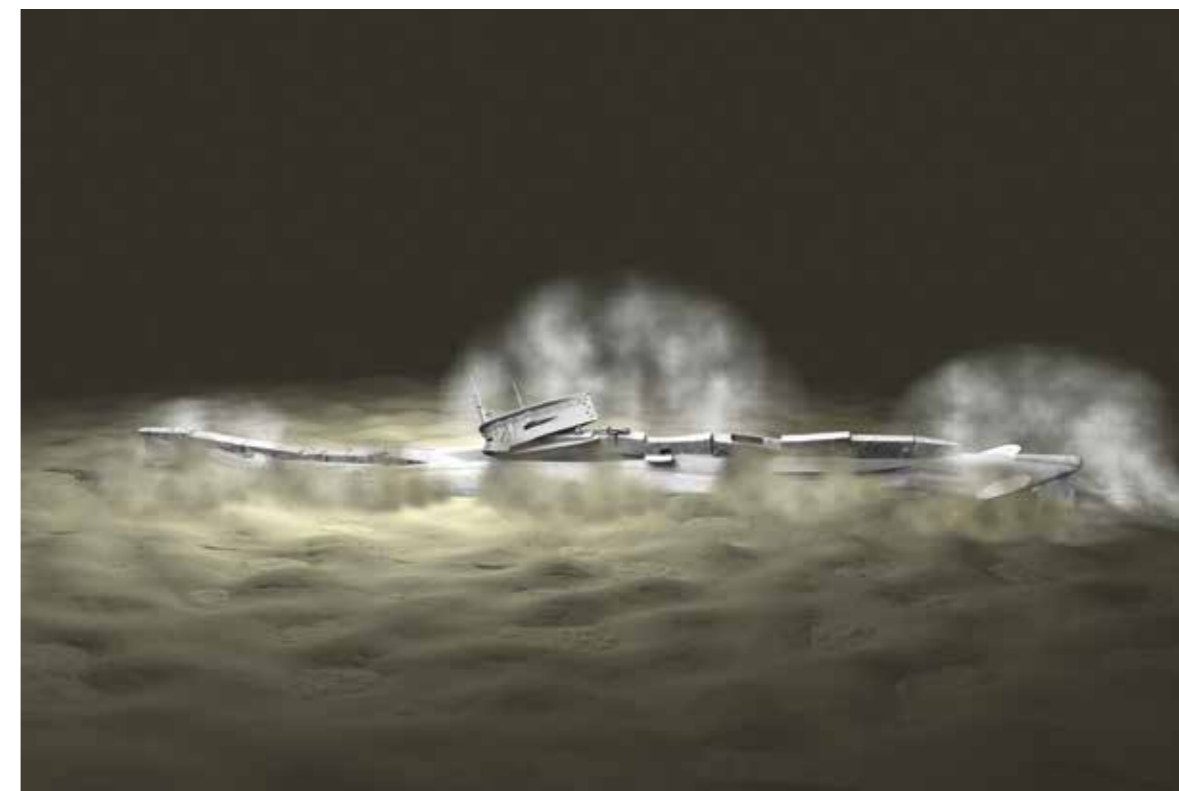
The second impact appears to have been sufficient to cause the forward hydroplane guards to break off and fall to the bottom under their normal position on the hull.

Figure 31 – Artist's impression of final situation as submarine settled on the bottom. Grant Gittus for Find AE1 Ltd

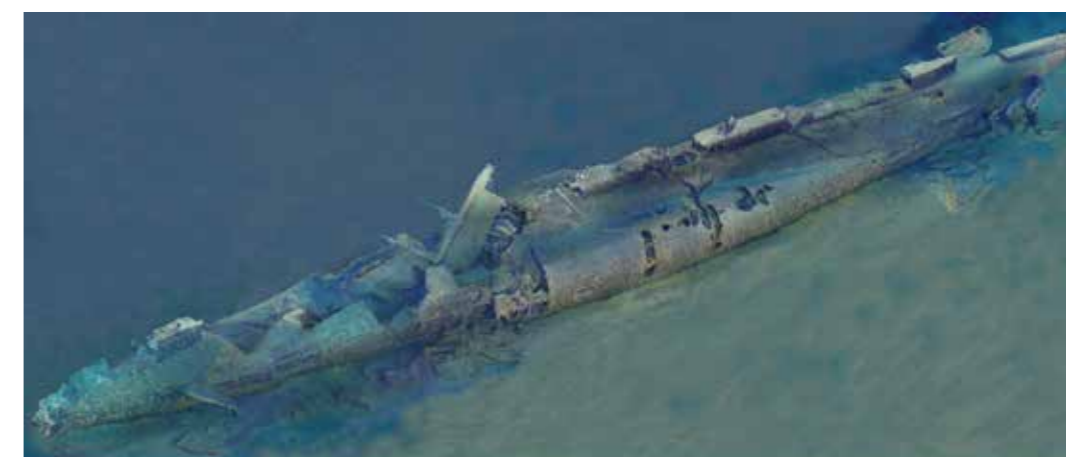
AE1's overall appearance is shown in the interim photogrammetric full 3D model developed by Curtin University's HIVE (Figure 3). *AE1* is resting upright on a largely flat, featureless sand/silt seabed and is almost completely exposed, with only the keel and the tip of a blade from each propeller buried in the surrounding silt. While the approximate aft half of the submarine is largely intact, hull sections forward of the fin have collapsed inwards as a consequence of a catastrophic implosion event. Specific activity areas within *AE1* devastated by implosion damage include the control room and forward torpedo compartment. Structural failure of the forward pressure hull has resulted in the fin collapsing and toppling forward into the remnants of the control room.

While still largely intact, the submarine's hull has been detrimentally affected by differential corrosion of its various metallic components. This is perhaps most evident in the destruction of *AE1*'s side-mounted 'saddle' ballast tanks, which were constructed of lighter-grade steel than the pressure hull and appear to have preferentially corroded, fragmented and collapsed to the seabed. Other disarticulated hull elements observed during the survey include *AE1*'s hydroplane guards, rudder and skeg. All four guards are lying flat on the seabed, just beneath their respective hydroplanes. While natural processes such as corrosion could have caused them to fall away from the hull, a more likely explanation is that they snapped off as *AE1* fell onto its keel after initially striking the seabed stern first and pitching forward. *AE1*'s rudder and skeg were found lying beneath the port side propeller. Both appear to have been broken off by the submarine striking the seabed stern first; however, the angle of the impact was shallow enough that it did not damage *AE1*'s propellers.

Figure 3 – Interim 3D photogrammetric model of *AE1*. The submarine's port side is shown, and the bow is at image left. 3D models by Curtin University from images courtesy of Paul G Allen, Find *AE1* Ltd, Australian National Maritime Museum and Curtin University. © Curtin University

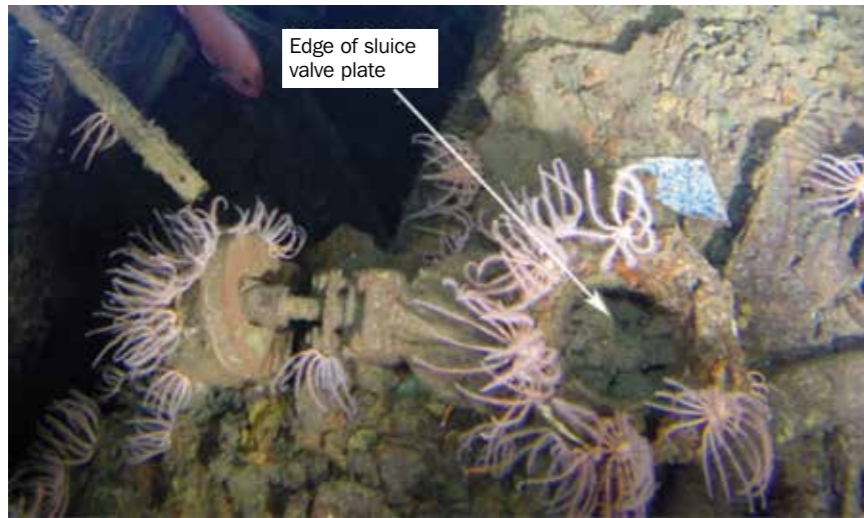
Close inspection of the submarine's ventilation valve – which was positioned in the after section of the fin and is currently exposed as a consequence of the fin toppling forward and dislodging the valve's associated ventilation trunking – revealed that the edge of its sluice plate is positioned across the valve so that it was ~60% open (Figure 5). Given that the ventilation valve was not completely shut, it would have served as a point of ingress for water while the submarine was submerged, and likely was the primary contributing factor to its loss. The ventilation valve's mechanism, and its hypothesised role in AE1's loss, are discussed in greater detail in Annex C (see page 59).

Figure 5 – AE1's open ventilation valve; the arrow indicates the edge of the valve's sluice plate. Image courtesy of Paul G Allen, Find AE1 Ltd, Australian National Maritime Museum and Curtin University. © Navigea Ltd

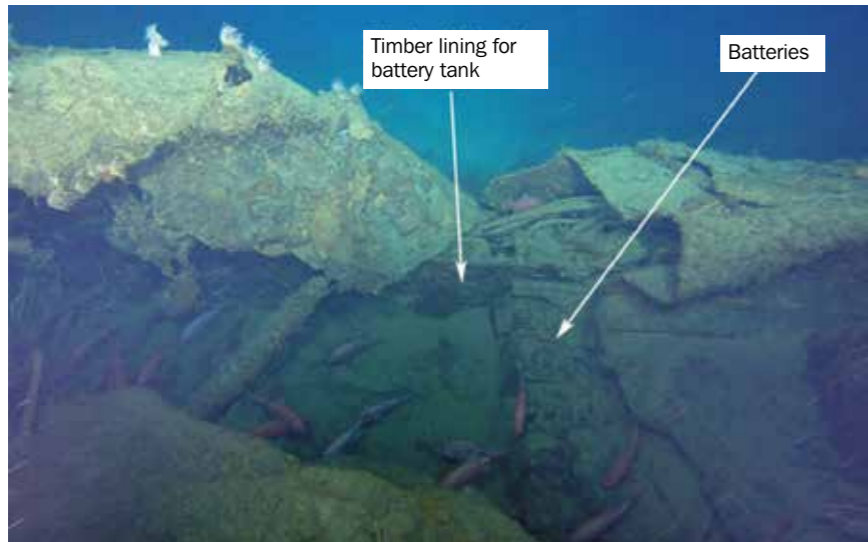
Figure 8 – Remnants of the timber lining for one of *AE1*'s battery tanks, located within the remains of the control room along the submarine's starboard interior hull. Image courtesy of Paul G Allen, Find *AE1* Ltd, Australian National Maritime Museum and Curtin University. © Navigea Ltd

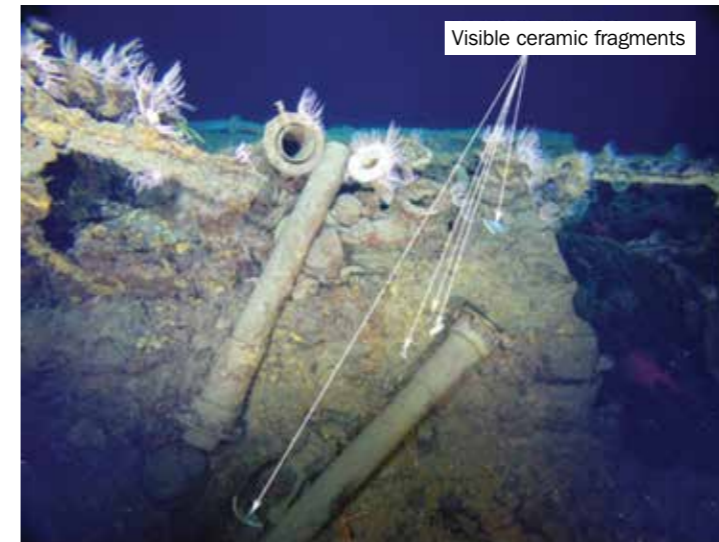
Five fragments of a basin-shaped ceramic vessel were discovered in the approximate location of the aft end of *AE1*'s fin and appear to be remnants of either a porcelain chamber-pot or the basin from a purpose-made ship's head (Figure 9). One fragment clearly has a blue-and-white floral motif and appears to be transfer-printed whiteware. Efforts are ongoing to identify the specific transfer-printed pattern on these fragments and determine the date range, origin and purpose of the ceramic vessel. While it is possible the ceramic fragments could be intrusive, the fact that there are multiple examples relatively close to one another, and that at least one is pinned beneath hardware from the submarine, lends credence to its being associated directly with *AE1*. If this is the case, the presence of the fragments also strongly suggests the fin did not completely dislodge until the submarine struck the seabed, as relatively light artefacts of this type would almost certainly have been removed from context and dispersed into the water column.

Figure 9 – Upper surface of *AE1*'s pressure hull at its junction with the after end of the fin, showing five ceramic fragments believed to have once comprised one of the submarine's heads. Image courtesy of Paul G Allen, Find *AE1* Ltd, Australian National Maritime Museum and Curtin University. © Navigea Ltd

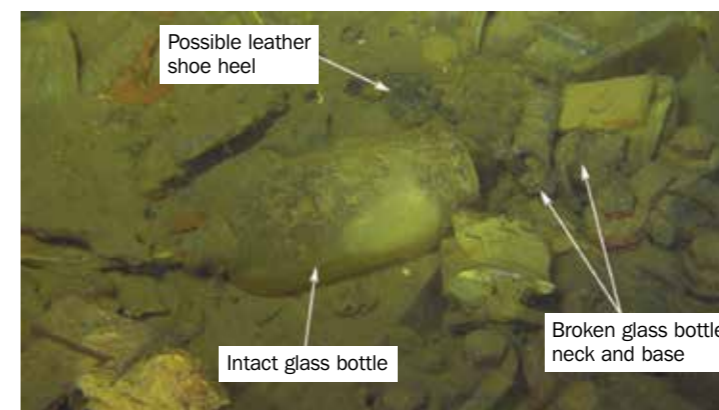
The only other small finds observed during the 2018 survey were an intact glass bottle, the neck (with what appears to be an applied lip) and base of a broken glass bottle, and what appears to be the heel from a leather shoe or boot (Figure 10). All four artefacts are located within the remnants of *AE1*'s control room, lying atop a surviving bank of batteries in the approximate centre of the pressure hull. The intact bottle is manufactured from clear glass and is cylindrical in form, with a short shoulder and neck. An object that appears to be a stopper is visible in the bottle's mouth, and an opaque, white-coloured substance that may represent the bottle's original contents is pooled near the base. No markings indicative of contents or manufacturer are visible, although much of the bottle is covered in marine growth.

Figure 10 – Small finds located within *AE1*'s control room, including an intact glass bottle, two bottle fragments and what appears to be a leather shoe or boot heel. Image courtesy of Paul G Allen, Find *AE1* Ltd, Australian National Maritime Museum and Curtin University. © Navigea Ltd

Two fragments of another glass bottle are located immediately adjacent to the first and comprise a complete neck with rim and part of the base. In terms of appearance, the neck and rim most closely approximate a spirit (beer or wine) bottle. The glass does not appear to be transparent, although its colour is difficult to discern due to adhering marine growth and available image resolution (the bottle fragments and other artefacts were only captured by one of the ROV's standard-definition video cameras). As with the intact bottle, no diagnostic markings are visible on either fragment. What appears to be a leather shoe or boot heel is located a short distance forward of the bottle neck. It is roughly triangular in shape, brownish-black in colour, and appears to be positioned with its upper (interior) surface facing upwards. The glass artefacts and possible heel were located in the approximate location of the officers' wardroom lockers and may represent clothing and personal belongings that were stowed at the time of *AE1*'s loss.

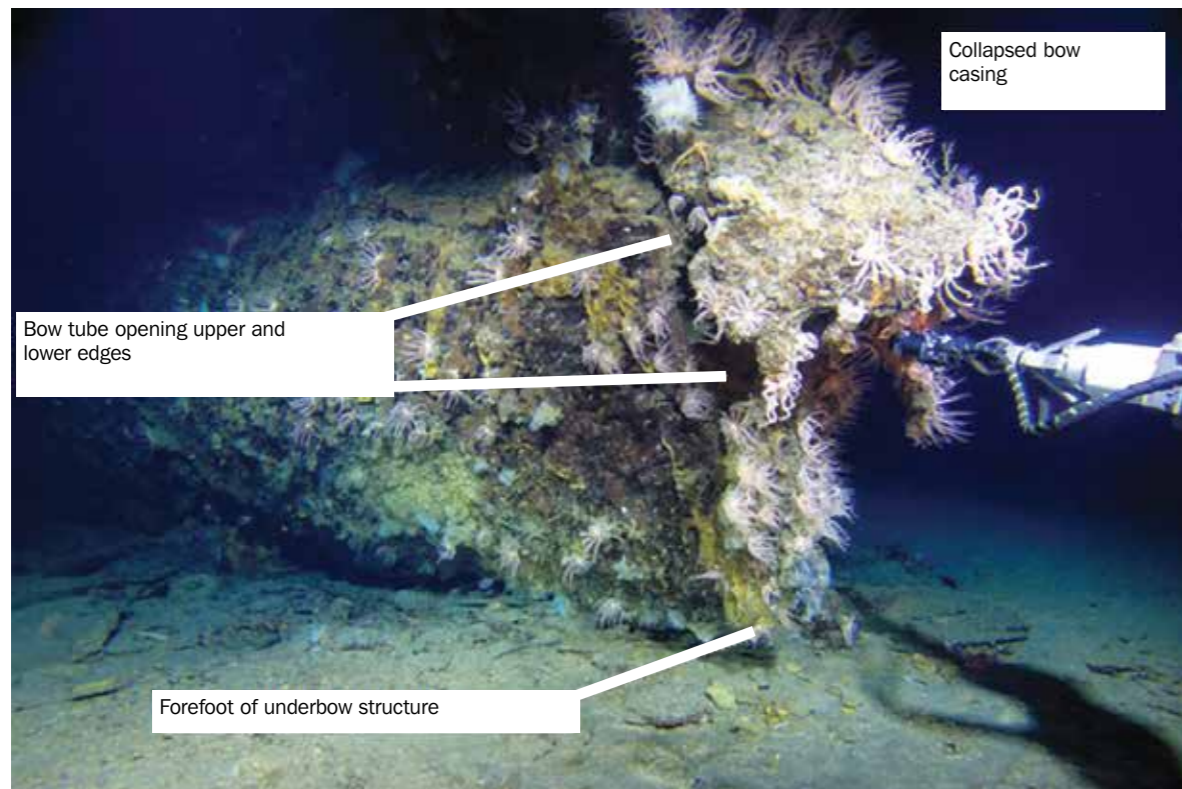
- The structure beneath the forward tube (bow, forefoot and supporting structure) is intact, with no sign of impact damage. This section appears to be clear of the seabed.

Figure 1 – Bow section.
Image courtesy of Paul G Allen, Find AE1, Australian National Maritime Museum and Curtin University. © Navigea Ltd

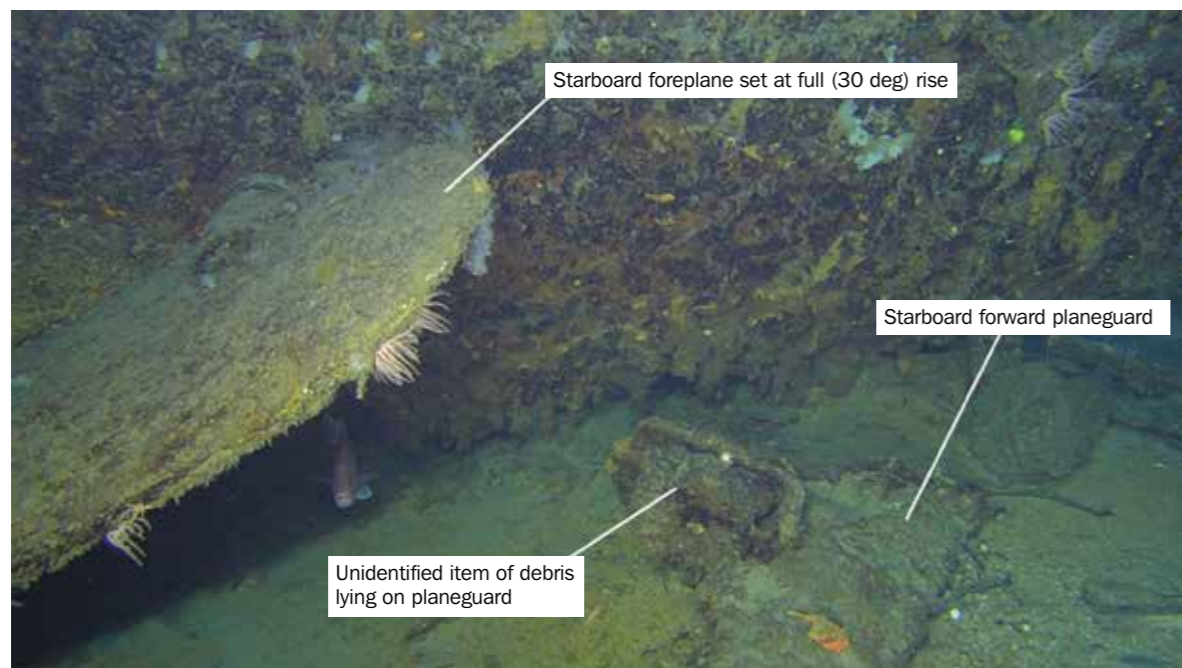
- The foreplanes are set hard (30 degrees) to rise.
- The forward planeguards are lying on the seabed close to below their mounted position.
- The forward planeguard securing points appear to have the same degree of corrosion/concretion/marine growth as the surrounding pressure hull.

Figure 2 – Starboard foreplane and planeguard.
Image courtesy of Paul G Allen, Find AE1, Australian National Maritime Museum and Curtin University. © Navigea Ltd

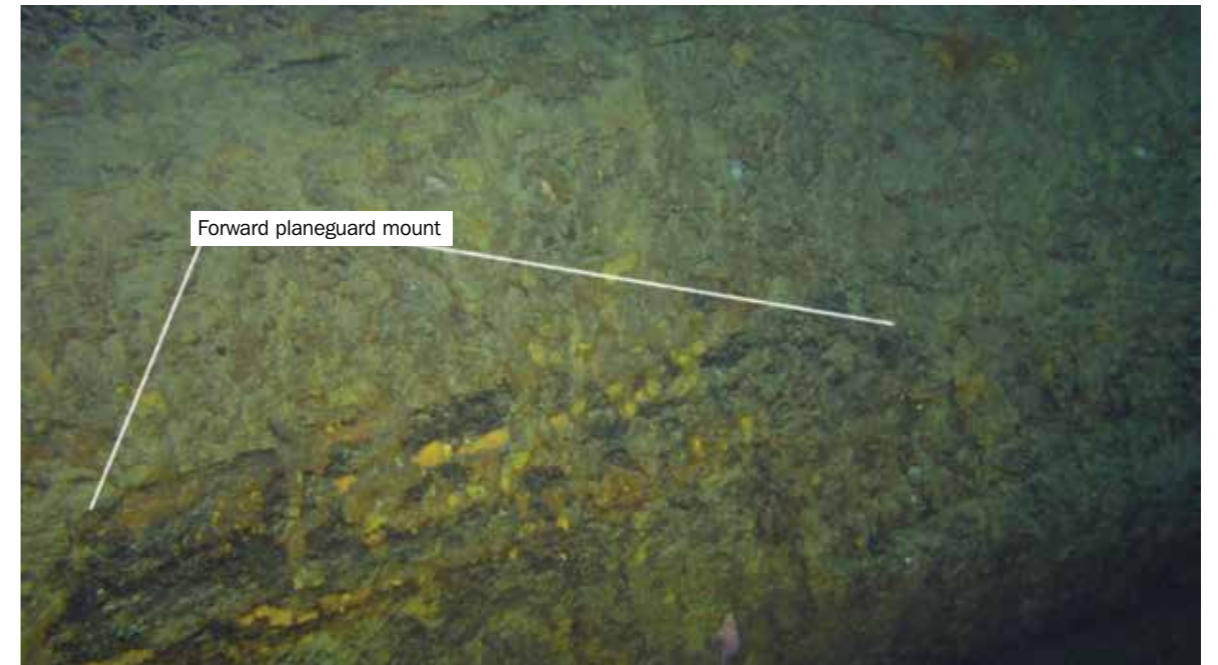
Figure 3 – Starboard forward planeguard mount.
Image courtesy of Paul G Allen, Find AE1, Australian National Maritime Museum and Curtin University. © Navigea Ltd
