Research Vessel *Petrel* Baseline Survey of HMAS *AE1*

April 2018

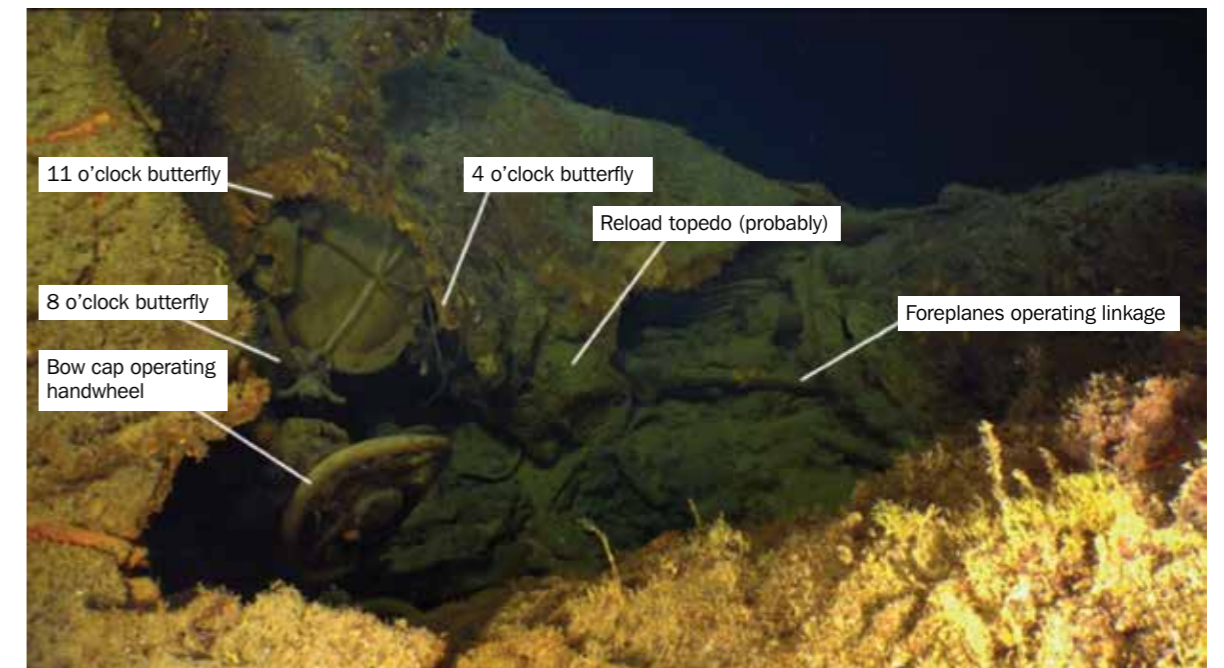
- The forward torpedo compartment has suffered a complete implosion, with the pressure hull folded flat to the point of failure with sections of the hull now lying on what was the deck of the forward torpedo compartment.

Figure 4 – Forward implosion area and forward tube rear door.
Image courtesy of Paul G Allen, Find AE1, Australian National Maritime Museum and Curtin University. © Navigea Ltd

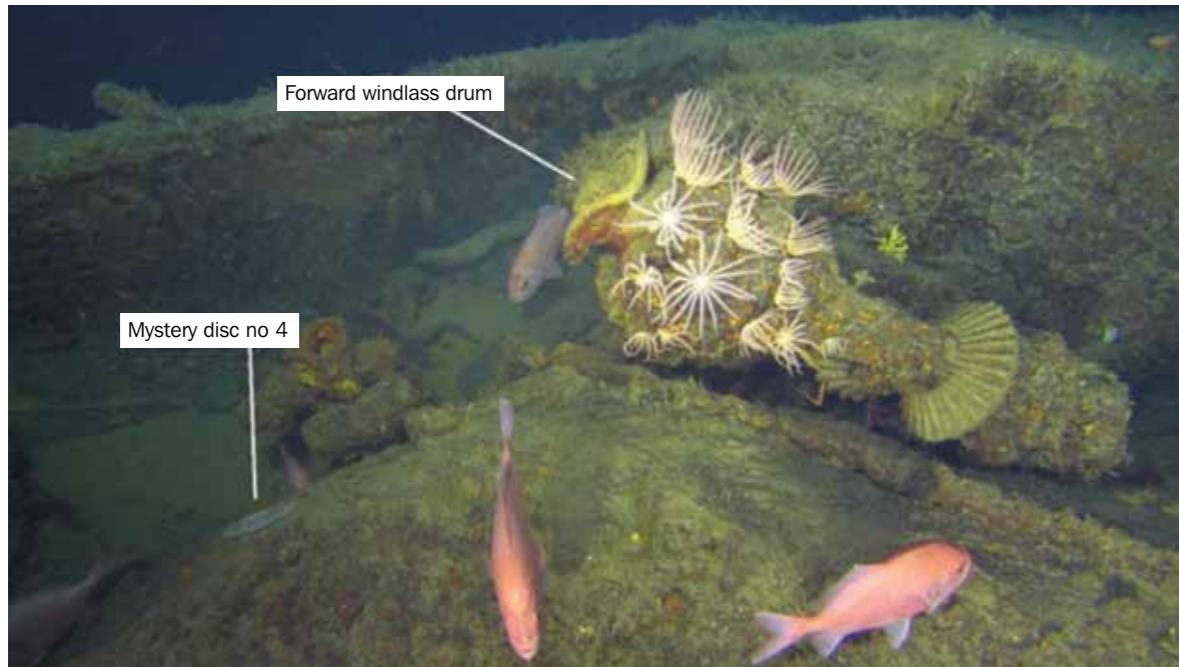
Figure 5 – Forward windlass.
Image courtesy of Paul G Allen, Find AE1, Australian National Maritime Museum and Curtin University. © Navigea Ltd

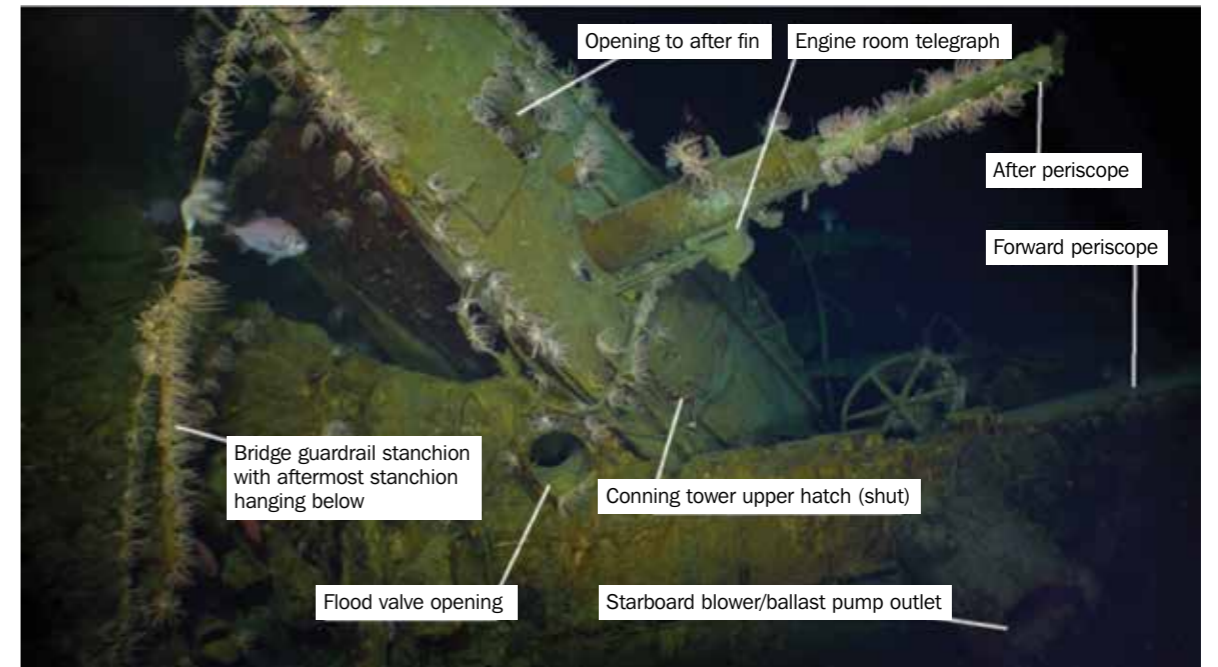
Figure 7 – Fin area from starboard.
Image courtesy of Paul G Allen, Find AE1, Australian National Maritime Museum and Curtin University. © Navigea Ltd

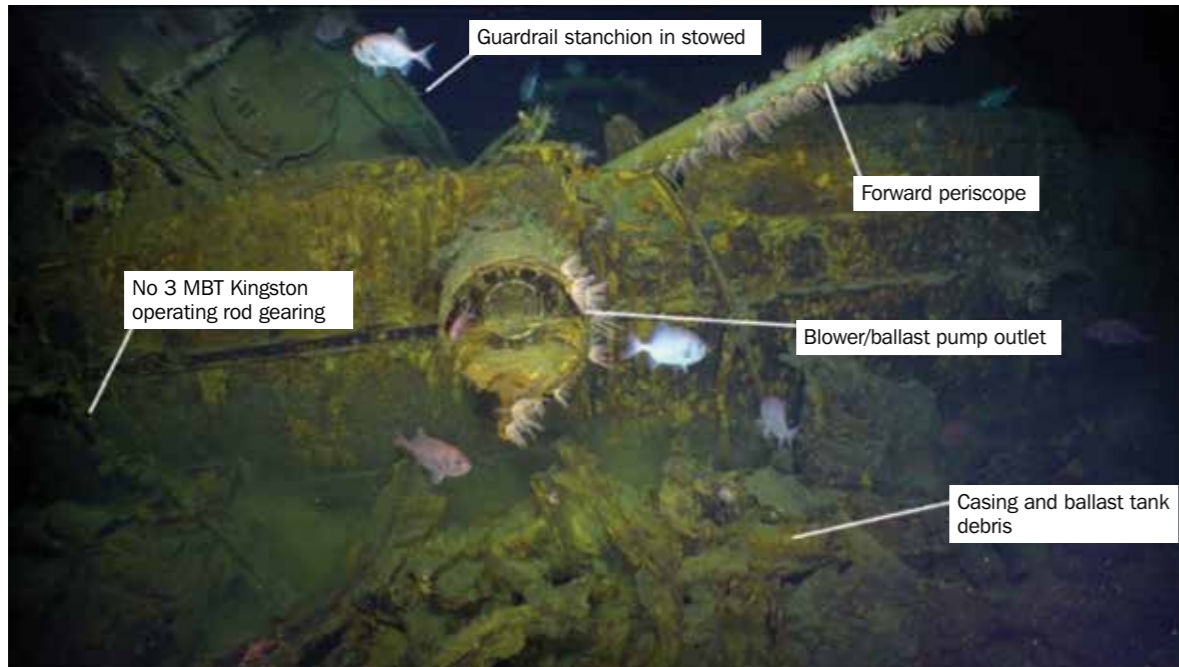
Figure 9 – Starboard blower and No. 3 main ballast tank debris.
Image courtesy of Paul G Allen, Find AE1, Australian National Maritime Museum and Curtin University. © Navigea Ltd

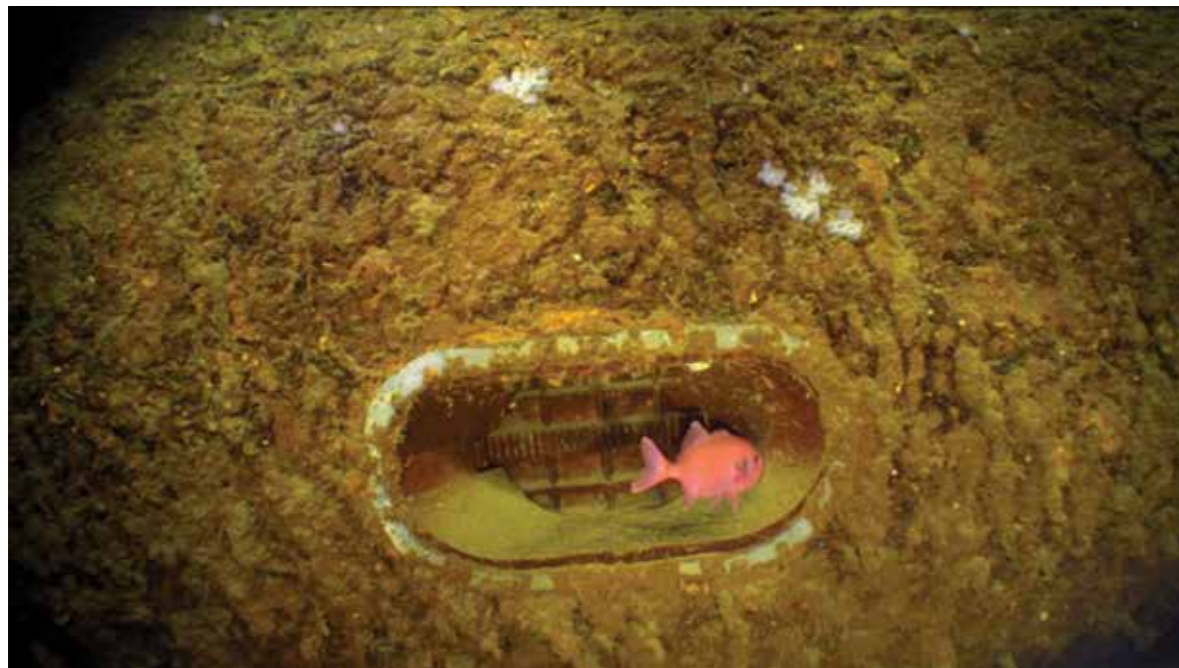
Figure 10 – Starboard beam tube outer door (shut).
Image courtesy of Paul G Allen, Find AE1, Australian National Maritime Museum and Curtin University. © Navigea Ltd

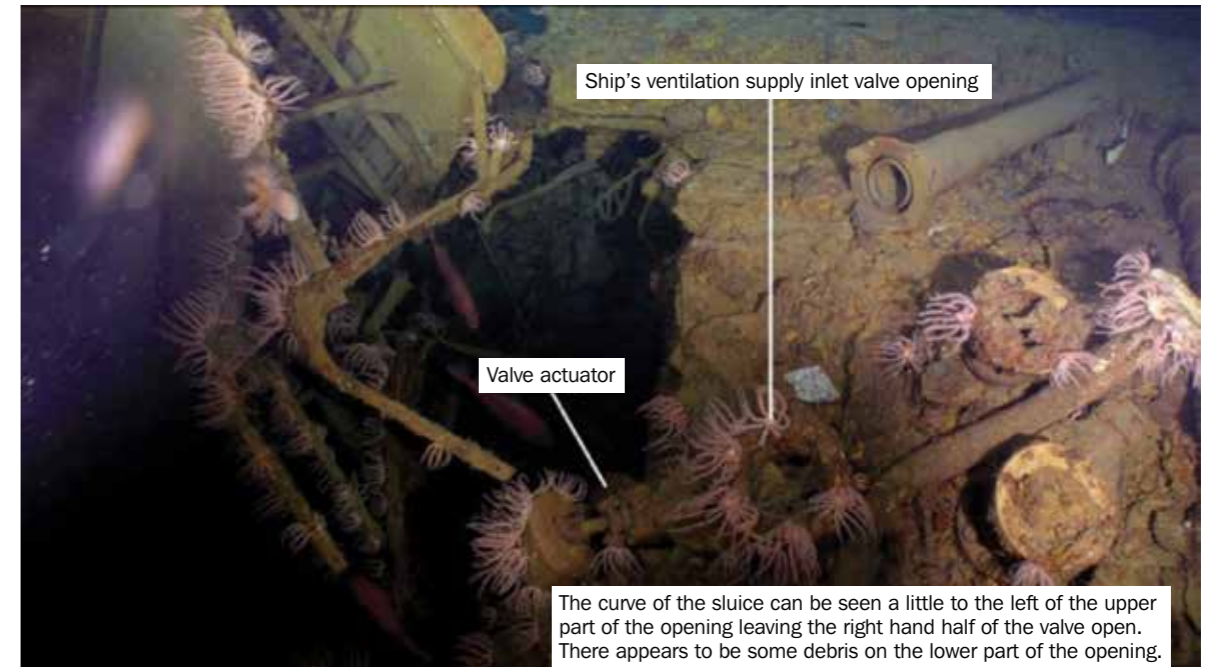
Figure 11 – Ventilation trunking and hull valves.
Image courtesy of Paul G Allen, Find AE1, Australian National Maritime Museum and Curtin University. © Navigea Ltd

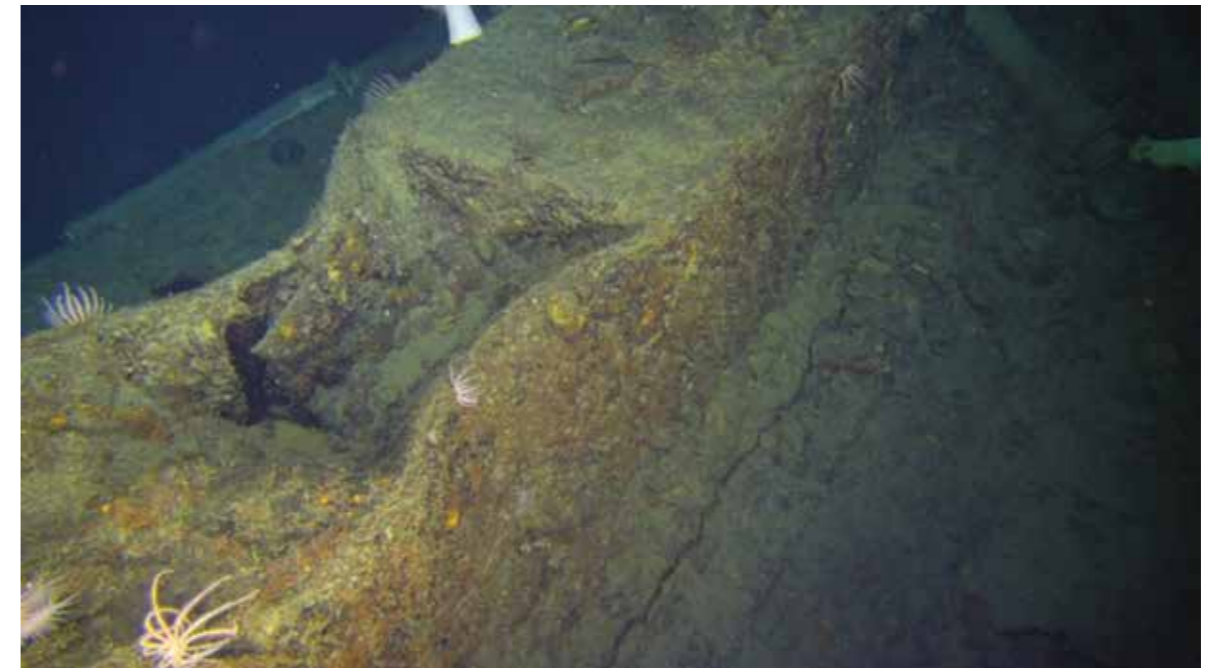
Figure 12 – Beam tube firing tanks.
Image courtesy of Paul G Allen, Find AE1, Australian National Maritime Museum and Curtin University. © Navigea Ltd

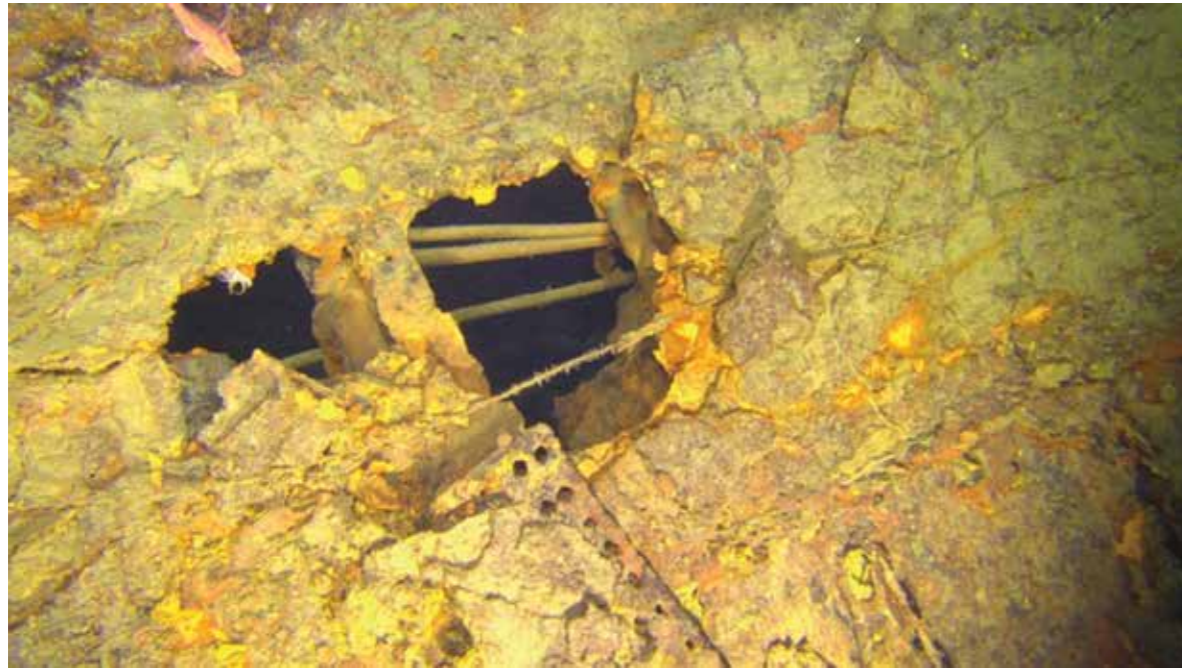
Figure 13 – Hole over senior sailors' mess.
Image courtesy of Paul G Allen, Find AE1, Australian National Maritime Museum and Curtin University. © Navigea Ltd

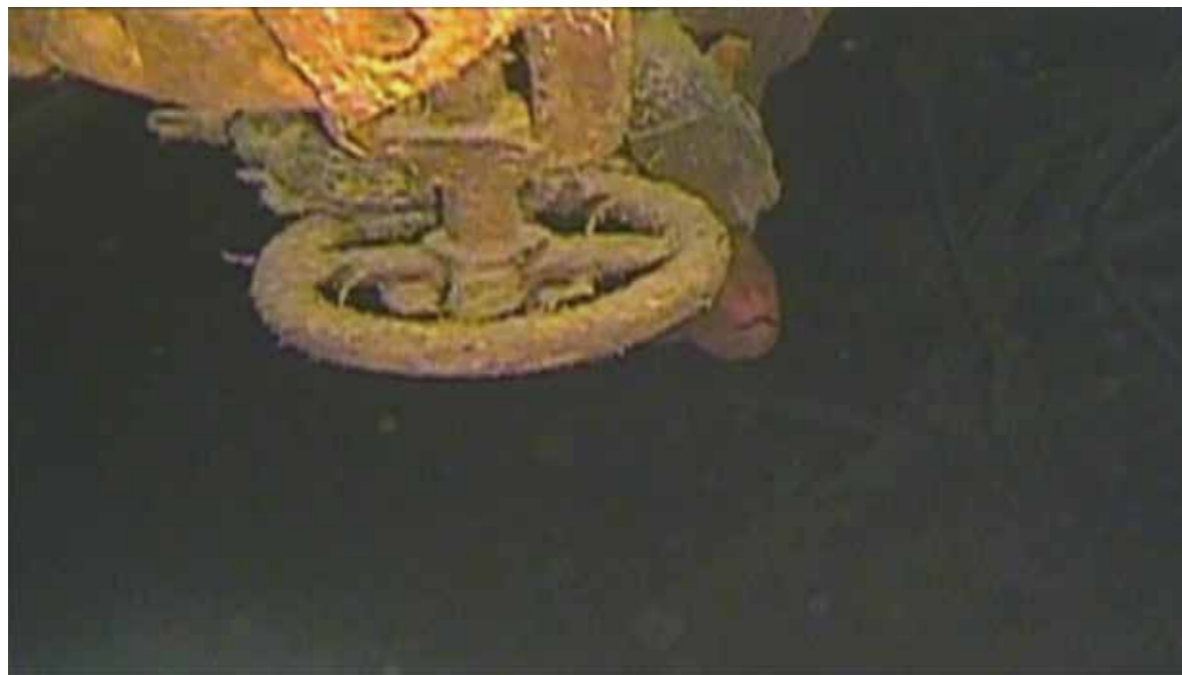
Figure 14 – No. 5 main vent valve handwheel.
Image courtesy of Paul G Allen, Find AE1, Australian National Maritime Museum and Curtin University. © Navigea Ltd

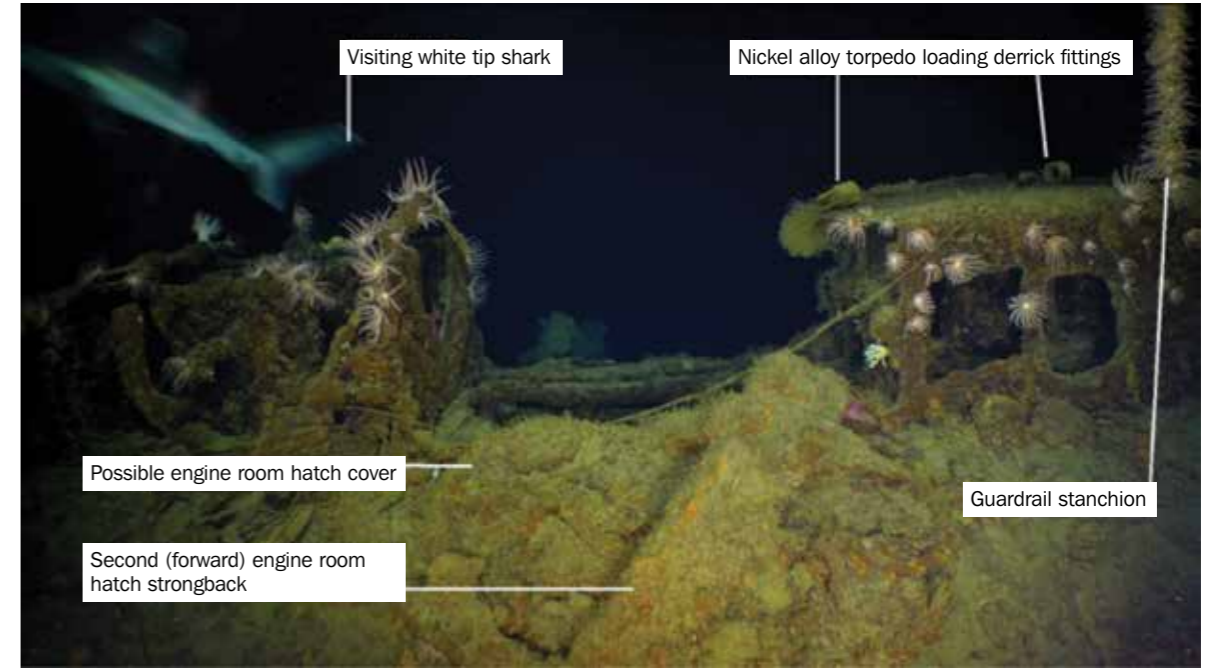
Figure 15 – Engine room hatch from port side.
Image courtesy of Paul G Allen, Find AE1, Australian National Maritime Museum and Curtin University. © Navigea Ltd

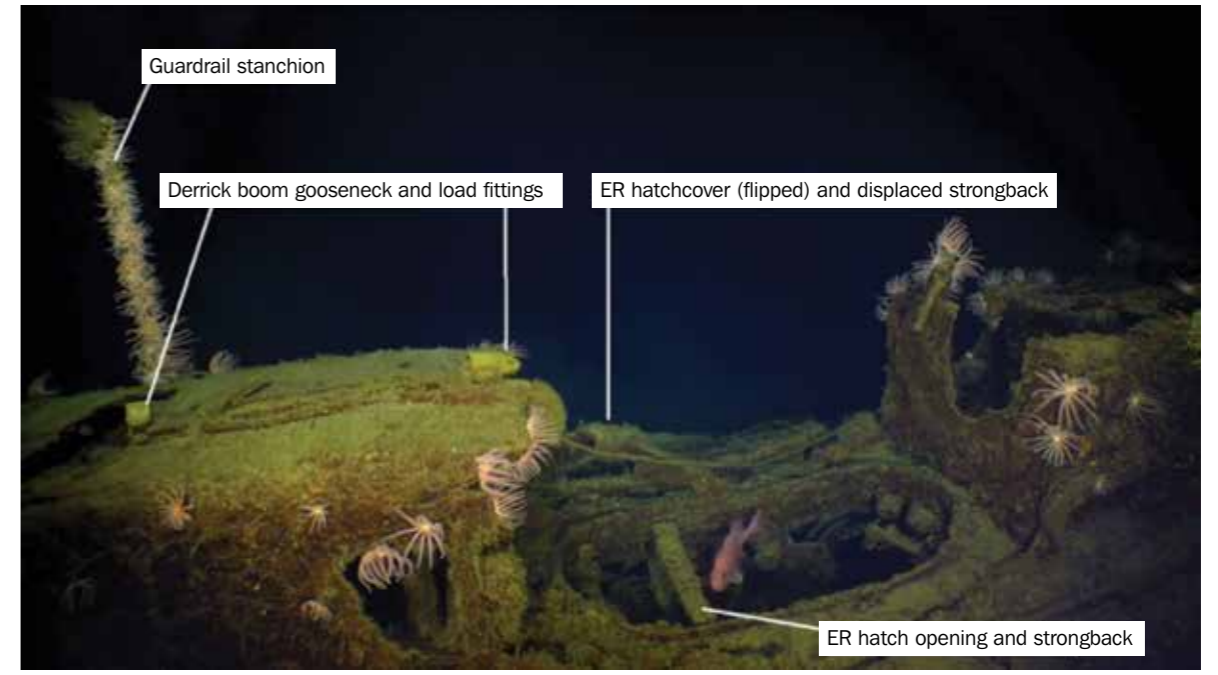
Figure 16 – Engine room hatch from starboard.
Image courtesy of Paul G Allen, Find AE1, Australian National Maritime Museum and Curtin University. © Navigea Ltd

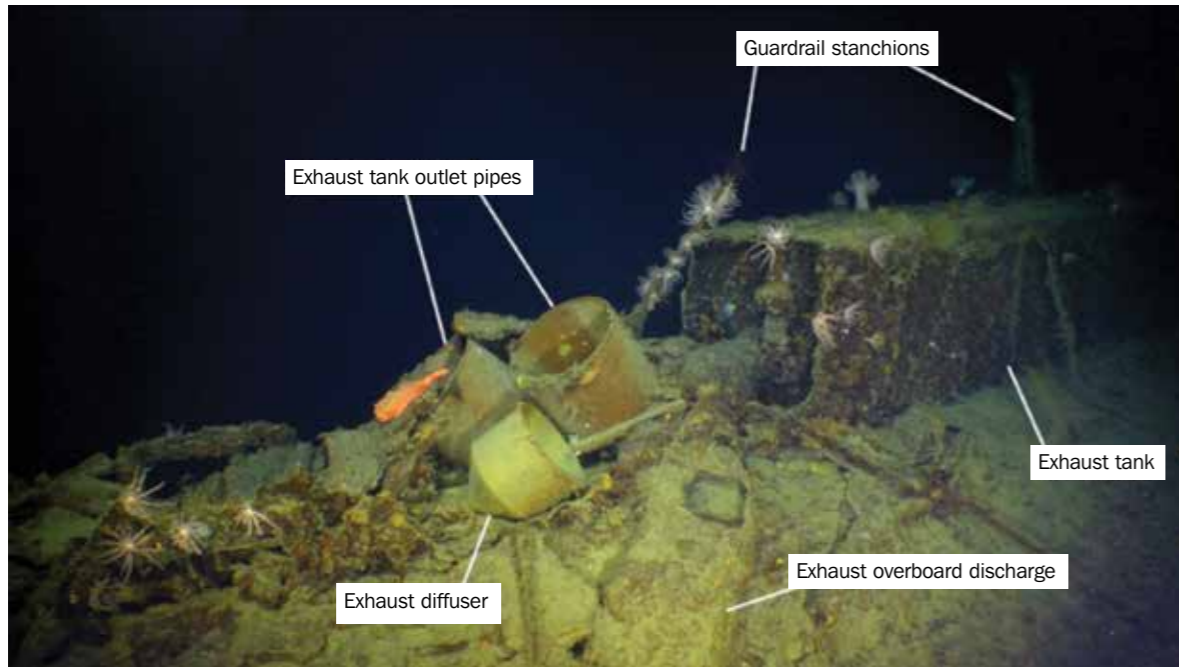
Figure 17 – Exhaust tank outlet pipework.
Image courtesy of Paul G Allen, Find AE1, Australian National Maritime Museum and Curtin University. © Navigea Ltd

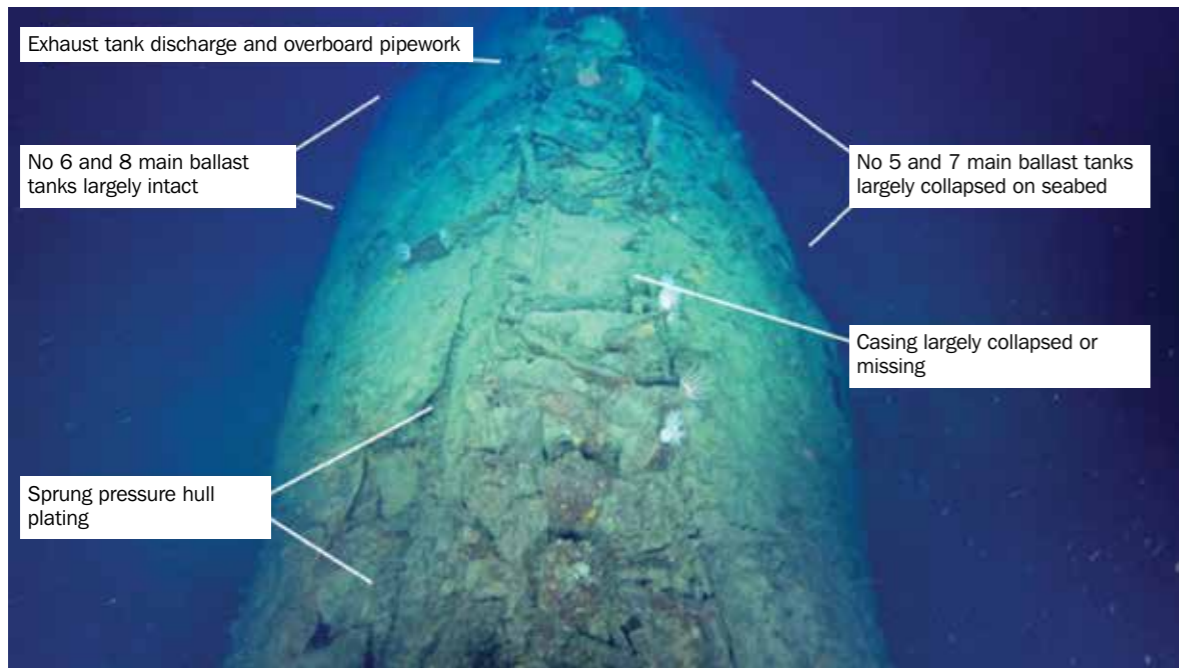
Figure 18 – After casing area. Note how little of the casing remains.
Image courtesy of Paul G Allen, Find AE1, Australian National Maritime Museum and Curtin University. © Navigea Ltd

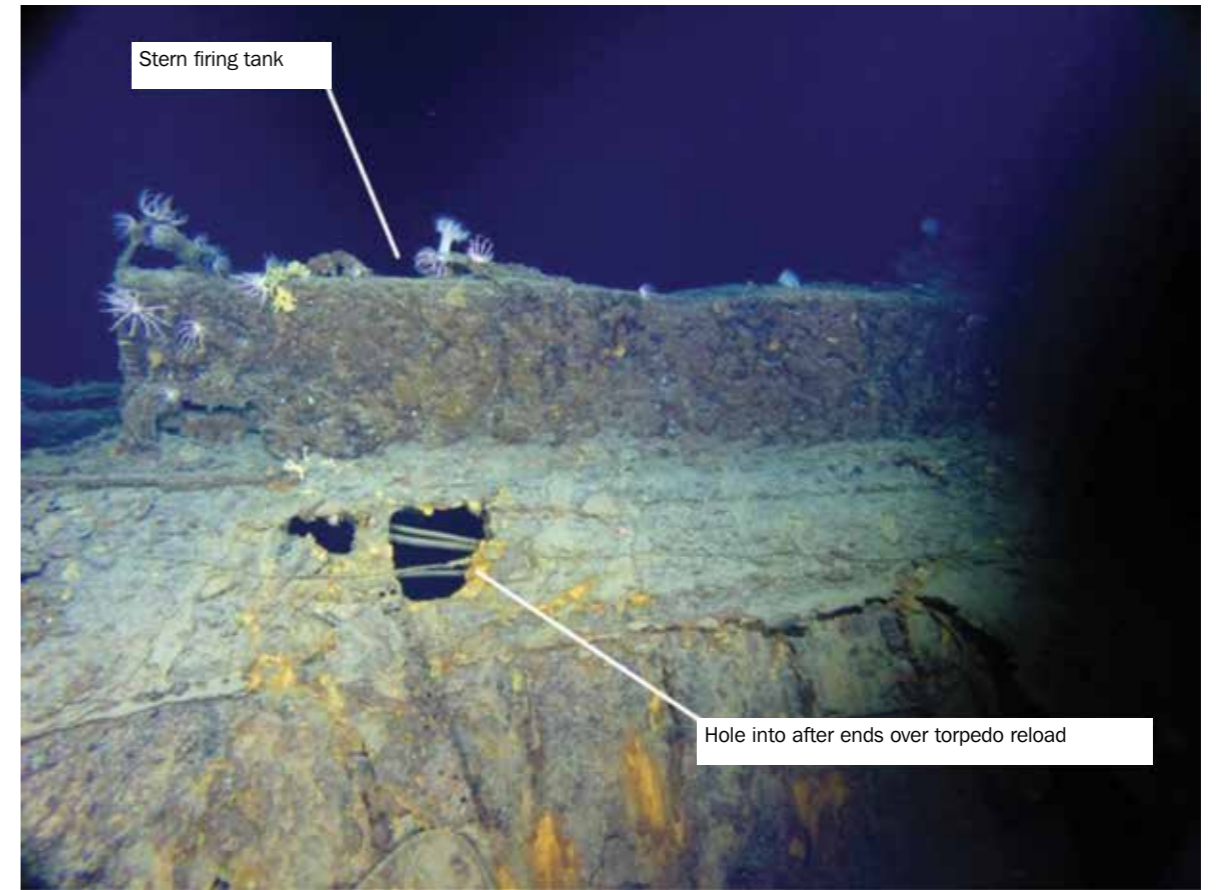
Figure 19 – Stern firing tank and hole over after ends (viewed from port).
Image courtesy of Paul G Allen, Find AE1, Australian National Maritime Museum and Curtin University. © Navigea Ltd

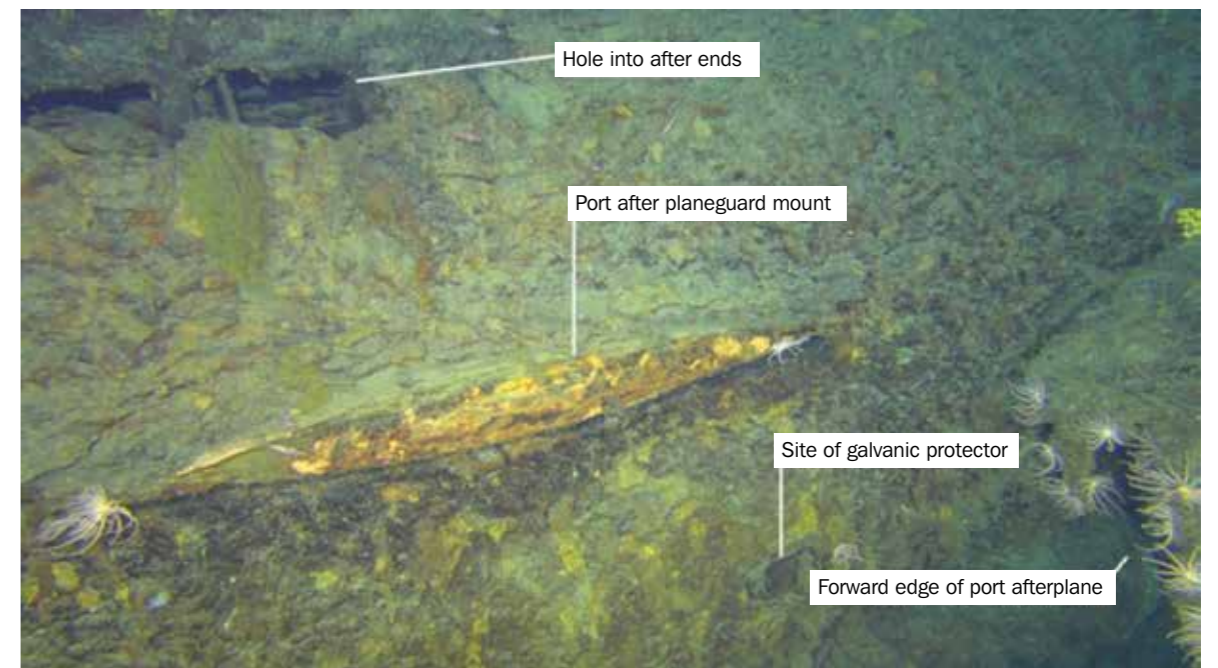
Figure 20 – Port after plane guard mount.
Image courtesy of Paul G Allen, Find AE1, Australian National Maritime Museum and Curtin University. © Navigea Ltd

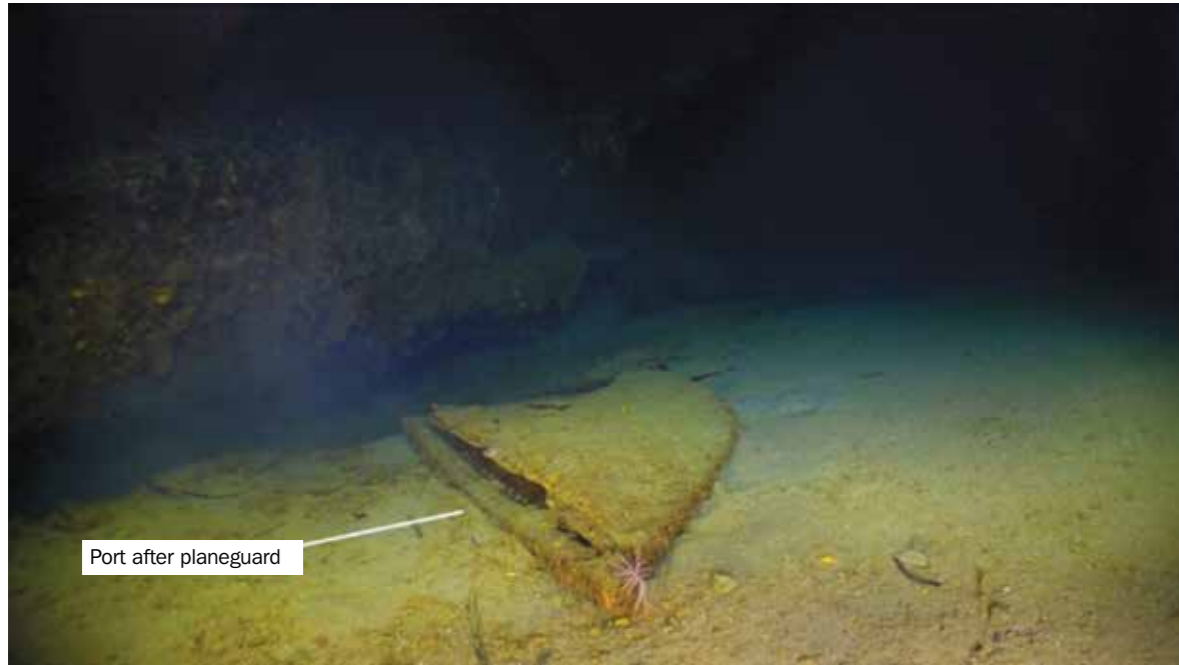
Figure 21 – Port after planeguard.
Image courtesy of Paul G Allen, Find AE1, Australian National Maritime Museum and Curtin University. © Navigea Ltd

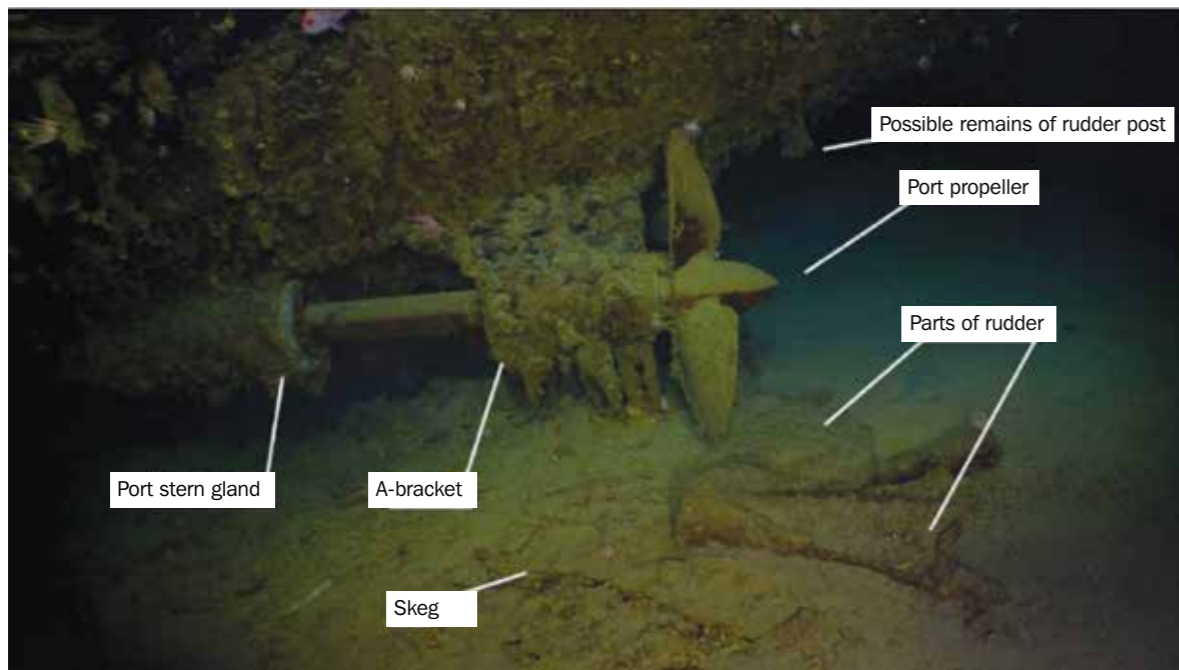
Figure 22 – Port propeller shaft, rudder and skeg.
Image courtesy of Paul G Allen, Find AE1, Australian National Maritime Museum and Curtin University. © Navigea Ltd

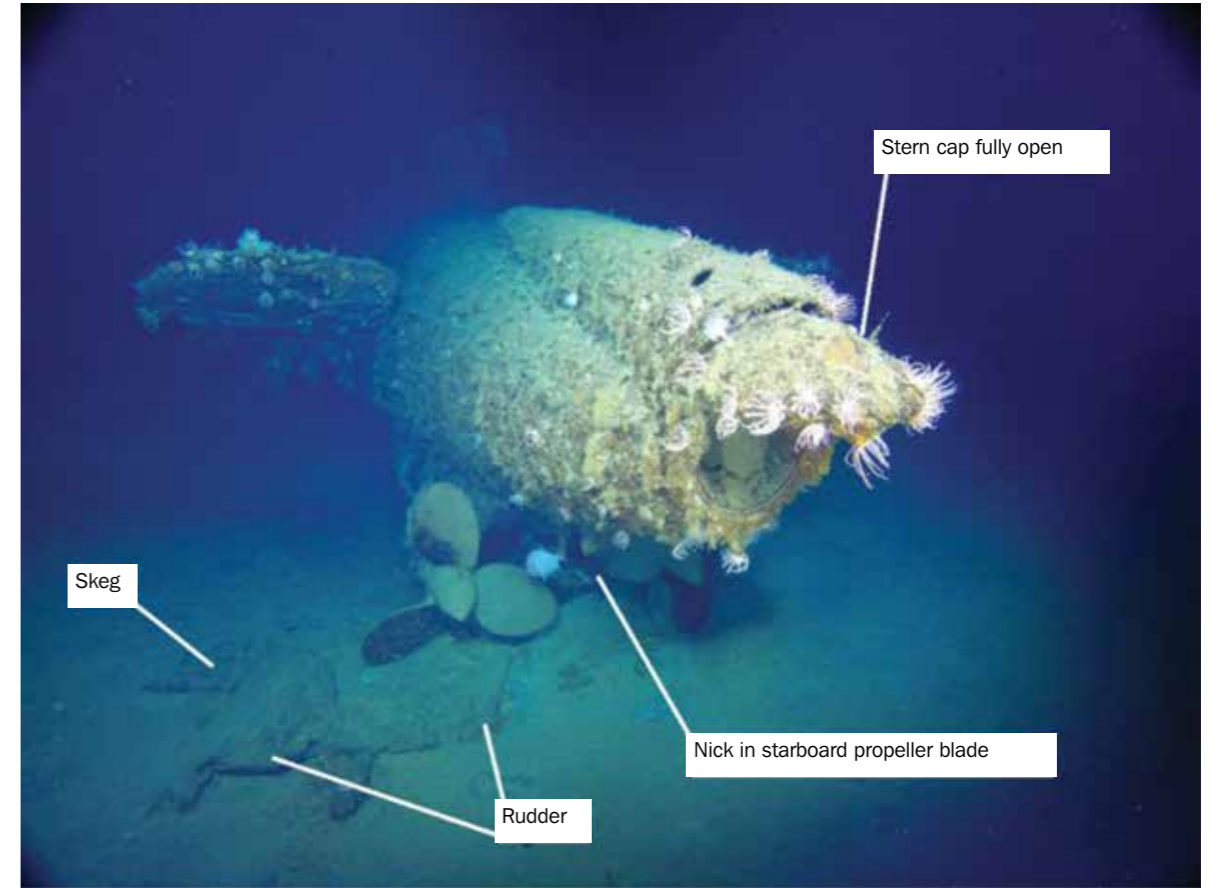
Figure 23 – Stern tube, rudder and skeg.
Image courtesy of Paul G Allen, Find AE1, Australian National Maritime Museum and Curtin University. © Navigea Ltd

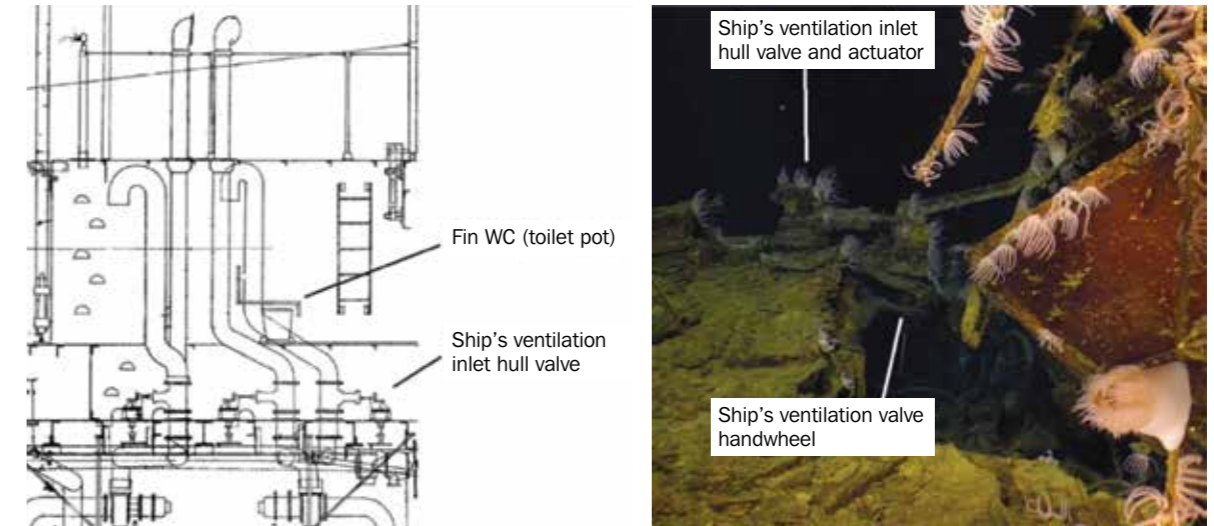
Given that the valve actuator is in the ruptured pressure hull and that the area has been subjected to some severe forces as the fin has torn the systems away, consideration was given to the possibility that the actuator arm was subjected to an extreme longitudinal tension which wrenched the valve sluice into its current part-open position. However, the system drawing³ shows the valve to be screw-actuated, thus movement of the sluice would not be possible without rupture of the actuator body, of which there is no visible sign. Furthermore, inspection of the valve body and actuator from the starboard side (Figure 25, opposite page) shows it still to be attached to the pressure hull, thus any longitudinal force would be borne by the actuator body, not the sluice.

From this we can only conclude that the valve was at least part-opened at the time of the accident. It is possible that it was fully open at the time of diving, which resulted in a flood to the ventilation trunking. On seeing the flood, attempts were made to shut the valve, resulting in it being in its current position.

If the submarine were to dive with the valve open or part (60%) open it would result in a large ingress of water at pressure to the ship's ventilation supply trunking. The build specification calls for the trunking to be fitted with a quick-closing valve similar to those fitted to the battery ventilation system. However, the drawings – neither ship and battery ventilating system drawing no. 2923 nor the general arrangement – show such a valve and the configuration of the internal pipework is such that it is hard to see where it could be successfully fitted. That is not to say a quick-acting valve was not fitted but it does increase the possibility that the open sluice valve could have led to a flood.

Figure 25 – Extract from general arrangement drawing of ventilation hull valves (L) and ship's ventilation hull valve (*Petrel*) (R).
Image courtesy of Paul G Allen, Find AE1, Australian National Maritime Museum and Curtin University. © Navigea Ltd

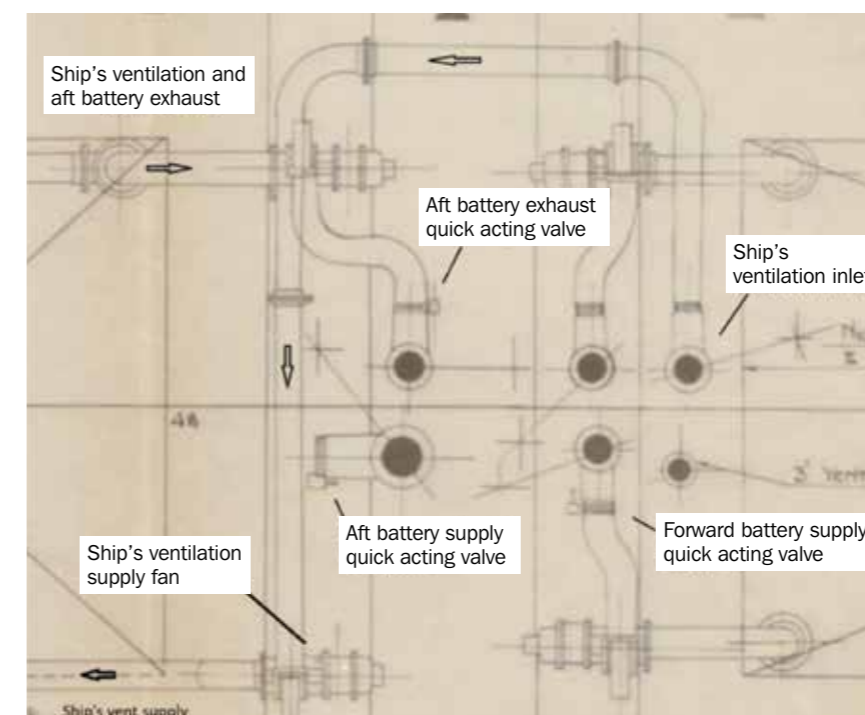
Figure 26 – Extract from ship's drawing No. 2923, 'Battery and ship's ventilation'. Note absence of quick-acting valve from ship's supply trunking.
Image courtesy of NAA: MP551/1, 109/77

A comparison of the battery and ship's ventilation drawing (Figure 26) with the (later) general arrangement drawing (Figure 27) shows that the forward battery supply quick acting valve was moved to be just above its entry to the battery tank. It was in this position that such a valve was seen in AE2. The change to the design was presumably made because of the physical difficulty of mounting such a valve in the overhead trunking. There would have been similar difficulties with the ship's ventilation supply. It is also possible that in the face of those practical difficulties, a quick-acting valve was considered less of a priority when the trunking did not lead into a battery tank.

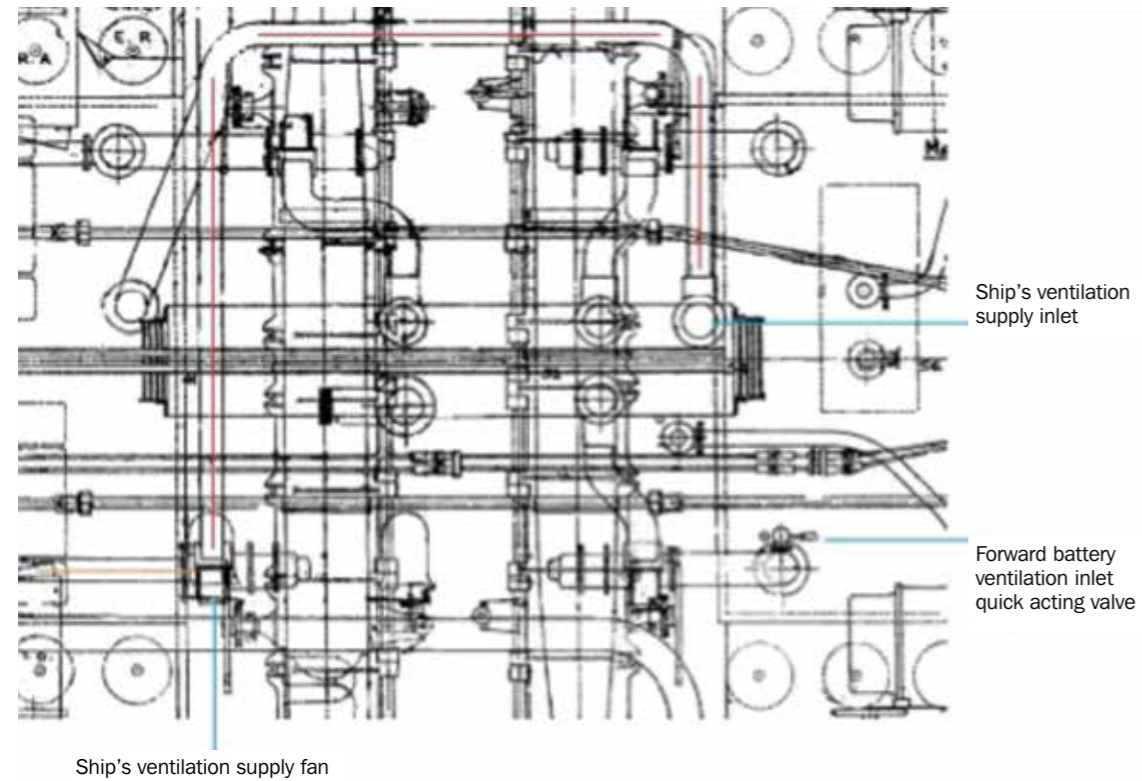
Figure 27 – Extract from general arrangement drawing of ventilation supply arrangement. Note new position of forward battery vent supply quick-acting valve and absence of quick-acting valve from ship's supply.

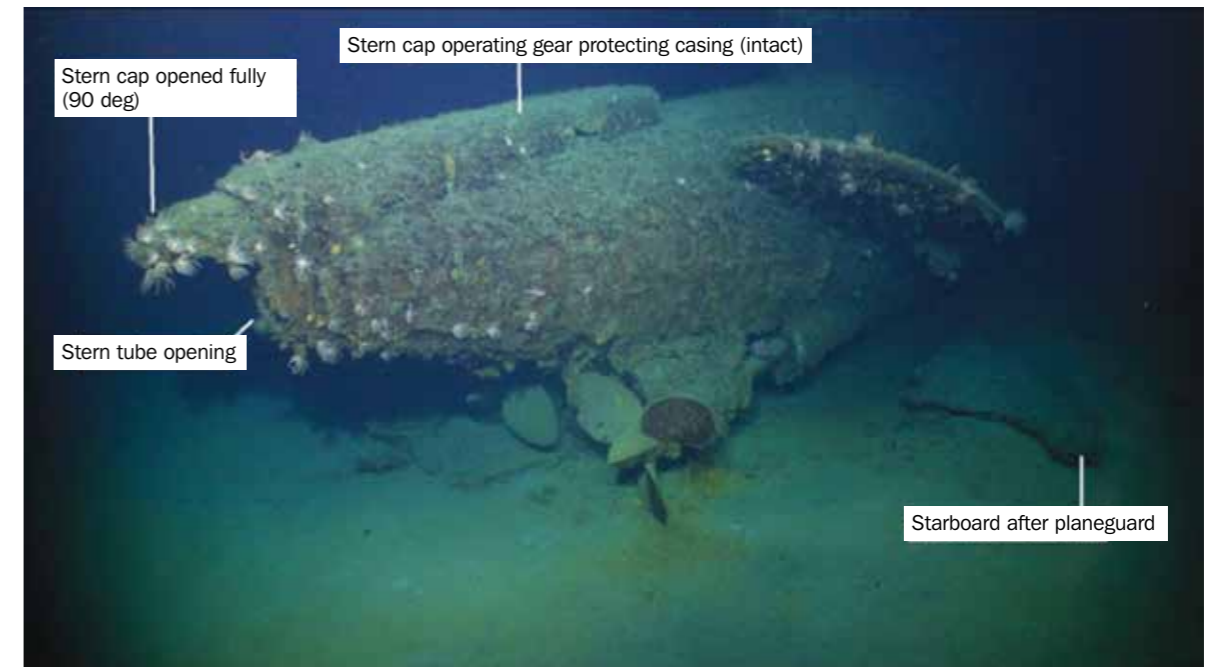
It might be possible given the forces acting in the implosion and the impact with the seabed for the worm gear to slip a tooth or two, but it is hard to imagine that the stern cap could be 'flicked' to the fully open position, particularly as the whole of the stern area is intact and in fact quite well-preserved. Thus, if we accept that the accident occurred on diving (due to the open ship's ventilation valve) we must conclude that the stern cap was deliberately opened prior to the submarine diving.

Given that the stern tube is clear of the water when the submarine is at full buoyancy it is practical for it to be opened when the submarine is surfaced. It could have been opened as part of a weapons drill or perhaps with the intention to achieve a higher level of weapons readiness in the expectation of meeting the German steamer. We cannot know why the stern cap is open but the evidence is that it is.

Figure 28 – View of after ends, showing open stern cap. Image courtesy of Paul G Allen, Find AE1, Australian National Maritime Museum and Curtin University. © Navigea Ltd

With the stern cap open, the outer section of the tube would flood on diving. This represents an increase to the submarine's bodily weight of some 97 gallons (~367 litres, weighing some 440 kilograms) at the extreme after end. If compensation had not been made, the submarine would have had a reduced buoyancy, been heavy overall and significantly out of trim (heavy aft). From this we can conclude that the stern cap being open could have worsened the situation on diving.

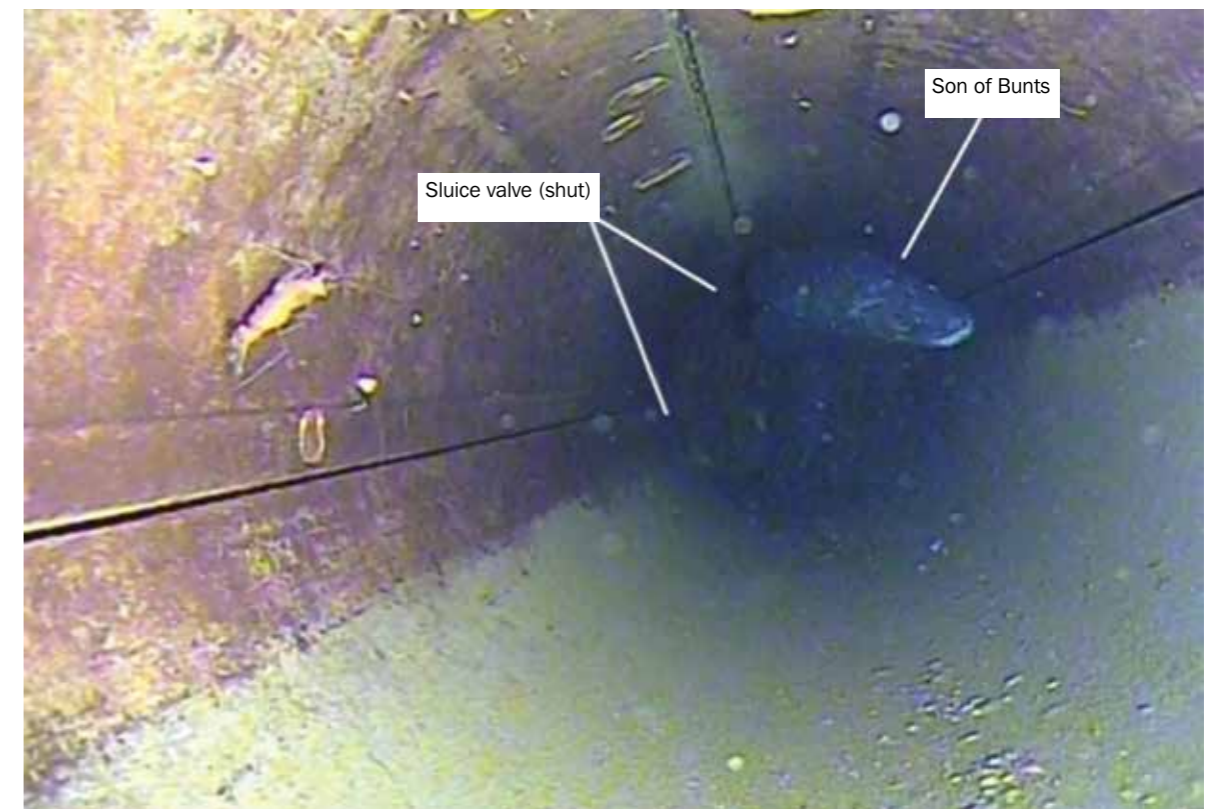
Having the stern cap open provided the opportunity to sight the sluice valve, located some 1.9 metres into the tube. This was successfully done, despite it being diligently guarded by a large eel.

Figure 29 – Inside the stern tube. Image courtesy of Paul G Allen, Find AE1, Australian National Maritime Museum and Curtin University. © Navigea Ltd

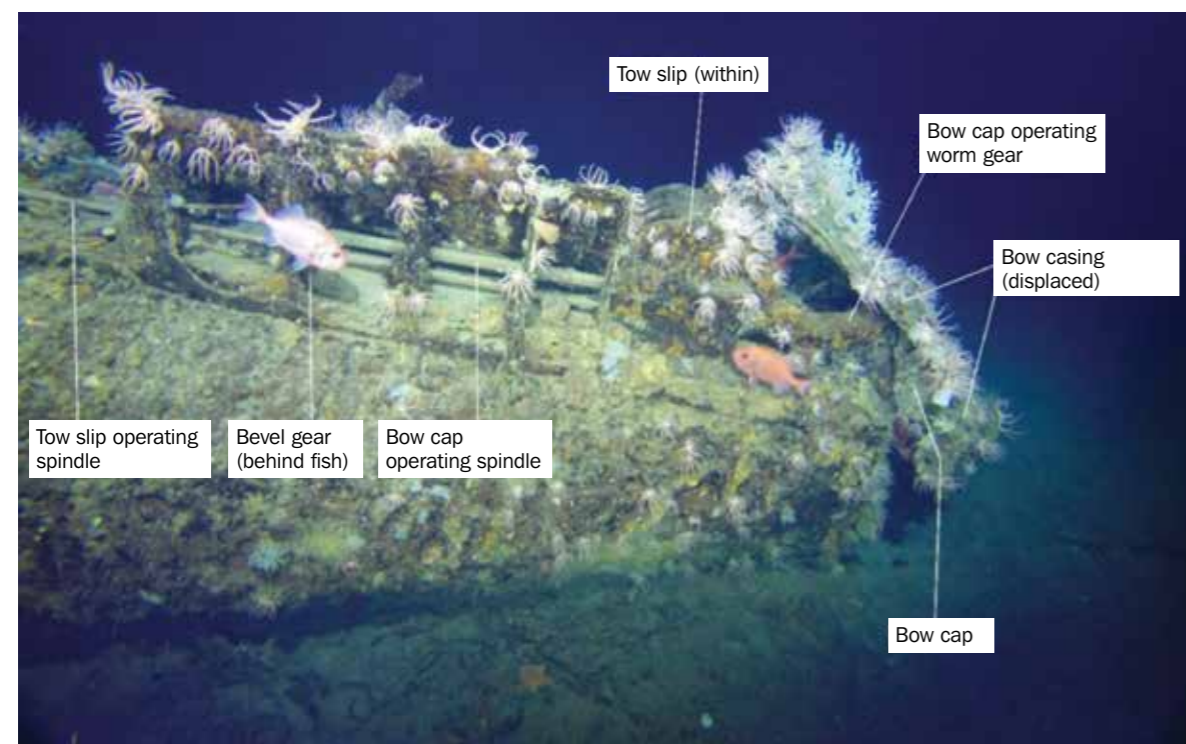
- The forward torpedo tube outer door (bow cap) is open by some 20–25 degrees.
- The forward casing has slumped forward and down over the bow cap and can be confused with the bow cap itself, presenting a confusing perspective from some aspects.
- The forward tube rear door is exposed in the imploded forends area, allowing inspection of the rear door and the operating handwheels (see Figures 4, 30 and 31).
- Three of the four rear door retaining butterfly clips (4, 8 and 11 o'clock) have been dislodged. The fourth is obscured.
- The bow cap operating handwheel has been badly distorted downwards.
- The sluice valve operating handwheel has been dislodged but appears intact.
- Access to inspect the tube sluice valve was prevented by the narrow opening of the bow cap and the slumped casing.

The bow cap operating mechanism is similar to that of the stern tube, being a worm gear actuator operated by rod linkage which passes through two bevel gear actuators, all operated by a handwheel located to port of the rear door. The linkage is protected by the forward casing, which is now badly damaged through a combination of collapse and corrosion. The operating handwheel has been subjected to strong downward forces, presumably the consequence of the implosion.

Figure 30 – Forward torpedo tube.
Image courtesy of Paul G Allen, Find AE1, Australian National Maritime Museum and Curtin University. © Navigea Ltd
