Research Vessel *Petrel* Baseline Survey of HMAS *AE1*

April 2018

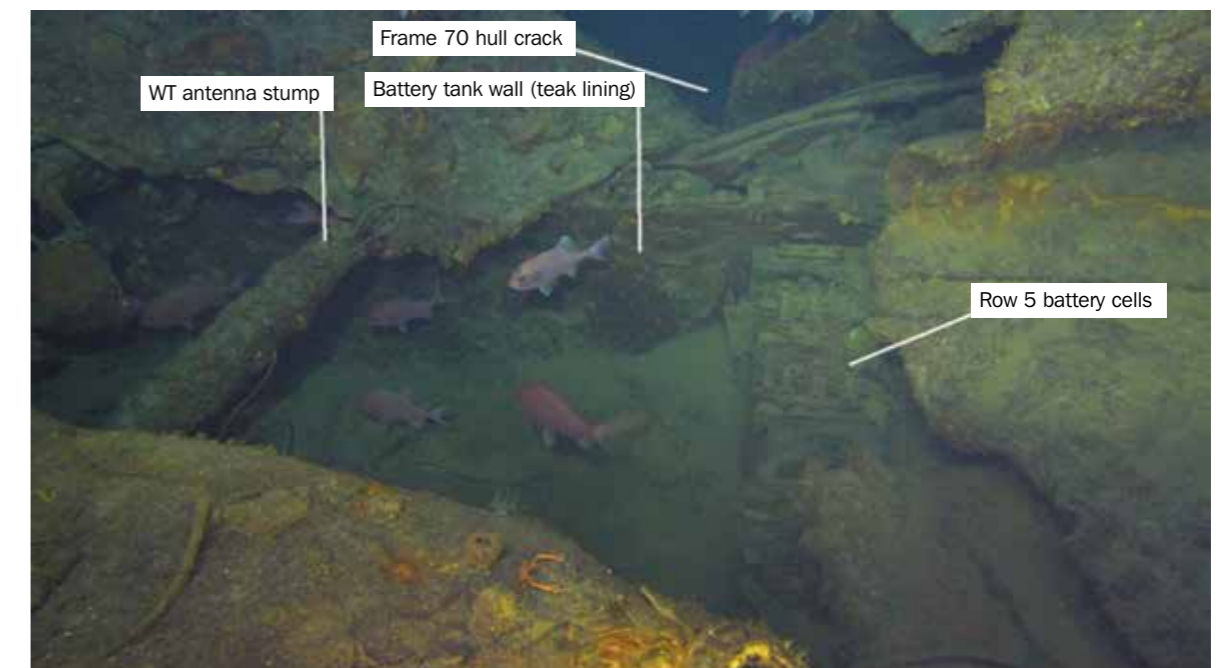
The pressure hull has experienced a major rupture at Frame 70. This is visible in Figure 32 but also in Figure 6 (starboard side internal) and Figure 33 (port side internal). The crack appears to have opened by 1–3 degrees and has allowed the pressure hull forward of this area to have settled somewhat lower than if the hull were complete.

It was a surprise to find that much of that area is now fully open. The deck and its canvas cover have gone and a row of battery cells (row 5 counting from forward) has been exposed at the forward end of the battery tank (see Figures 6 and 33). One cell from row 6 is visible under the collapsed pressure hull on the outermost starboard side. The curiosity is that the remainder of rows 6 and aft are not visible. Instead, there is an apparently level area of sediment placed some 0.4 metres lower than the top of the battery cells of row 5. In Figure 33 the battery tank's teak wall (port side) can be seen extending aft from row 5. The height of the wall edge above row 5 is as per the drawings at around 0.2 metres. This suggests that the entire battery from row 6 aft has slumped by around 0.4 metres to provide a level area which has then been subject to sedimentation.

For interest, the upper section of the WT antenna stump has fallen into the battery tank void and is visible in Figure 33.

Figure 33 – Battery tank from starboard.
Image courtesy of Paul G Allen, Find AE1, Australian National Maritime Museum and Curtin University. © Navigea Ltd

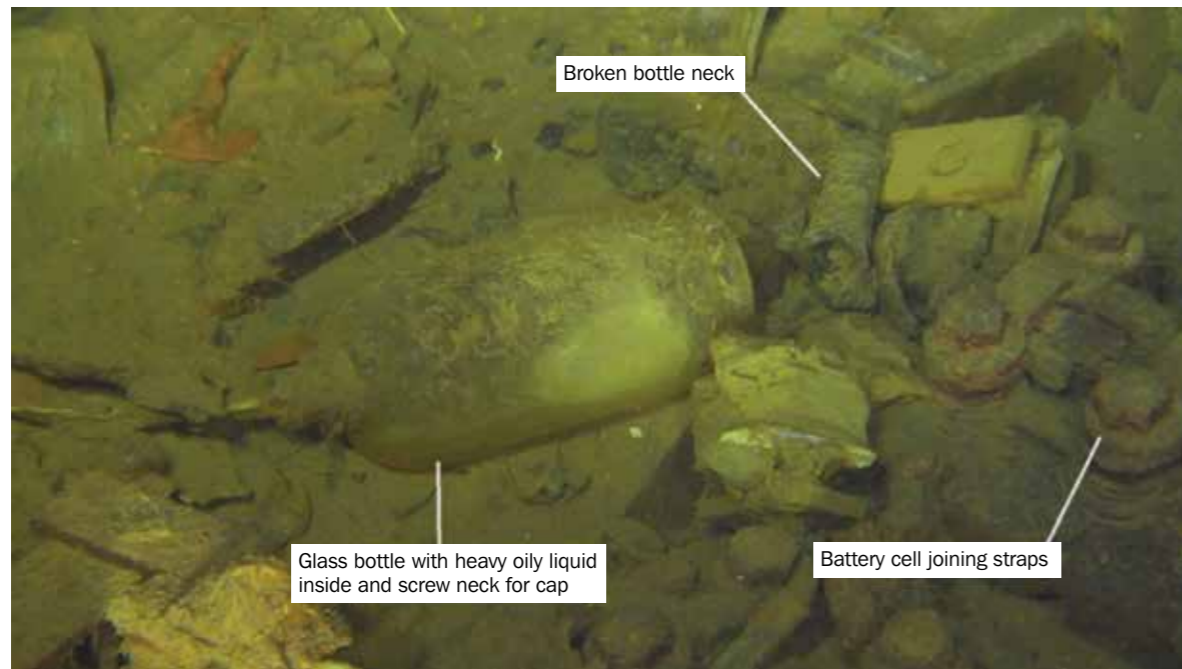
It may also be noted (Figure 34) that there is what appears to be a screw-top bottle, missing its top but containing the residue of a heavy straw-coloured liquid, located on the debris above row 4 of the battery. Next to it is the broken neck of another glass bottle. To the left of the bottle is a square cornered piece of (probably) teak, which could be a remnant piece of furniture. Row 4 of the battery is directly beneath the after end of the officers' quarters. It is reasonable to assume that these items fell to their current position from the writing desk or the wardroom table. It is a delightfully curious coincidence that this, the only real 'human' artefact observed in the wreck, is a drink-related item located in exactly the same position as the port decanter found in the wreck of HMAS AE2.

Figure 34 – Bottle located on row 4 battery.
Image courtesy of Paul G Allen, Find AE1, Australian National Maritime Museum and Curtin University. © Navigea Ltd

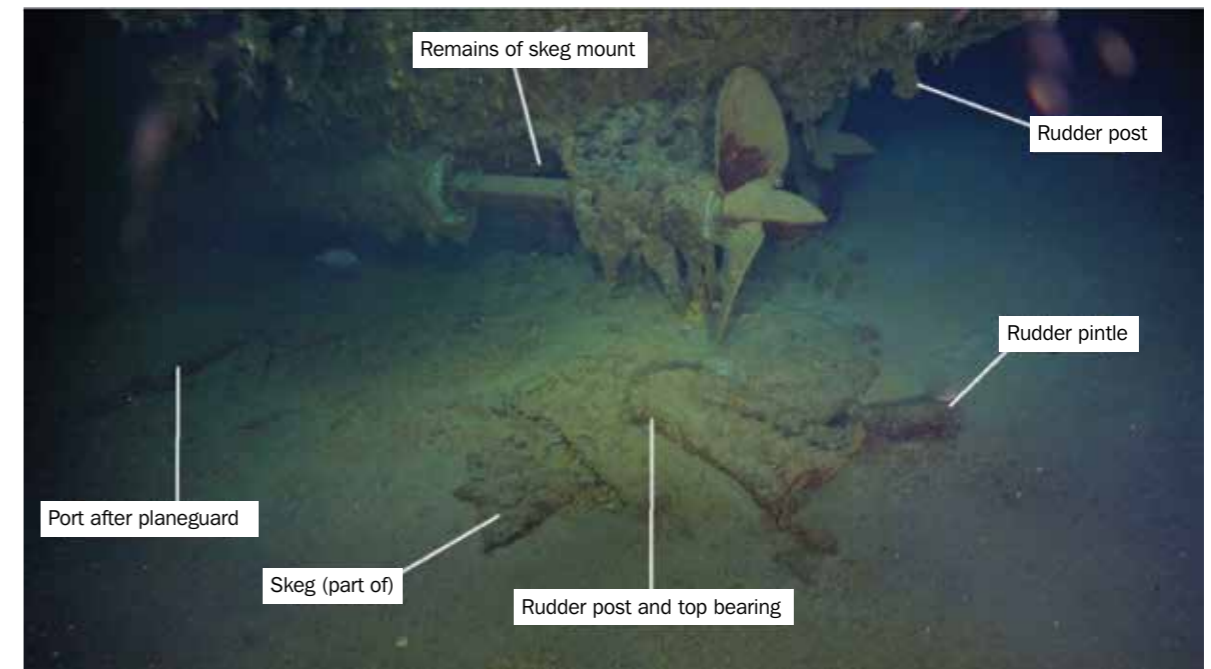
Figure 36 – Rudder and skeg on seabed.
Image courtesy of Paul G Allen, Find AE1, Australian National Maritime Museum and Curtin University. © Navigea Ltd

With the submarine at a level trim, the base of the skeg would sit about 1 metre above a level seabed. For the skeg and rudder to have been damaged so conclusively the submarine must have struck the seabed with a bow-up angle sufficient to close that gap. Measured from the general arrangement drawings, this would imply that the submarine would have had to impact the seabed with a bow-up angle of at least 3 degrees. However, the propellers are quite intact and therefore were not included in the impact with the seabed. For the propellers to remain clear of the seabed the bow-up angle could not have been greater than 7 degrees.

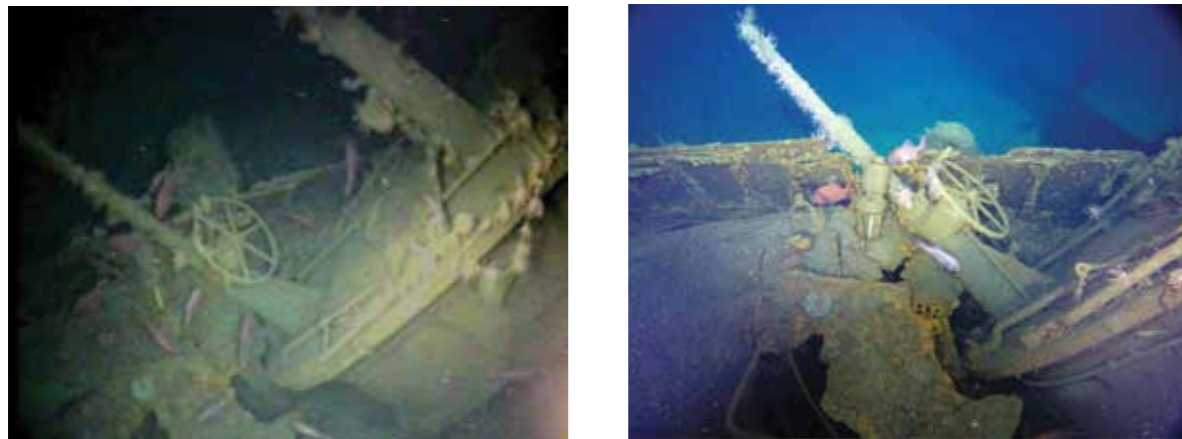
The combination of the submarine striking the seabed aft then falling onto its keel conspired with the momentum of the fin itself to cause it to begin its topple into the imploded control room.

By how much it moved at that stage cannot be estimated but the movement has certainly continued, presumably as a consequence of the pressure hull softening with the subsequent corrosion. Indeed, it is quite possible that the fin did not begin to topple until some time (possibly decades) after the sinking and did so only after its supporting flange and pressure hull had lost strength due to corrosion.

Figure 37 – Comparison of fin angle from *Fugro* image (L) to *Petrel* image (R).
Images courtesy of Paul G Allen, Find AE1, Australian National Maritime Museum and Curtin University. © Navigea Ltd

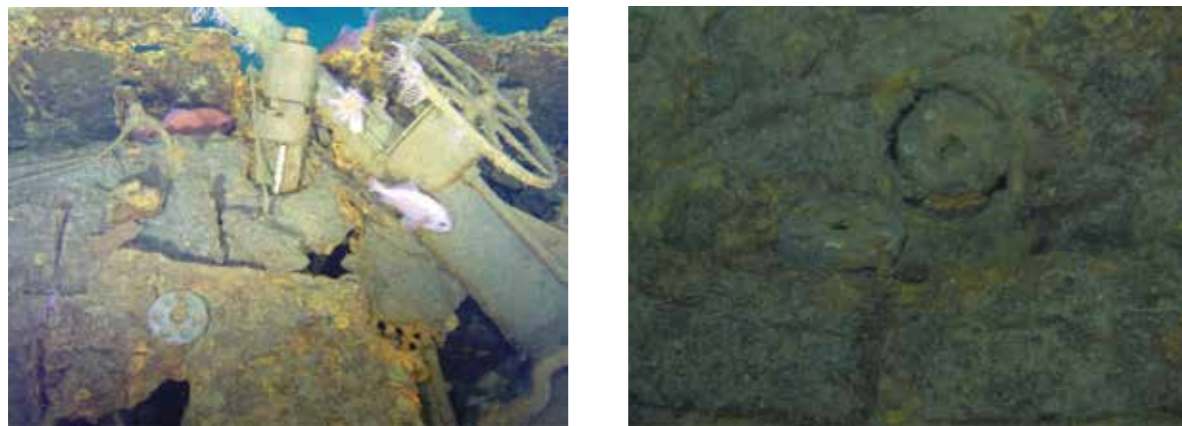
- MD1, located at Frame 65 – lying on the pressure hull by the WT stump
- MD2, located at Frame 56 – lying on the port pressure hull/saddle tank join adjacent to a flanged hull opening.

Figure 38 – Mystery discs 1 and 2.
Images courtesy of Paul G Allen, Find AE1, Australian National Maritime Museum and Curtin University. © Navigea Ltd

MD1 is in a position where it could be associated with No. 1 main vent outlet, but no pipe outlet can be seen behind the disc, suggesting that the disc fell from its original position before that pressure hull damage occurred. This might imply that the ongoing fin movement has contributed to the separation of the disc from its original position.

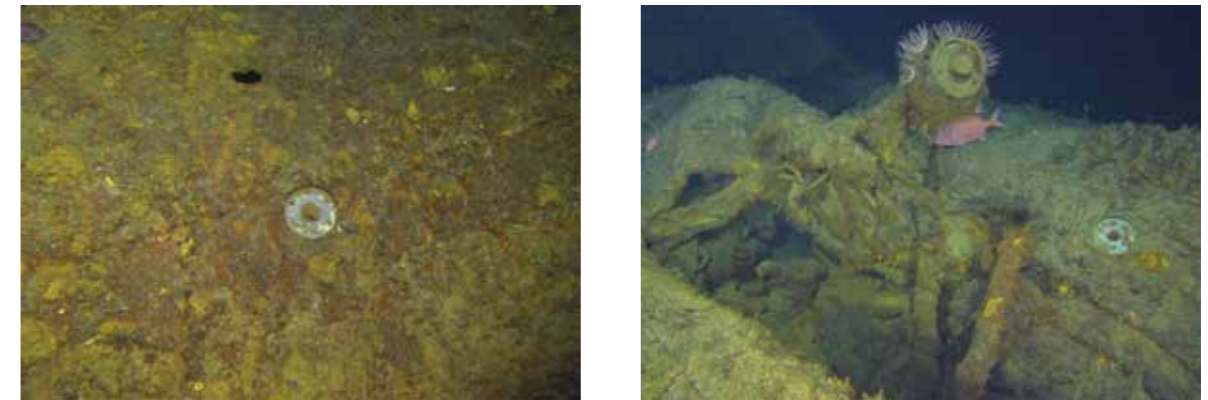
- MD3, located at Frame 54 – lying on starboard saddle tank abeam vent trunk
- MD4, located at Frame 75 – lying on starboard pressure hull by the windlass.

Figure 39 – Mystery discs 3 and 4.
Images courtesy of Paul G Allen, Find AE1, Australian National Maritime Museum and Curtin University. © Navigea Ltd

Pursuing the same line, from its location MD3 appears to be the outlet for No. 3 main vent, although it has apparently fallen from its original position to place it lower on the ballast tank. The original position of the outlet should be higher on the hull and is possibly where there is a hole in the pressure hull some 50 centimetres above where it now lies.

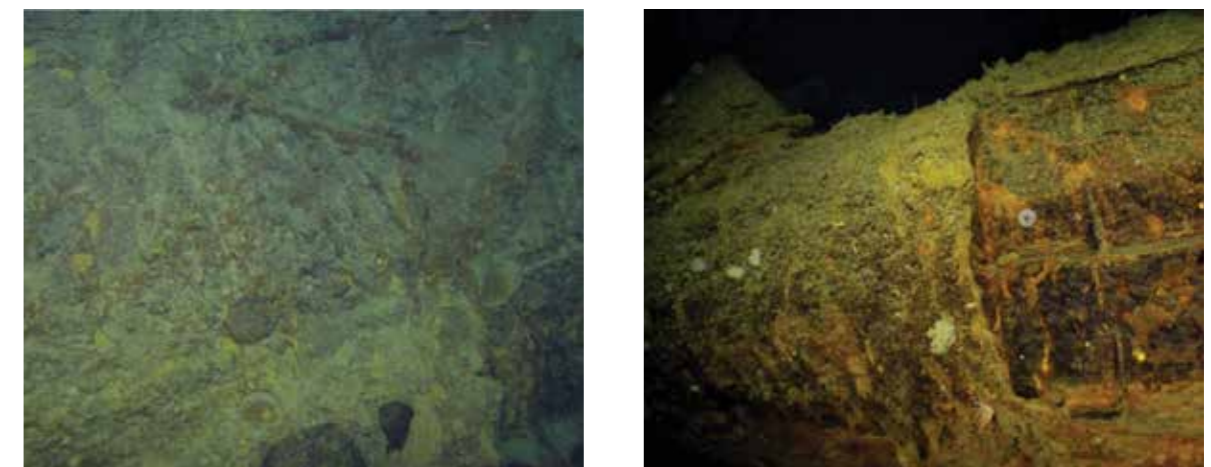
- MD5, located at Frame 25 – lying on the starboard ballast tank; appears to have moved from its original position
- MD6, located at Frame 79 – a spiral wound gasket (only the asbestos spiral remains) lying on the pressure hull inside 2 main ballast tank and has therefore been deposited there after the ballast tank has disintegrated.

Figure 40 – Mystery discs 5 and 6.
Image courtesy of Paul G Allen, Find AE1, Australian National Maritime Museum and Curtin University. © Navigea Ltd

MD5 is located over the starboard side of the after ends and could be associated with the bilge and ballast line. It too appears to have moved from its original position.

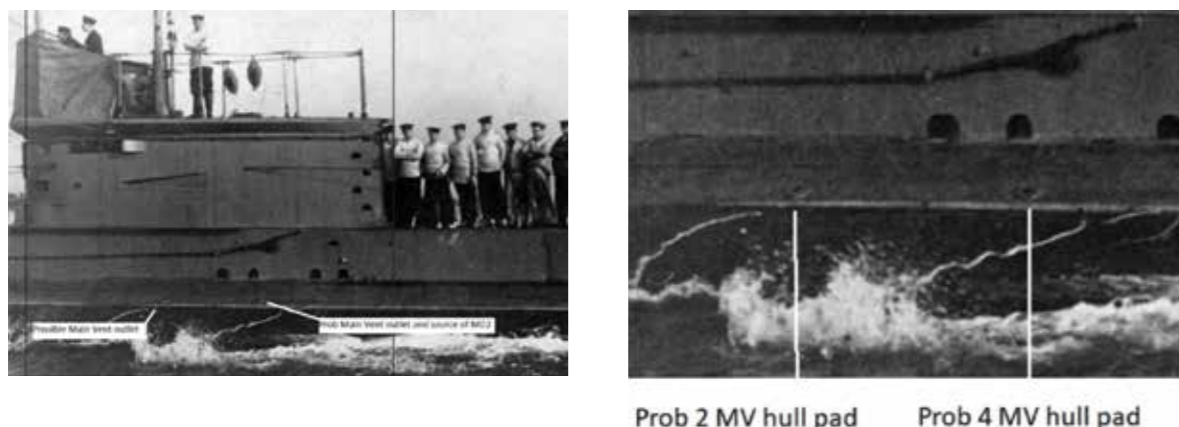
A possible solution to this puzzle emerged from the image of *AE1* showing two hull pads mounted on the pressure hull in the vicinity of the fin in a position where we could expect to see the main vent outlets. Based on its location we can propose that MD2 is the outlet for No. 4 main vent. The gasket appears to have fallen from the flanged outlet, probably as a consequence of the securing bolts having corroded. The general arrangement drawings show that No. 3 and No. 4 main vent outlets discharge to short pipe sections under the casing, the former being adjacent to the ship's ventilation valve. If this were the case it would be visible in Figures 24 and 25, whereas it cannot be found in any of the images of that area. This supports the possibility that the design had changed and that the main vents were routed direct to outlet hull pads in the pressure hull clear of the casing.

Figure 41 – External view showing No. 2 and No. 4 main vent hull pads

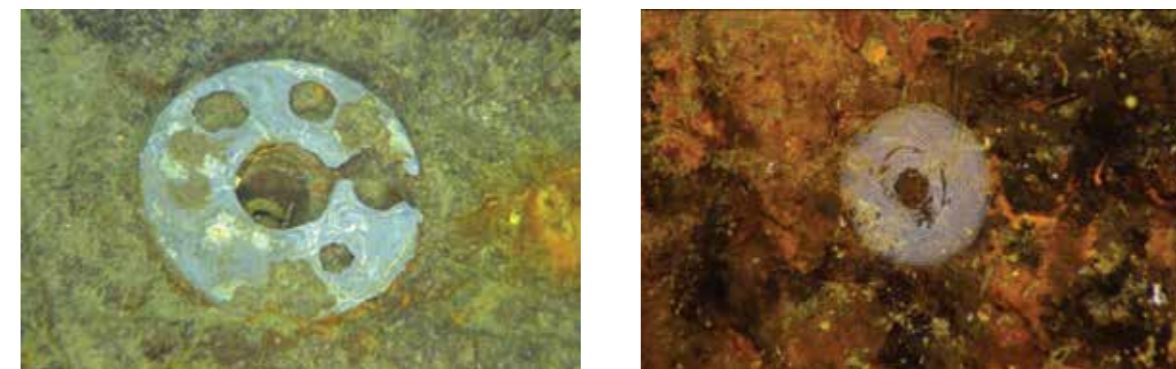
MD4 is located further forward and immediately over the starboard bilge pump, suggesting that it is the bilge pump high-level discharge outlet (Figure 42).

MD6 differs from the others in that while of similar dimensions it appears to be the asbestos winding of a spiral-wound gasket (Figure 42). The supporting metal (usually copper-based) appears to have gone, which is itself curious in that any copper should have been preserved in favour of the contacting iron. This suggests that the event occurred some time after the sinking in order to establish an insulating layer of concretion. A further curiosity of MD6 is that there are no bolt holes, implying that this was a 'green' gasket which had not yet been drilled or that it was not from a flanged joint but from (for example) an air bottle cap seat.

Figure 42 Mystery discs 4 (L) and 6 (R) (close-up). Note the recess behind MD4, suggesting that it is a pipe outlet. Images courtesy of Paul G Allen, Find AE1, Australian National Maritime Museum and Curtin University. © Navigea Ltd

One possible explanation is that some parts of a high-pressure air system remained pressurised at the time of the bottom impact. That part then failed, either due to rupture during the event itself or due to subsequent corrosion. As the system failed, the gasket was freed while at the same time the escaping high pressure air blew it out of the wreck from where it fell to its current position. A possible candidate for such an event for MD6 is the forward torpedo firing air system bottles located nearby.

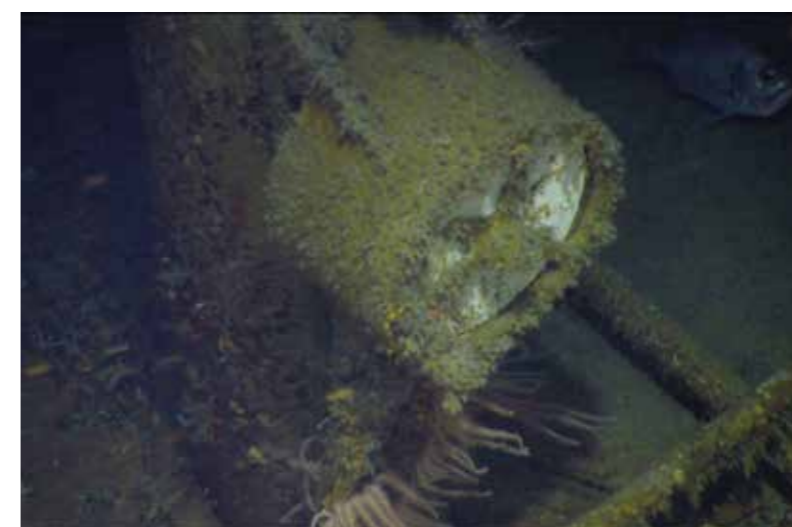
The bridge telegraph in *AE1* (Figure 43) appears to have a broad arrow aligned at about 10 o'clock. There may also be a second broad arrow aligned at 12 o'clock. There are three external strengthening webs at 12, 4 and 8 o'clock.

Figure 43 – Engine room telegraph – bridge transmitter. Image courtesy of Paul G Allen, Find AE1, Australian National Maritime Museum and Curtin University. © Navigea Ltd

The lettering on this telegraph cannot be read but from the conning tower telegraph of HMAS AE2 and the build photographs of a later (unidentified) E-Class, we can conclude that AE1's bridge telegraph is acknowledging an order for half-astern.

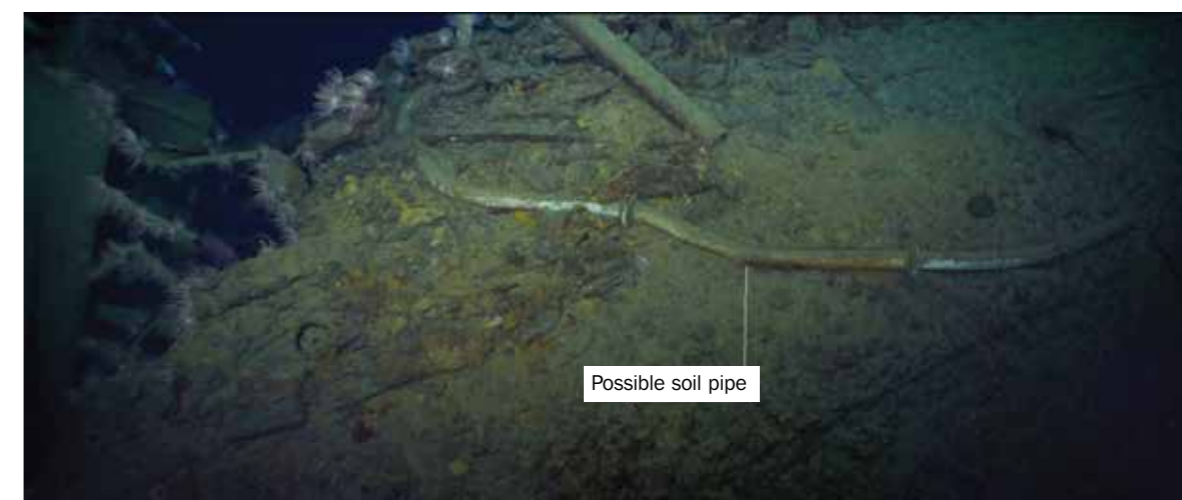
- Flanged entry (white), with remains of a metal gasket (also white) – possibly signs of another pipe having been inserted
- Three 2-metre lengths of ~4-inch pipe joined by two flanged joints from which the bolts are missing. Upper section may be a little longer
- No flange on the lower end (open discharge)
- White where the surface is exposed. Some sediment on upper surface
- Appears to have shaped curves in first pipe section (that is, not a straight run).

Figure 45 – Possible soil pipe located by ventilation trunking.
Image courtesy of Paul G Allen, Find AE1, Australian National Maritime Museum and Curtin University. © Navigea Ltd

The colour and state of preservation of the pipe suggest that it is made of lead, which was typically used in soil pipework.

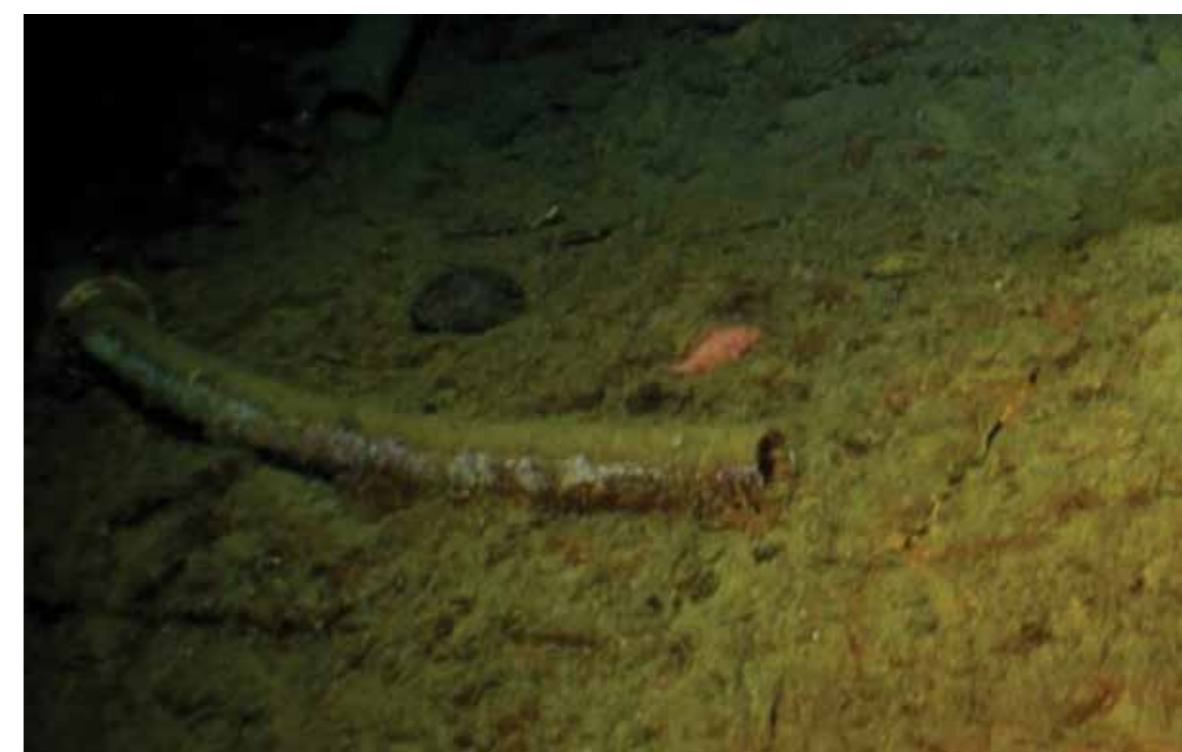
The location of the upper-end flange is close to the ventilation system hull valves and directly under the fin WC. Close to it are the blue and white pottery shards which are assumed to be the remains of the fin WC. One possible explanation for the pipe is that the fin WC (shown on the general arrangement drawing as being a simple bucket and seat) had in fact been replaced with a ceramic pan and lead soil pipe. The pipe had been led below the casing such that it would drain directly into the sea.

Figure 46 – Possible soil pipe flanged upper opening (L – the other flange is a battery ventilation inlet) and (R) open-ended outlet.
Image courtesy of Paul G Allen, Find AE1, Australian National Maritime Museum and Curtin University. © Navigea Ltd

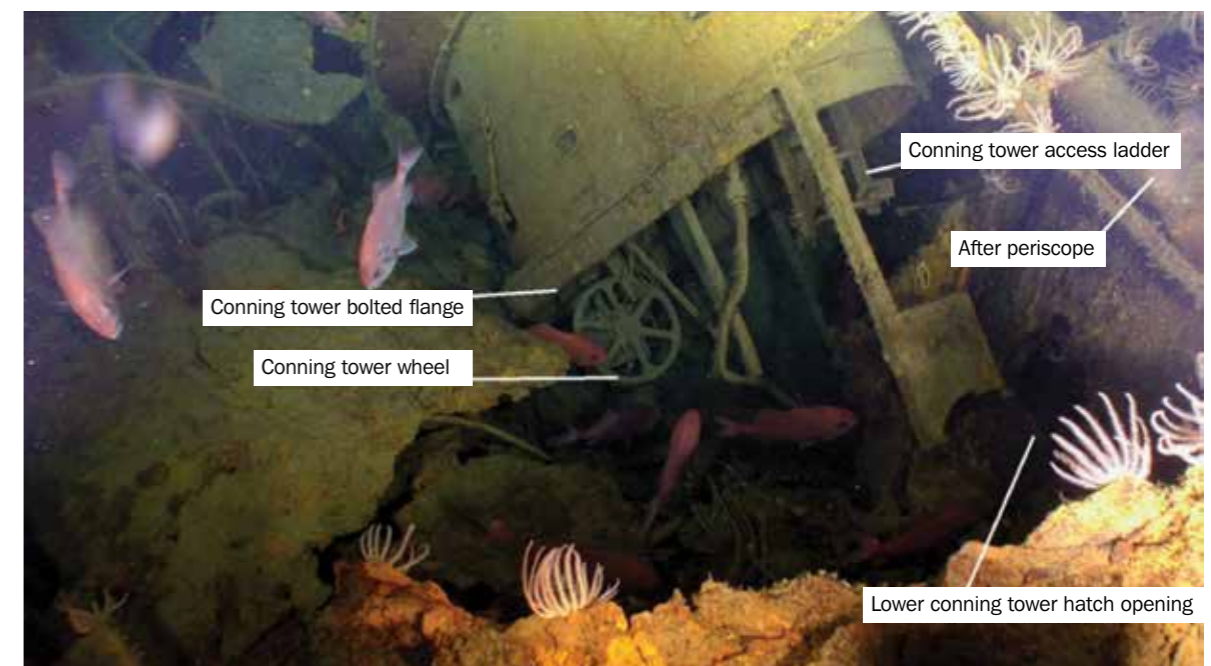
Figure 50 – Underside of toppled fin. Image courtesy of Paul G Allen, Find AE1, Australian National Maritime Museum and Curtin University. © Navigea Ltd

In doing so, an opening was seen which is in the right location. However, there is no sign of the hatch, the hatch coaming or indeed of the conning tower lower section. These items were all manufactured of 20lb/in² steel, although the coaming may have been of a lighter structure. That they have all gone implies that there was a strong corrosion cell in the immediate vicinity of the conning tower upper section which resulted in these items dissolving completely. Regrettably, this means that the position of the lower conning tower hatch cannot be determined.

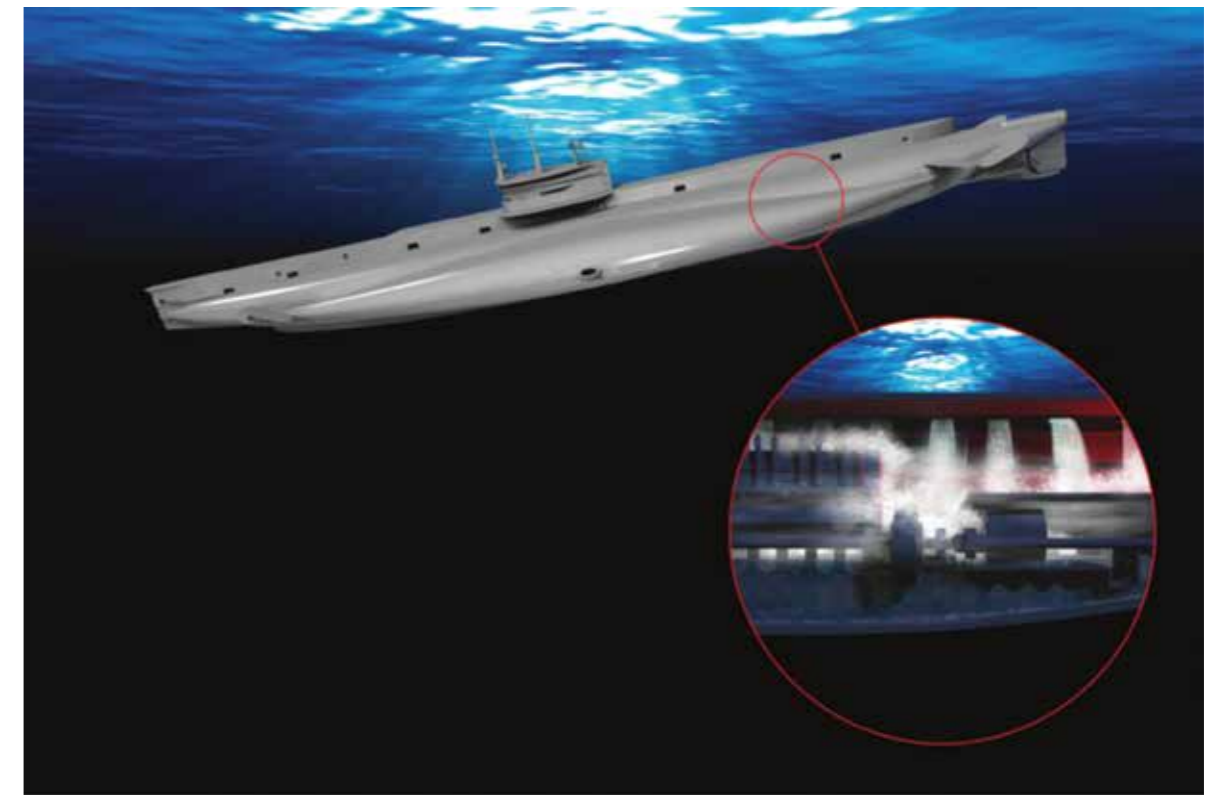
Figure 51 – *AE1* diving at or near periscope depth suffers a flood, resulting in loss of buoyancy and trim.
Image courtesy of Paul G Allen, Find *AE1*, Australian National Maritime Museum and Curtin University. © Navigea Ltd

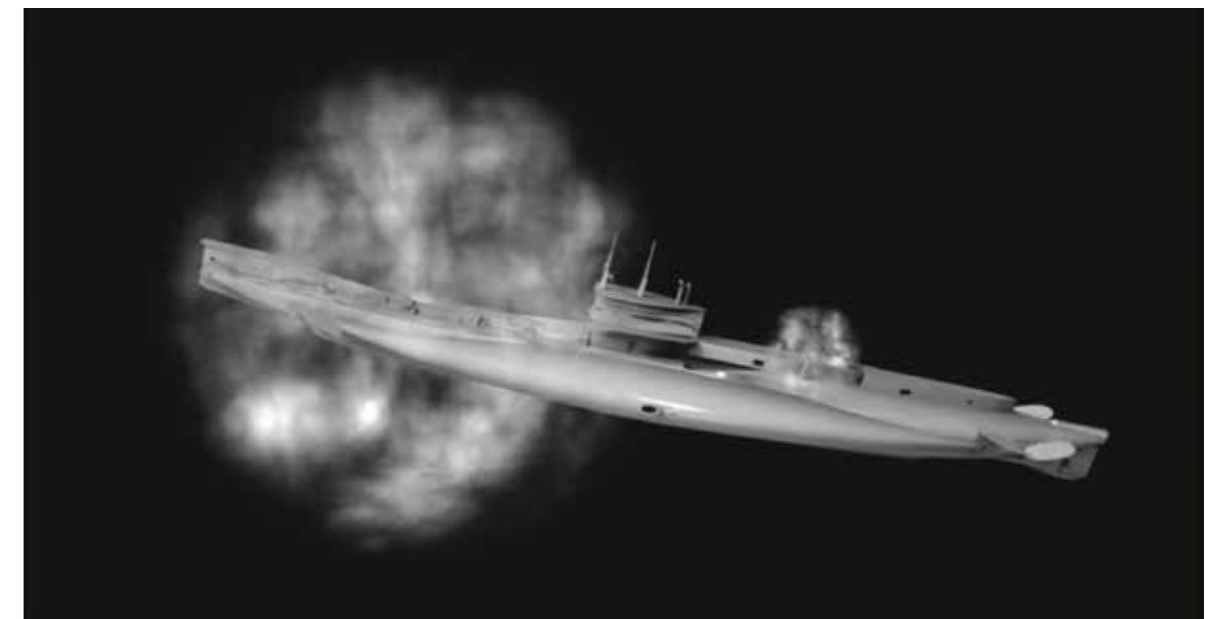
- The shock wave resulted in an explosive pressure which dislodged the engine room hatch.
- If the lower conning tower hatch were open (as expected at the time of diving) the shock wave would enter the tower and possibly initiate the conning tower flange rupture.

Figure 52 – Unable to recover, she carries on down until reaching crush depth when the control room and forward area implodes. The shock wave blows off the engine room hatch.
Image courtesy of Paul G Allen, Find *AE1*, Australian National Maritime Museum and Curtin University. © Navigea Ltd

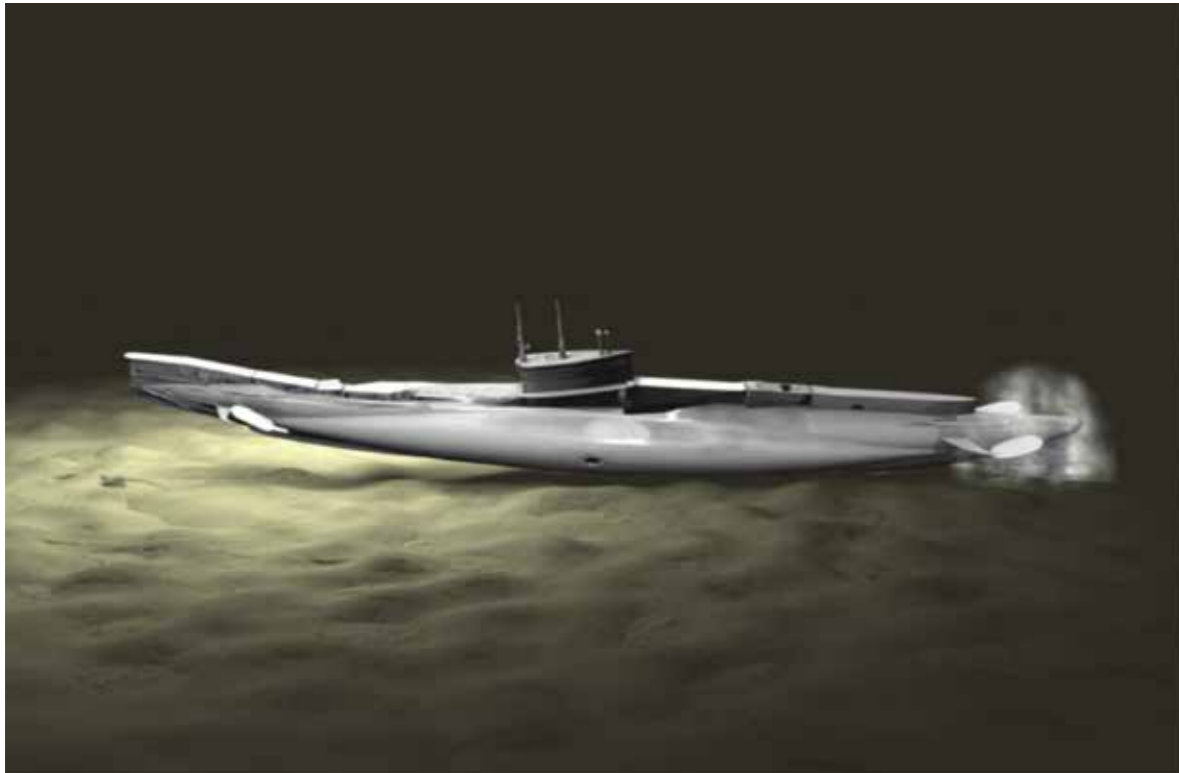
Figure 53 – AE1 continues down, gathering way until she strikes bottom at a bow-up angle of 3–7 degrees, impacting on the rudder and skeg.
Image courtesy of Paul G Allen, Find AE1, Australian National Maritime Museum and Curtin University. © Navigea Ltd

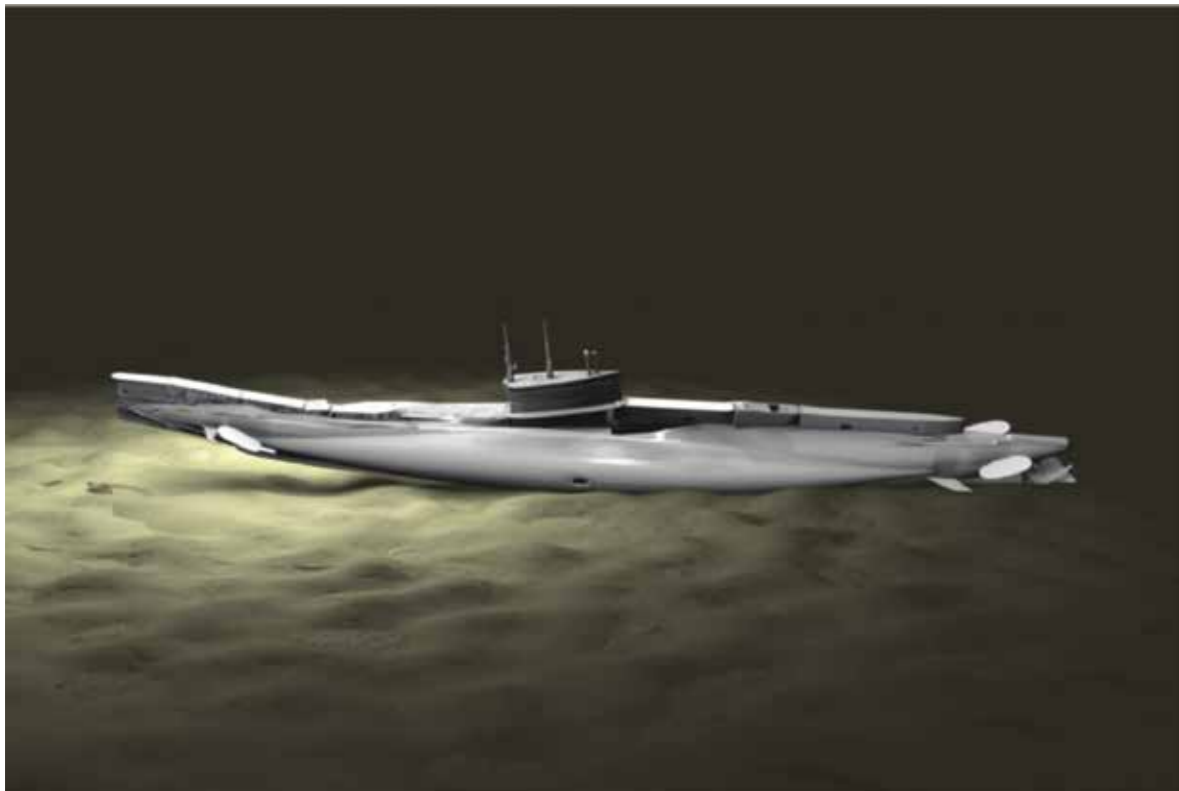
Figure 54 – The skeg and rudder collapse and a second impact occurs on the after end of the keel.
Image courtesy of Paul G Allen, Find AE1, Australian National Maritime Museum and Curtin University. © Navigea Ltd

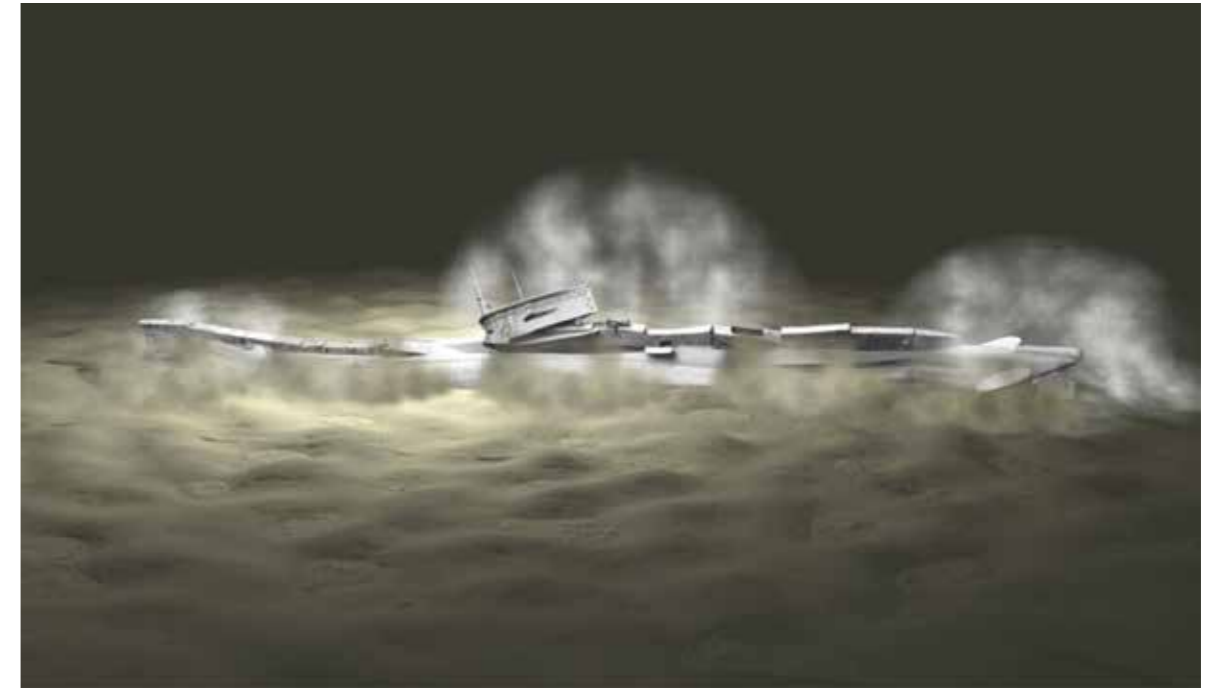
- Momentum caused the fin to begin a topple into the collapsed control room, resulting in:
 - the conning tower upper section hinging forward and shearing off at the join with the lower section.

- Momentum and cantilever effect caused the planeguards to shear off and carry straight down.
- The impact caused a section of the forward battery (from row 6 aft) to crush the (possibly also imploded) ballast tank underneath it (MBT internal X), allowing that section of the battery to settle by some 0.4 metres.

Figure 55 – The hull falls onto its keel, resulting in a third wave of damage, including dislodgement of the hydroplanes and initial dislodgement of the fin.
Image courtesy of Paul G Allen, Find AE1, Australian National Maritime Museum and Curtin University. © Navigea Ltd

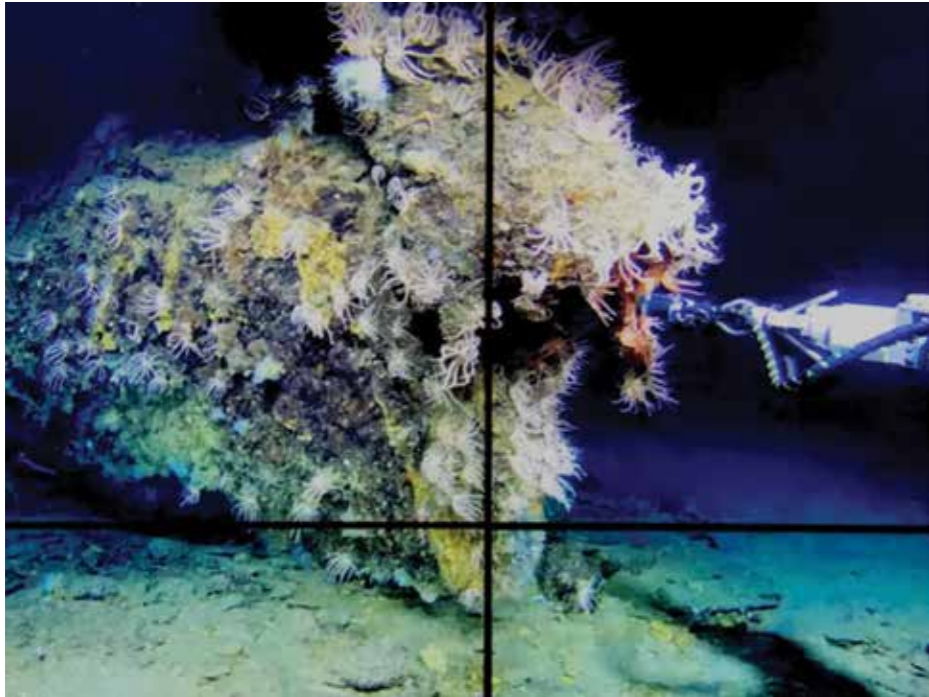
It was noted that the colonisation by anemones was much more intense on both the bow and stern caps than in all other locations on the shipwreck site. Similar localised colonisation processes were viewed on the HSK *Kormoran* (1943) wreck compared with the HMAS *Sydney II* and this is most likely due to the higher phosphorus impurities in the *Kormoran* mild steel which would have been using less than military specifications for the alloys used in its construction (MacLeod and McCarthy 2016). Under the cover of corrosion products from the oxidation of the metallic iron a suite of anaerobic bacteria converts inorganic iron phosphide (Fe_3P) inclusions present as the eutectic phase steadite. Because of their metabolic activity bacteria convert the inorganic metallographic phase into volatile phosphines which promote marine growth, since phosphorus is normally a limiting agent to growth of marine organisms, particularly in the darkness of deep ocean waters (MacLeod 1988).

Figure 3 – Image of the bow cap with prolific marine growth from dive 90. The black horizontal and vertical lines that appear in most of the images are because they were photographed off the high-resolution tiled display at the Curtin University HIVE visualisation facility.

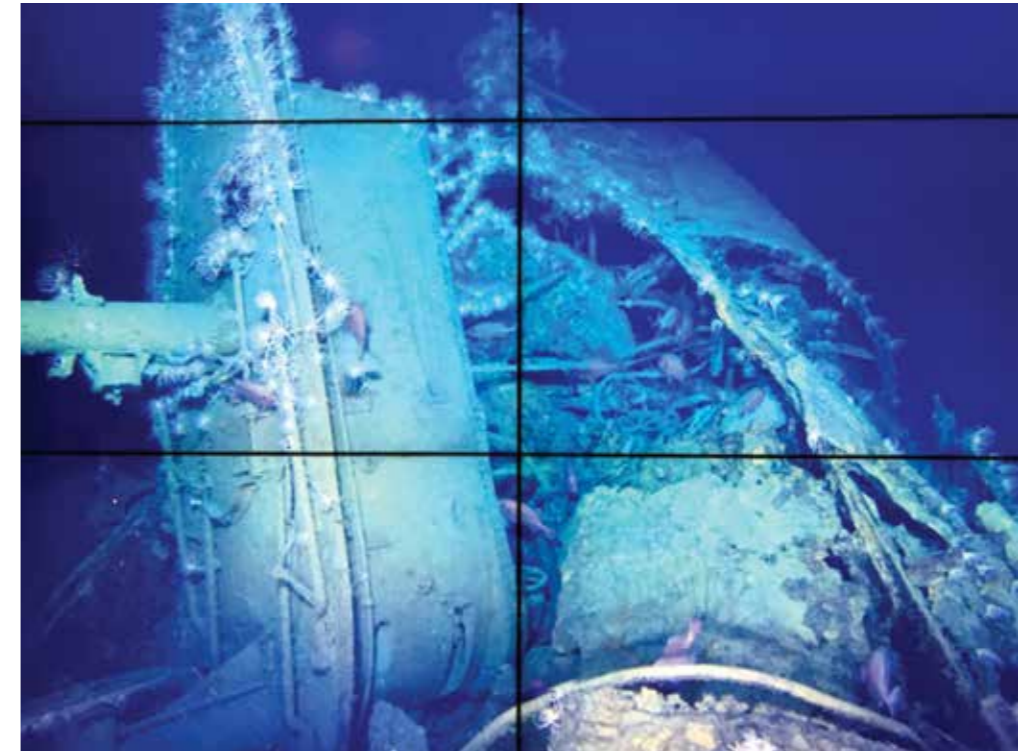
Figure 9 – Image 91-76913, showing fin free of marine concretions and a section of the pressure hull. Image courtesy of Paul G Allen, Find AE1 Ltd, Australian National Maritime Museum and Curtin University. © Navigea Ltd

The pressure hull at the maximum diameter of the submarine was made of 20-pound plate and an inspection of the corrosion data calculations in Table 2 indicates that even with galvanic coupling due to contact with the manganese bronze of the fin (60% Cu, 37% Zn, 2% Mn and 1% Sn) there is still about 5.6 mm of solid metal present in the pressure hull. The image 91-76913 (Figure 9) shows the well-defined remnant hull structure in the immediate vicinity of the fin. Although the residual metal represents a 45% loss of metal thickness since the submarine sank, there is still sufficient metal present to enable the form of the submarine to be maintained. These estimates of corrosion are based on 16-year experiments on various metal couples using a noble metal to iron ratio of ~1:7 (Zheng 2011). Naturally, corrosion issues will be exacerbated by the high current flowing through the site, but the data provide a guide to what can reasonably be expected to survive. Where galvanic corrosion is present the negative values for residual metal thickness shown in Table 2 simply mean that all the metal has corroded away, so in the worst-case scenario of galvanic corrosion any plate thickness less than 12.5 pounds per square inch is unlikely to be present. In addition, local effects (galvanic, microbial or both) could add to the rate of deterioration. Since there is no active concretions mechanism operating on the site, the once solid elements will be corroded away and removed by the current to feed the fishes.

It is noted that the extent of galvanic-induced corrosion will increase as the ratio of noble metal area compared with reactive metal increases. Owing to the very large surface area of the manganese bronze fin, the impact of this coupling on the parts of the submarine immediately adjacent to it will have been very significant. When this localised corrosion process is considered it should be remembered that there is also the added issue of microbial corrosion and differential aeration which further exacerbates the iron decay. Given that the specifications of AE1 and AE2 noted that the steel had to be able to withstand significant bending without brittle fracture, as would happen with cast iron, the collapse of the fin becomes more understandable. As the combined corrosion processes thin down the original 20-pound plate, the ability of the steel to support the deadweight of the fin and the dynamic load presented by the resistance of the fin to the prevailing current will diminish until it begins to fail under the tensile load. The fin will gradually topple forward, which only increases the stress and the concomitant corrosion rate on the remaining structure. This continued loss of support metal explains why the declination angle of the fin has increased in the time between the two surveys. It is possible that engineering modelling may be able to calculate when the fin first began to fall and so provide more of an idea of the overall degradation rate on this wreck site.

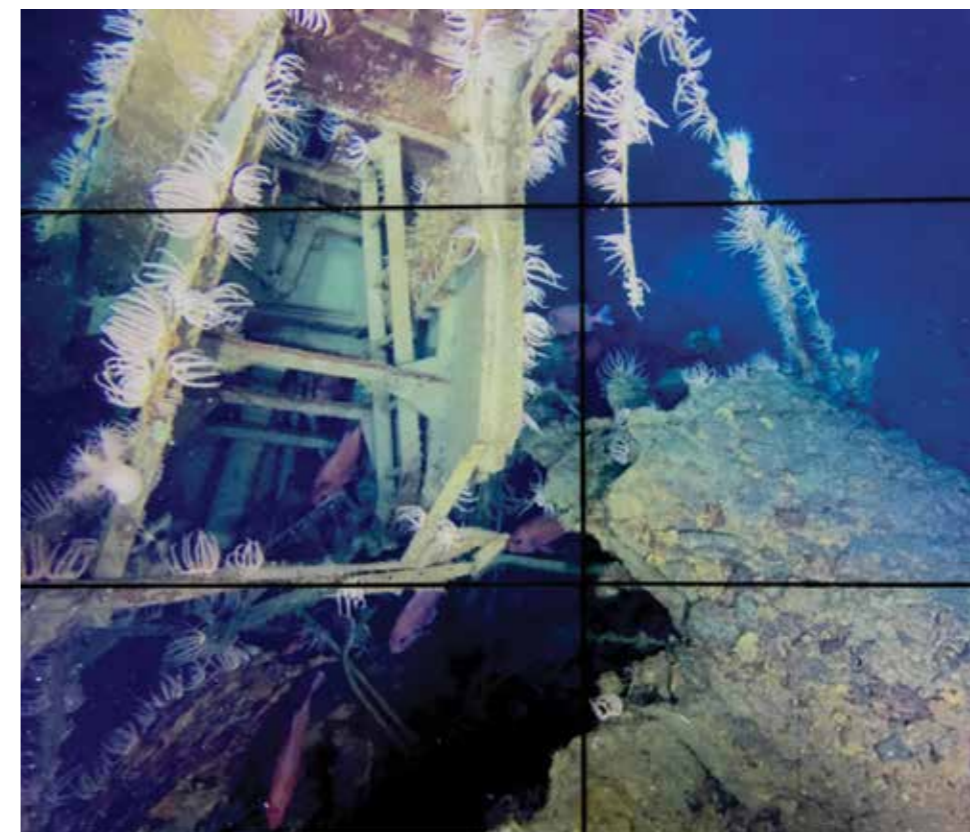
On inspection of the image 91-77813 shown in Figure 10 it was noted that there is essentially no living organism on the flat smooth surfaces of the fin, which appears to be sitting in an almost pristine condition on the wreck site. However, at the leading edges of the structure and on piping leading from the fin there is localised colonisation of the surface with the endemic marine organisms. Given that marine bacteria regularly utilise cycling of manganese ions in their metabolic processes it is likely that the marine organisms are utilising surface corrosion products to enhance their microenvironment. Thus, the enhanced growth on the edges of the fin and its fittings is likely to be due to marine organisms capitalising on the energy source associated with manganese, rather than with phosphorus as is likely on the bow and stern caps. Just as the localised increase in marine activity on the stern and bow caps was viewed as being a response to the release of phosphorus-containing species, resulting from anaerobic metabolic activity (Iversen and Olson 1983), so too the voltage gradient at the sharp edges is sufficient to bring about a subtle change in the corrosion microenvironment. Although the voltage of the fin will be the same throughout the structure, the voltage gradient in terms of the charge distribution is always higher at sharp edges. These differences are clearly enough to provide a niche environment for the colonising organisms. Within the biofilm on the fin's surface there will be a niche microenvironment for the anaerobic bacteria to mobilise the phosphorus in the copper alloy.

Figure 10 – Image 91-77813, showing ladder inside fin and marine organisms on leading edges of the structure. Image courtesy of Paul G Allen, Find AE1 Ltd, Australian National Maritime Museum and Curtin University. © Navigee Ltd

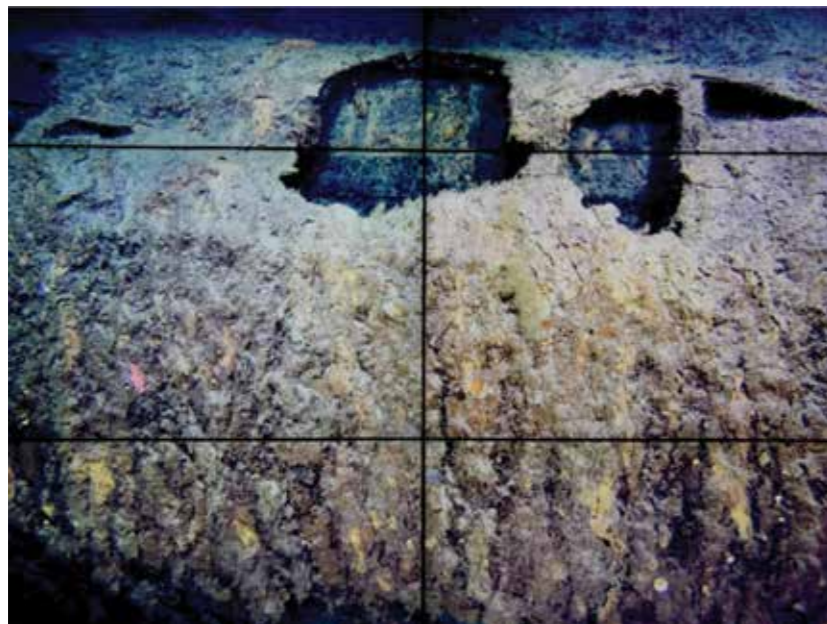
The image no 91-79170 (Figure 12) provides confirmation of the material loss of iron from the submarine in the region of the ballast tanks, which were 8.5 pound per square foot, and according to the data in Table 2, there is between -0.16 and -0.7 mm of residual metal thickness left; that is, there are large holes in the structure, which is clear. The interior image thus exposed is of the pressure hull, which is intact with a calculated residual thickness of between 5 and 5.5 mm, depending on either combination of both sides corrosion or galvanic coupling. It is important to conduct periodic monitoring, on a 5 to 10 year time frame, to monitor the decay of the residual metal structure. At present there are only two points, which are close together and only a few months apart after more than 100 years of decay in the warm, deep, tropical waters off Mioko Island. Without the data from future monitoring it will be difficult to confirm the overall conservation heritage management plan for this historic site, which forms a pivotal point of Australia's maritime heritage.

Figure 12 – Image 91-79170, showing ballast tank holes overlaying the pressure hull.

The image shown in Figure 12 illustrates the general distribution of iron corrosion products on the hull, with weeping runs of soluble iron precipitating in the oxidising microenvironment of the wreck site.

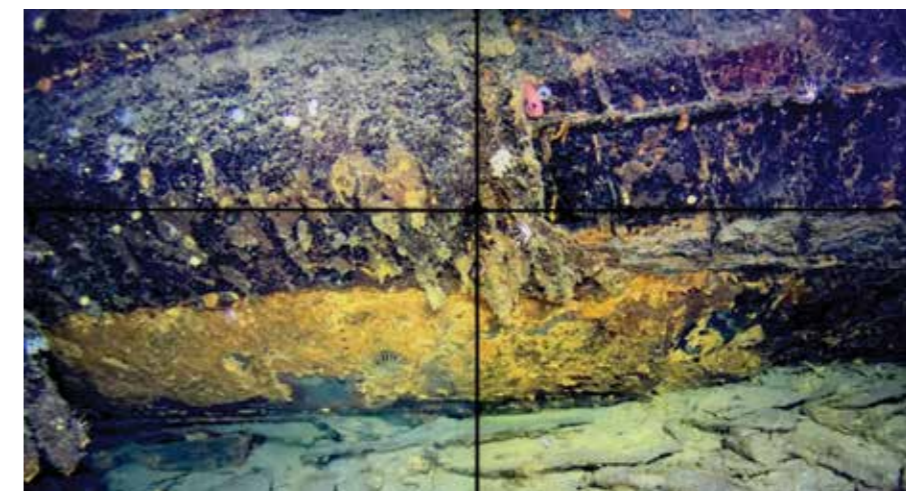
Figure 14 – Image 91-78424, showing significant active corrosion of lower hull plate among debris.
Image courtesy of Paul G Allen, Find AE1 Ltd, Australian National Maritime Museum and Curtin University. © Navigea Ltd

This penultimate figure (Figure 14) shows the pressure hull of the submarine in an active state of decay, with all the plate on the right-hand side having gone, leaving the heavier-gauge frames. This view is consistent with an area where the external ballast tank has sheared off from the pressure hull – probably the consequence of the bottom impact. The tank would have been flooded and hence very heavy – the momentum of the bottom impact would have caused it to shear: hence the debris on the seabed immediately below. The lower half of the image, around the grilled opening which is probably the starboard bilge and ballast line outlet, is undergoing sheet corrosion. What used to be submarine structure lies on the seabed in a scattered and heavily fragmented pattern. This debris field is likely to have arisen from the force of the bottom impact when the submarine hit the seabed and the relatively high corrosion rate, brought about by the combination of a moderate level of dissolved oxygen and a strong current. It is noted that a whole line of rivets on the left of the bilge and ballast line outlet has disappeared and this indicates that the lower plate has recently come away from its frame support and the minimal protection it had with the soft-bodied marine colonisation has been lost. The upper sections of the image also have active rusticle formation. There is an overall impression of an actively degrading submarine lying on the seabed.
