Research Vessel *Petrel* Baseline Survey of HMAS *AE1*

April 2018

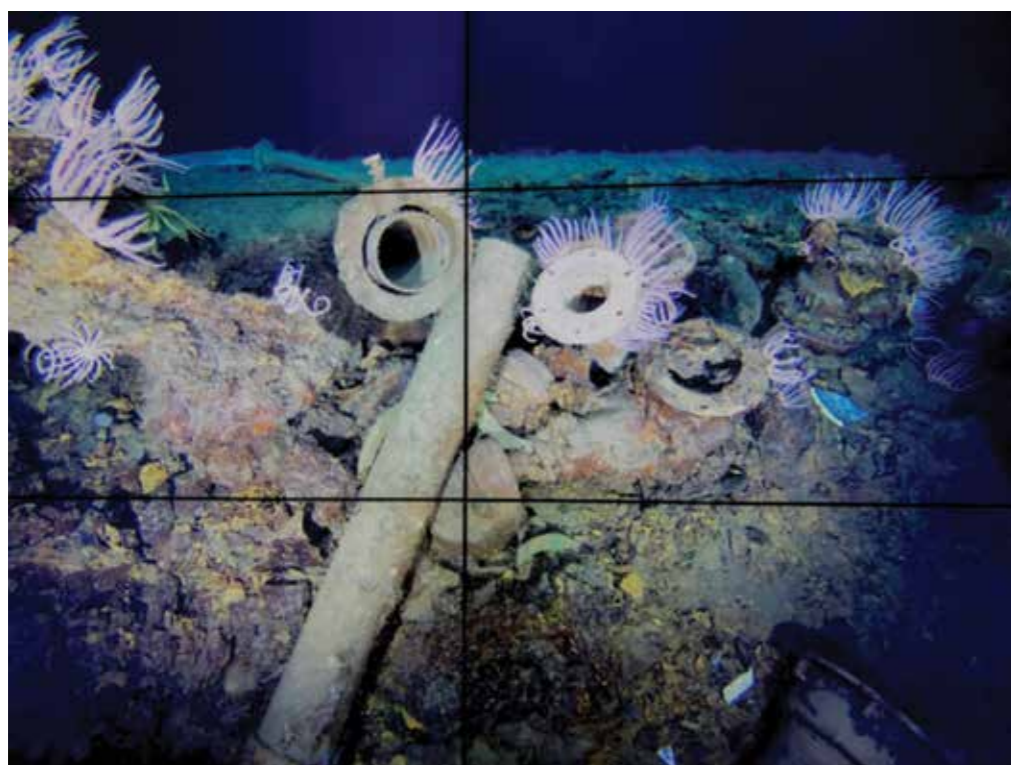
The image in Figure 15 shows three of the five ventilation trunks which once rose from their associated hull valves to their vented openings inside the after section of the fin. The bright white flanged opening has been the subject of considerable debate as to its function and purpose and where any waste material may have exited the submarine. However, some advice on the corrosion products formed on the non-ferrous metal alloys may be of assistance in managing the wreck site. It is highly likely that the piping is a lead alloy as material of this type has been used since the 1870s for removal of waste from steamships through direct porting to the external seawater. Owing to the ease of formability of lead, it was found that in a constrained physical environment the addition of antimony brought about a significant improvement in mechanical strength. The need to overcome the tendency of pure lead to creep and not to maintain its structural form is why the 12-tonne keel for the *Australia II* yacht was cast from a lead–antimony alloy (MacLeod and Kelly 2001). Assuming the colour in the image 91-76750 is reasonably accurate, the off-white patina of the pipe seen top left of the image is likely to be lead sulphate (anglesite) with some mixed lead–antimony oxides, which have a pale brown hue and have been found on ‘lead sculptures’ where there has been oxidation of the as-cast eutectic alloy composition (MacLeod 1991).

Figure 15 – Image 91-76750, showing debris field of ventilation trunking and flange plates probably associated with waste removal. Image courtesy of Paul G Allen, Find AE1 Ltd, Australian National Maritime Museum and Curtin University. © Navigea Ltd

It is very likely that there is a range of lead and lead–antimony alloys used in the construction of the waste removal system, which is why there is a variety of colours in the patina of the objects. When a lead alloy was being used as a flange seal for a pressure line it is likely that a lead–antimony alloy would have been used, as this will be less likely to lose its mechanical strength under tension and compression. Owing to the ease of fabrication of this system of alloys and the way in which the addition of small amounts (1–3%) of copper produces products that have a very fine surface finish, there is nothing in this image that is inconsistent with the piping and gaskets being made of various alloys in which lead was the principal component. A point of confusion as to why some gaskets appear to be made of copper may be cleared up if they were in fact made of something akin to Britannia metal, a tin–lead–antimony–copper alloy. Selective corrosion of copper can occur when the lead-rich phases have become passivated with adherent corrosion products. Some of the differences in patination are also likely to be due to galvanic coupling between iron of the submarine and the lead alloys. Although the voltage difference in flowing seawater between lead and iron is significantly less than the coupling between copper-based alloys and iron, if there had been galvanic coupling of the lead alloys it is unlikely that the impact would survive to the present times, for lead passivates quickly in seawater (MacLeod and Wozniak 1996). Lead and its corrosion products have good erosion resistance in currents up to a few knots, which is why it was used as an outer sheathing layer of copper-sheathed sailing vessels at the gripe, where the high water flow would too quickly erode the copper sheet (MacLeod and Wozniak 1997).

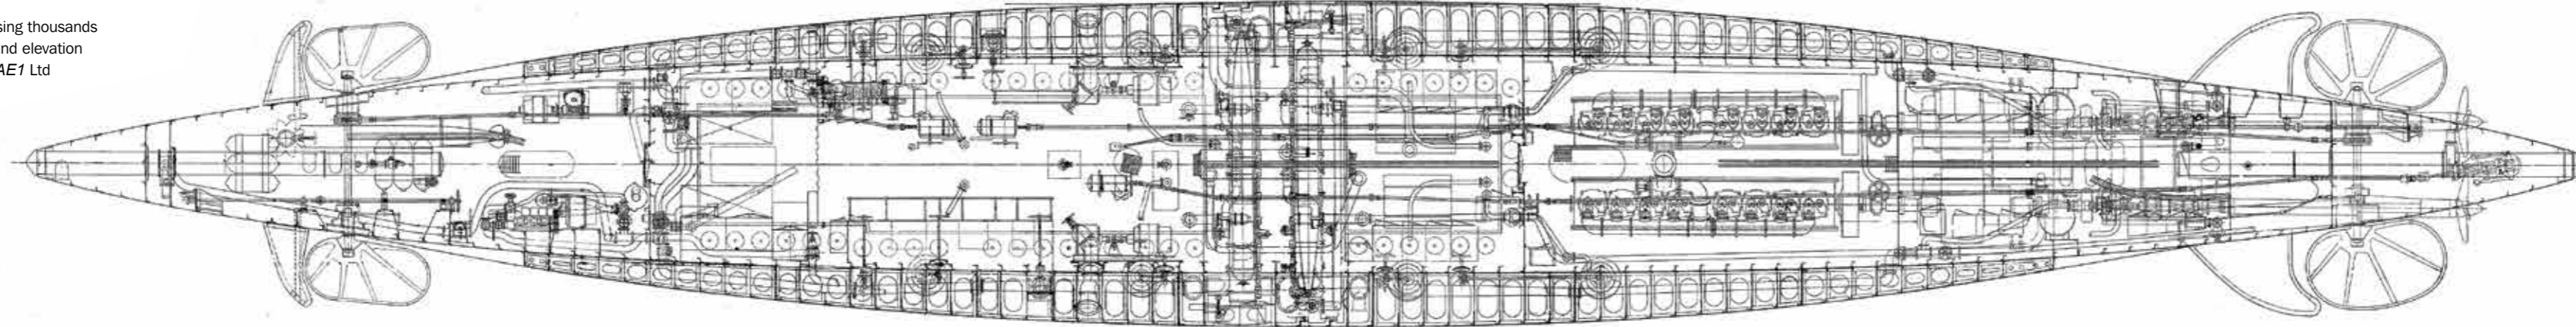
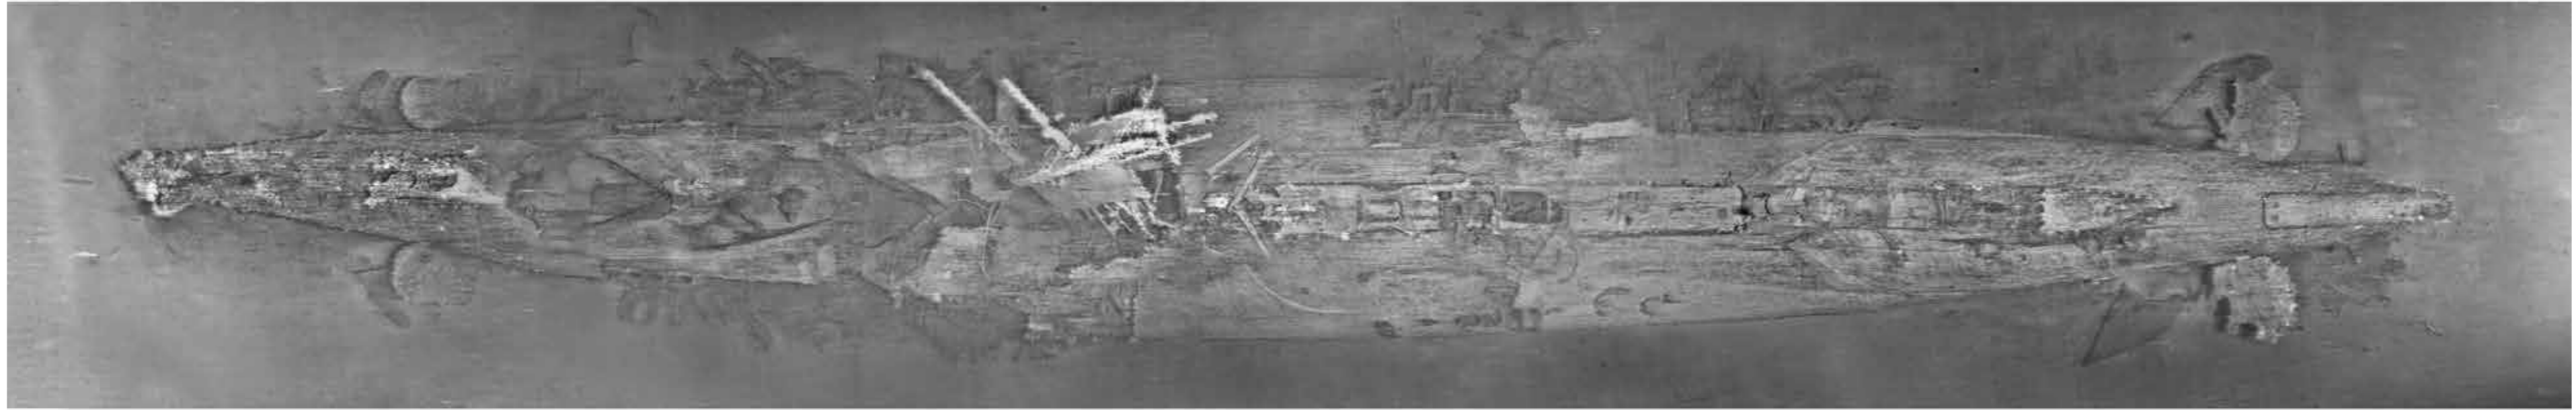
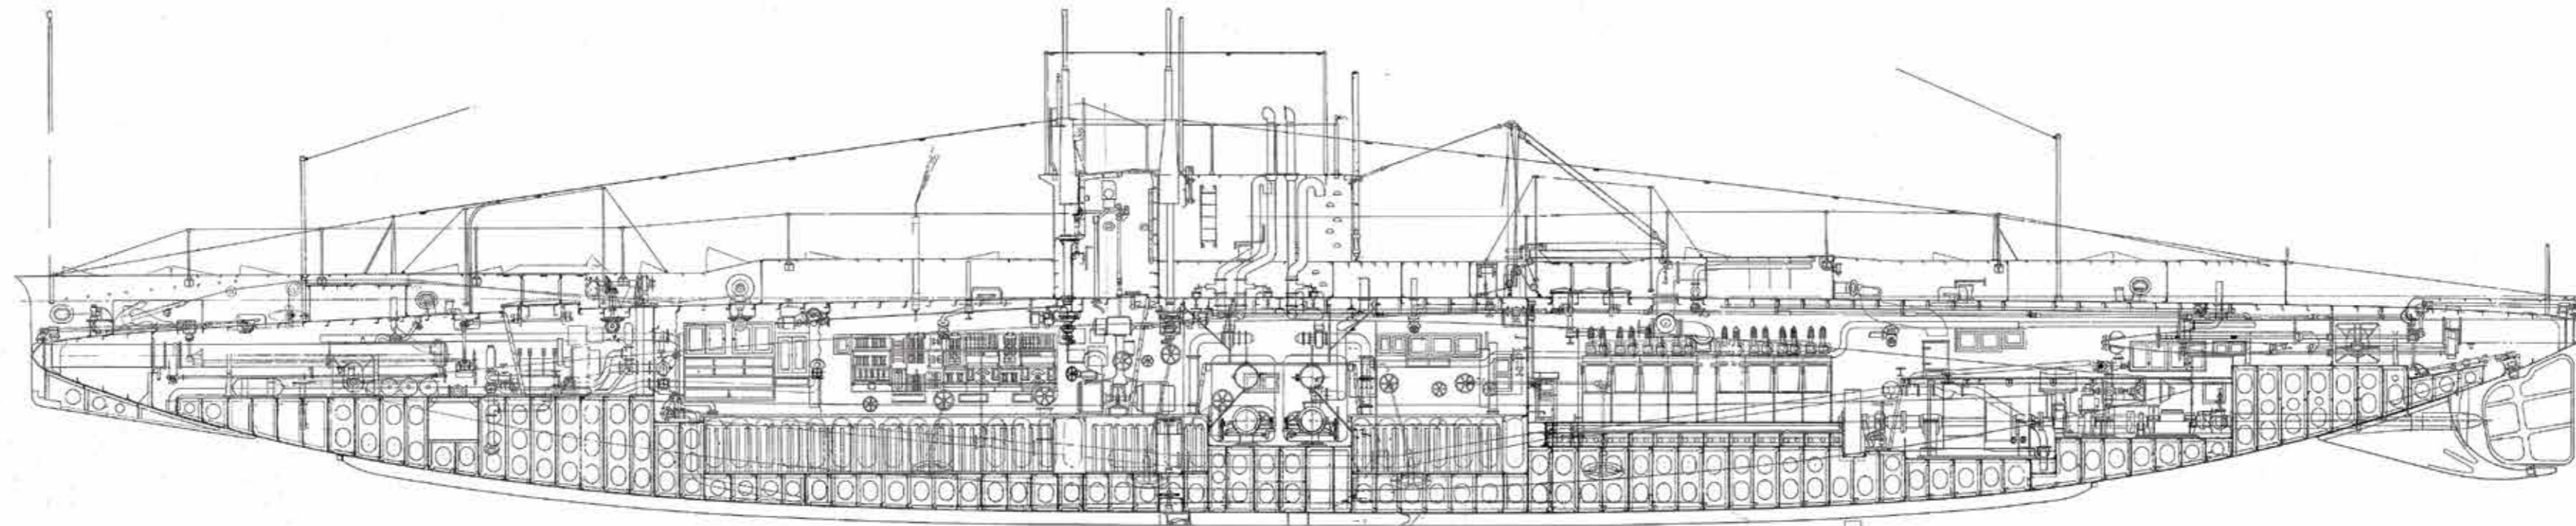
A composite image of the wreck of *AE1*, comprising thousands of individual photographs, juxtaposed with plan and elevation drawings of the vessel. Images Find the Men of *AE1* Ltd
