# Locating HM Bark *Endeavour*

Archaeological identification  
of shipwreck site RI 2394 in  
Newport Harbor, Rhode Island, USA

Kieran Hosty  
James Hunter

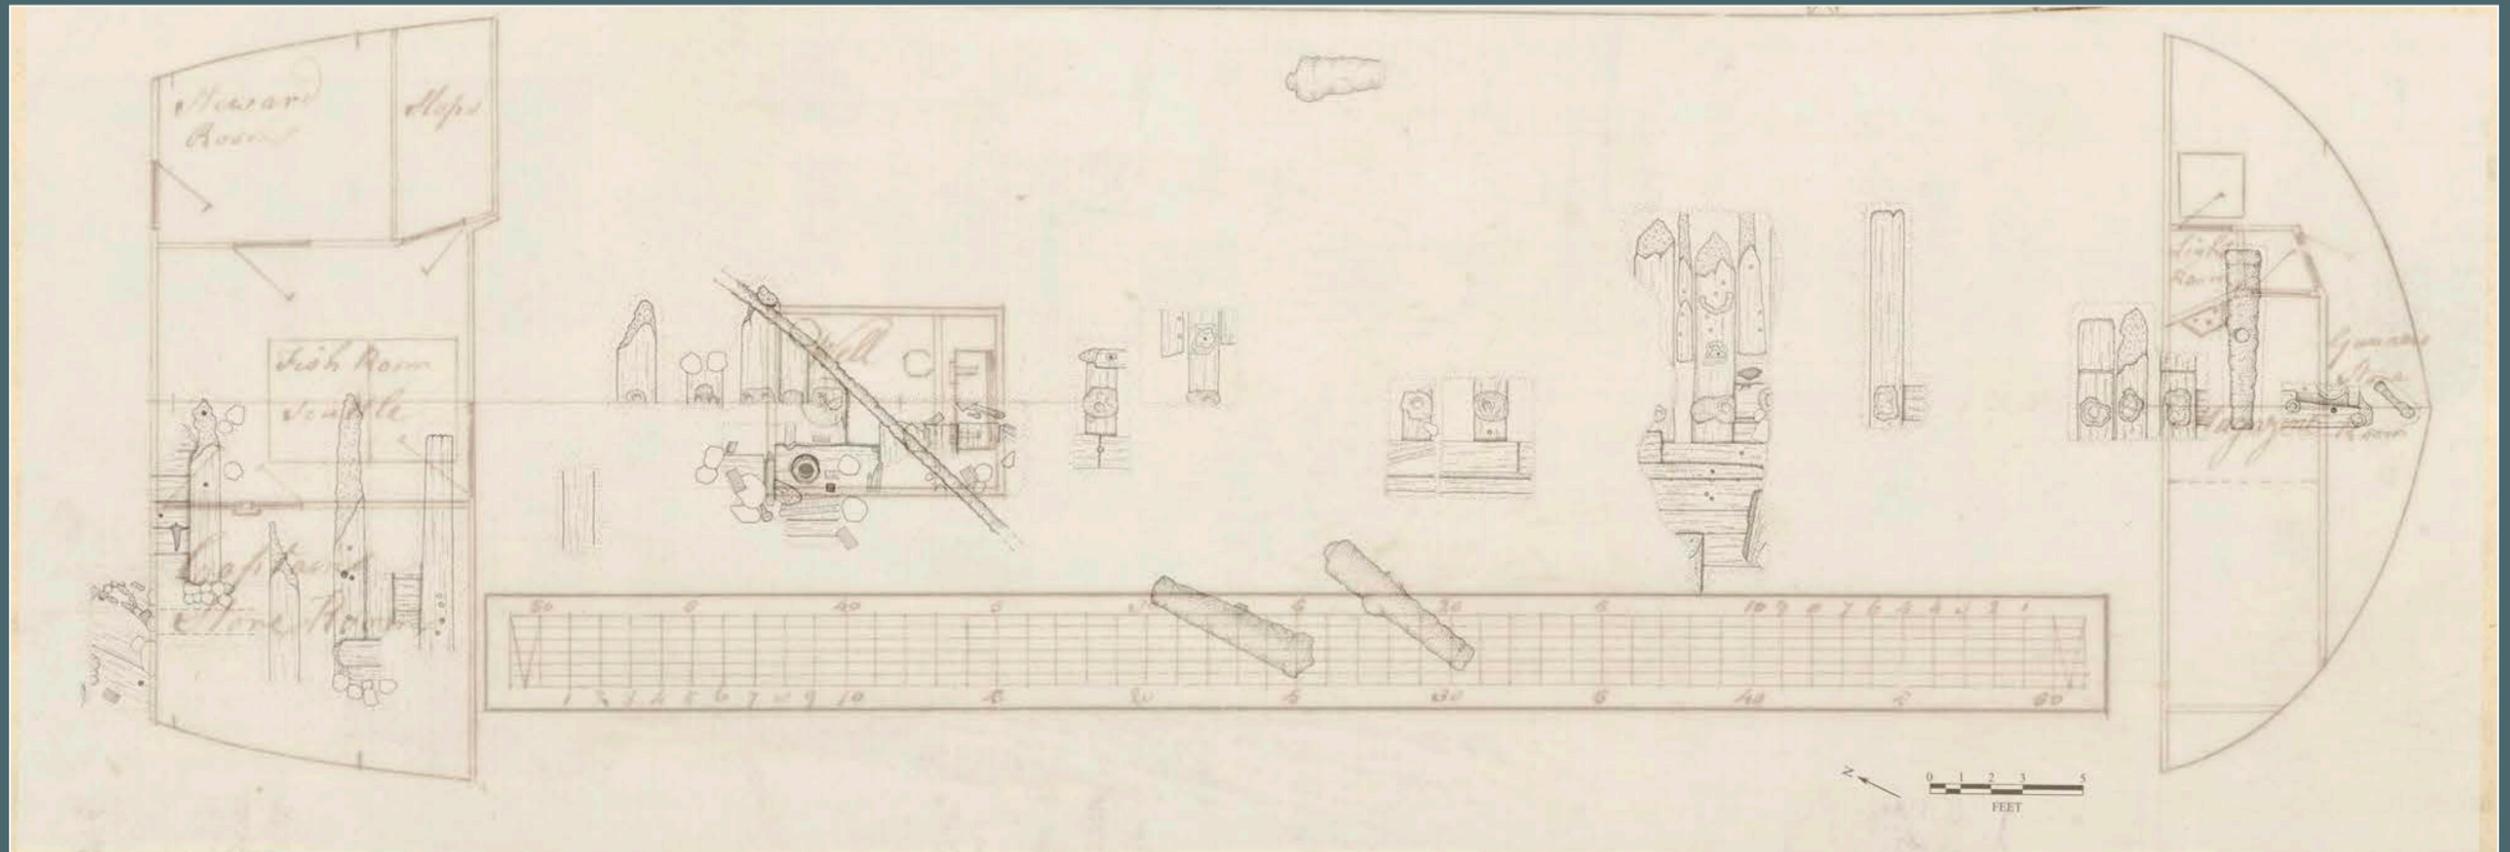
2019–21 archaeological site plan overlaid with *Endeavour's* 1768 survey draught, showing relative positions of shipwreck hull features such as the pump well compared with those on the archival plan. Images: Royal Museums Greenwich (1768 draught); James Hunter/ANMM (site plan).

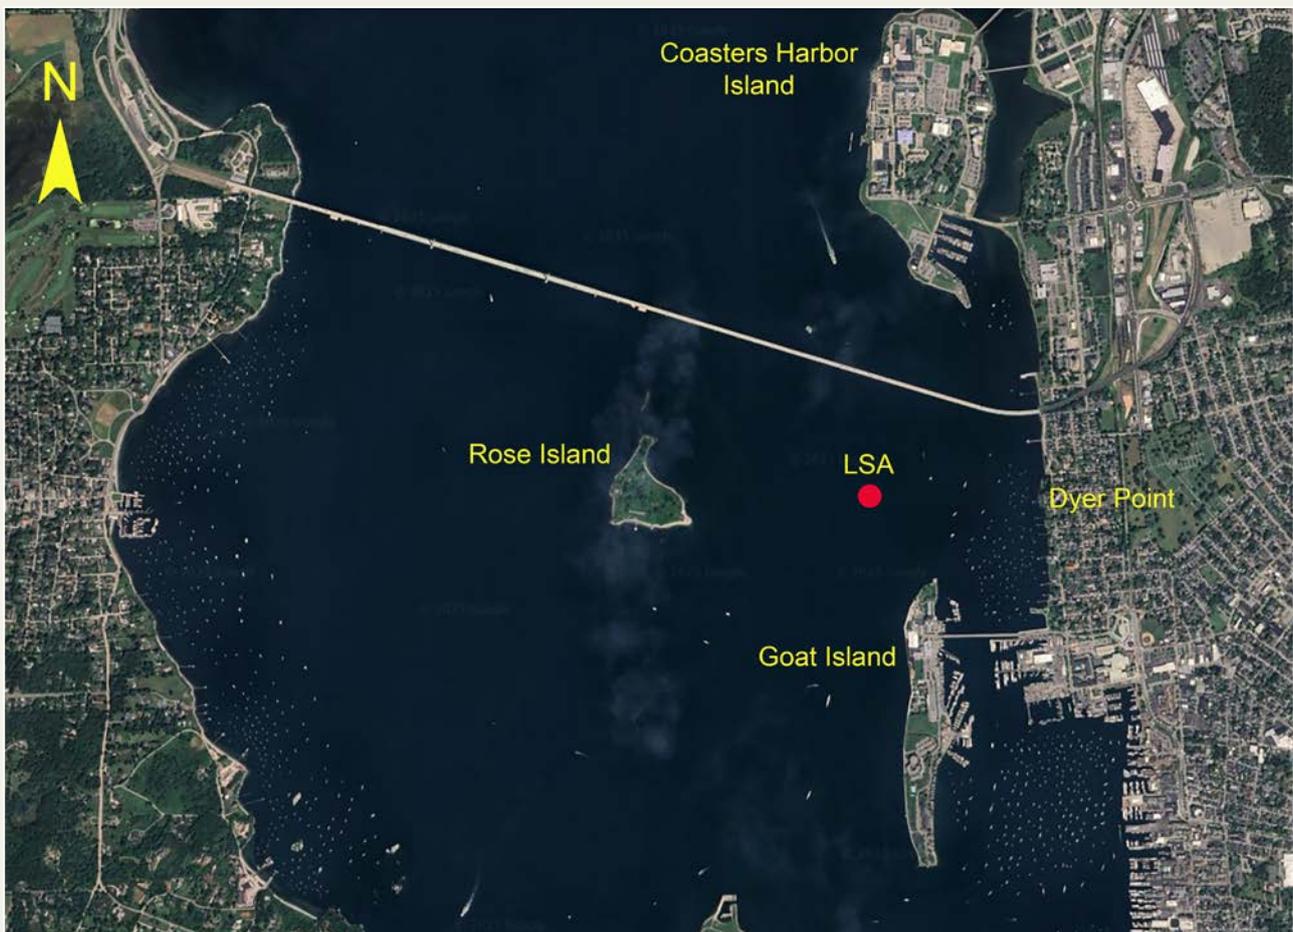
Figure 5. The area of Newport Harbor in which British vessels, including *Lord Sandwich*, were scuttled in August 1778. 'LSA' indicates the approximate centre of the Limited Study Area in which the wreck of *Lord Sandwich* is located. Image: James Hunter/ANMM; map data: ©2024 Google, Airbus.

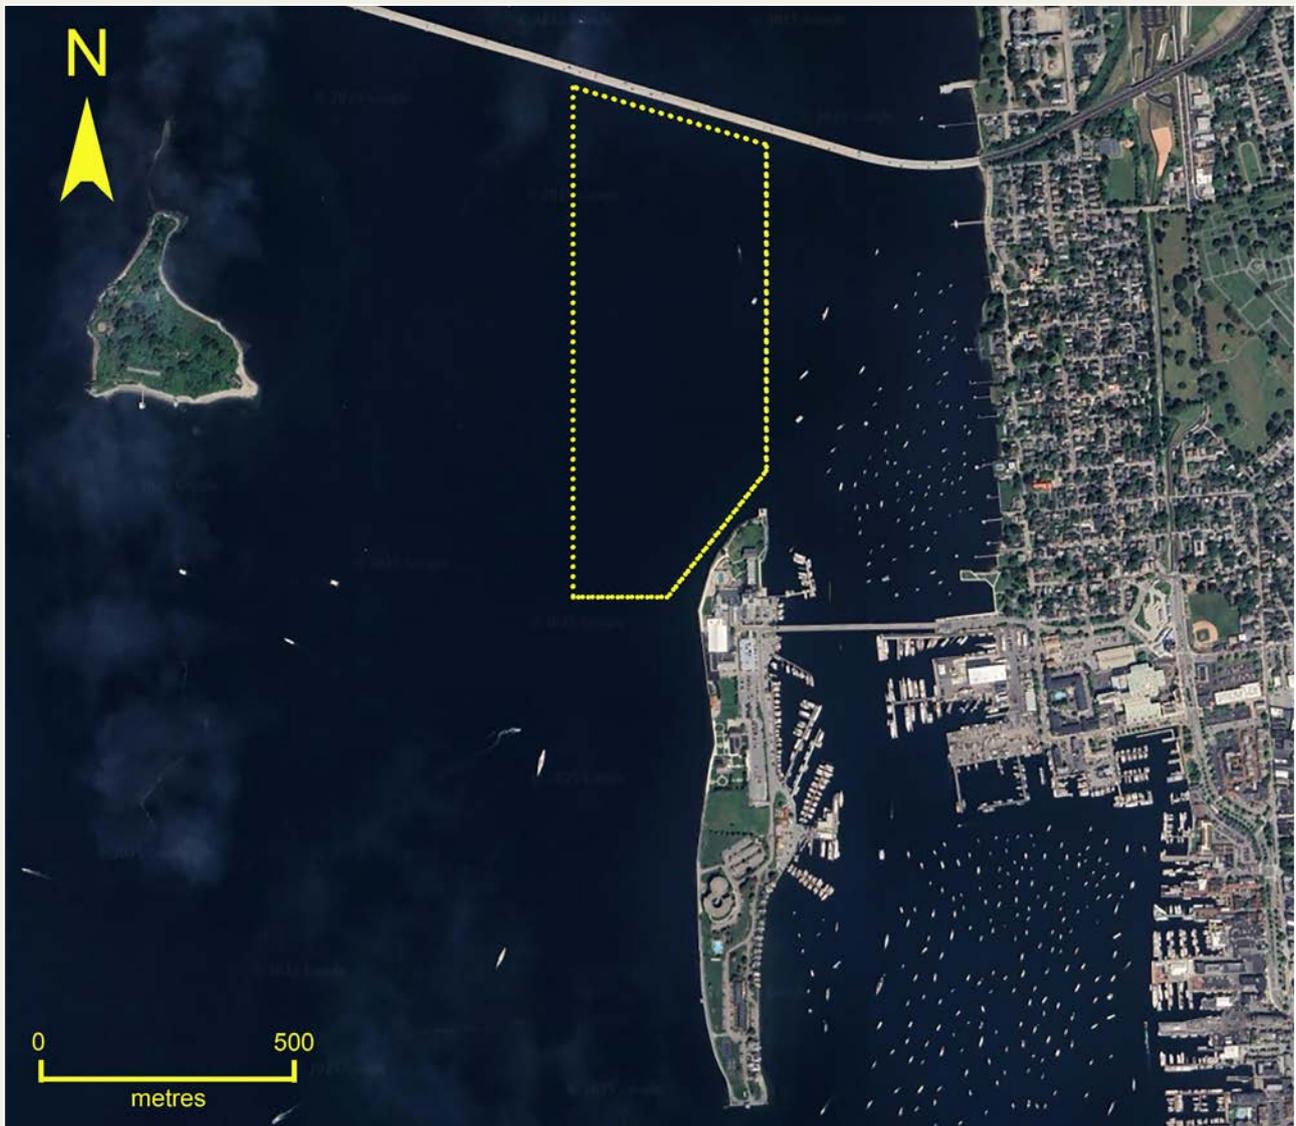
Figure 8. Dotted yellow line indicates the Limited Study Area established in 2017, indicating the approximate location of underwater archaeological sites in Newport Harbor considered to be possible locations of vessels scuttled in 1778. Image: James Hunter/ANMM; map data: ©2024 Google, Airbus.

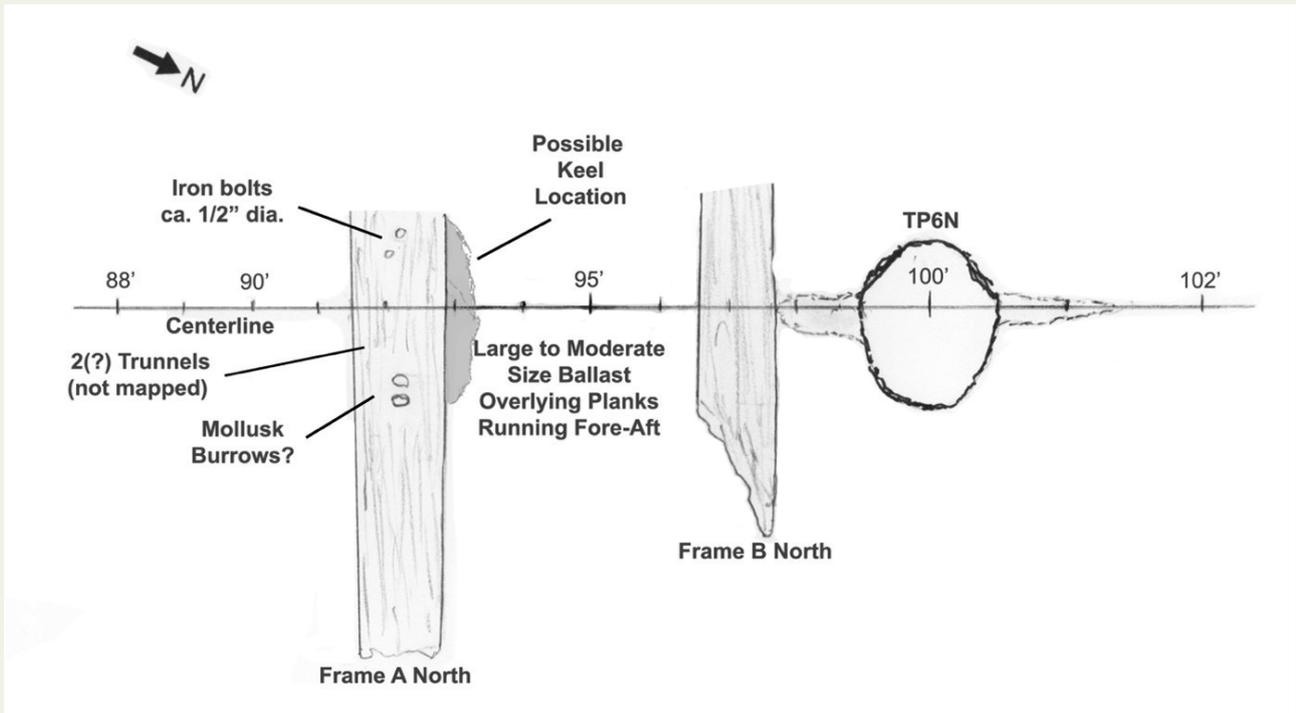
Figure 10. Area of archaeological investigation on RI 2394 during October 2020 (John D. Broadwater).

Figure 10 shows the two athwartship frames relative to TP6N. The upper sided surface of Frame A North features two large holes. These were located just east of the centreline and initially thought to be empty keel bolt holes. However, closer examination revealed the holes are not quite circular, do not contain adhering ferrous concretion and were likely made by marine molluscs. To the west of the centreline, the upper sided surface of the same timber features remnants of what appear to be two small iron bolts (approximately ½-inch or 1.3-centimetre diameter). These fasteners are too small to be keel bolts and were instead likely used to affix hull or ceiling planking in conjunction with at least two treenails found protruding from the frame's lower sided face. The treenails were cut flush with the timber's upper sided face and may have been wedged. Spacing between the frames is significantly greater than that observed elsewhere on RI 2394 and suggests additional intermediate frames are missing. This in turn provides additional evidence of hull deterioration at the site's northern end. Because the team could not locate the keel in TP6N, a small exploratory test pit was excavated along the northern moulded face of Frame A North.

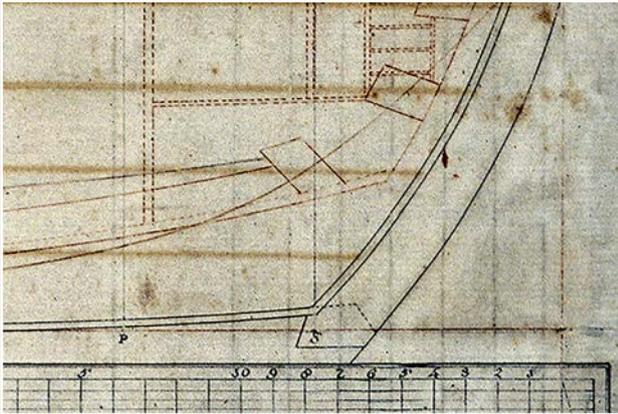
Figure 22. Detail of 1768 Admiralty draught showing *Endeavour's* unusual keel-stem scarp. Image: Australasian Pioneers' Club collection.

Criterion 7 states 'additional structural features such as the location of mast steps (if extant) and the shape of the hull are consistent with those of HMB *Endeavour*'. Discovery of RI 2394's keel-stem scarph revealed it was significantly different from the 'table' and 'box' scarphs typically used in mid-to-late 18<sup>th</sup>-century British shipbuilding (see Figures 22–26). When compared with the keel-stem scarph shown on *Endeavour's* 1768 Admiralty plan (see Figure 22), the resemblance between the two in terms of form and size are unquestionable.

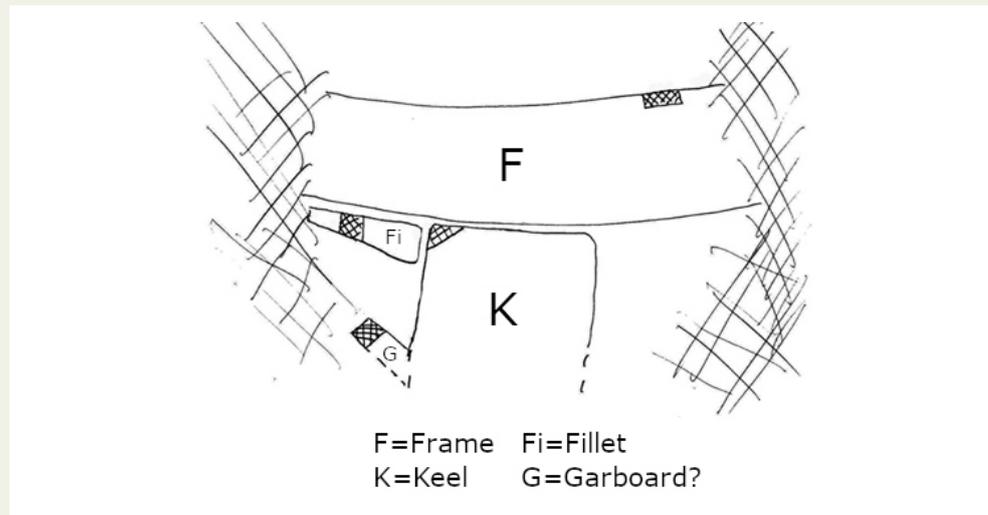
**Figure 27.** Locations where wood samples were recovered from TP3-S, view facing north (John D. Broadwater).

In September 2021, wood samples were recovered from four hull members in Test Pit 3-South (TP3-S): the keel, a floor timber, a fillet, and possible garboard strake (Figure 27). When a possible repair in the form of an unusual keel scarph was located in TP3-S, another sample was recovered from the keel in Test Pit 4-South (TP4-S) in an effort to identify possible use of exotic timbers in repairs to the keel (Broadwater and Daniel 2021: 13).

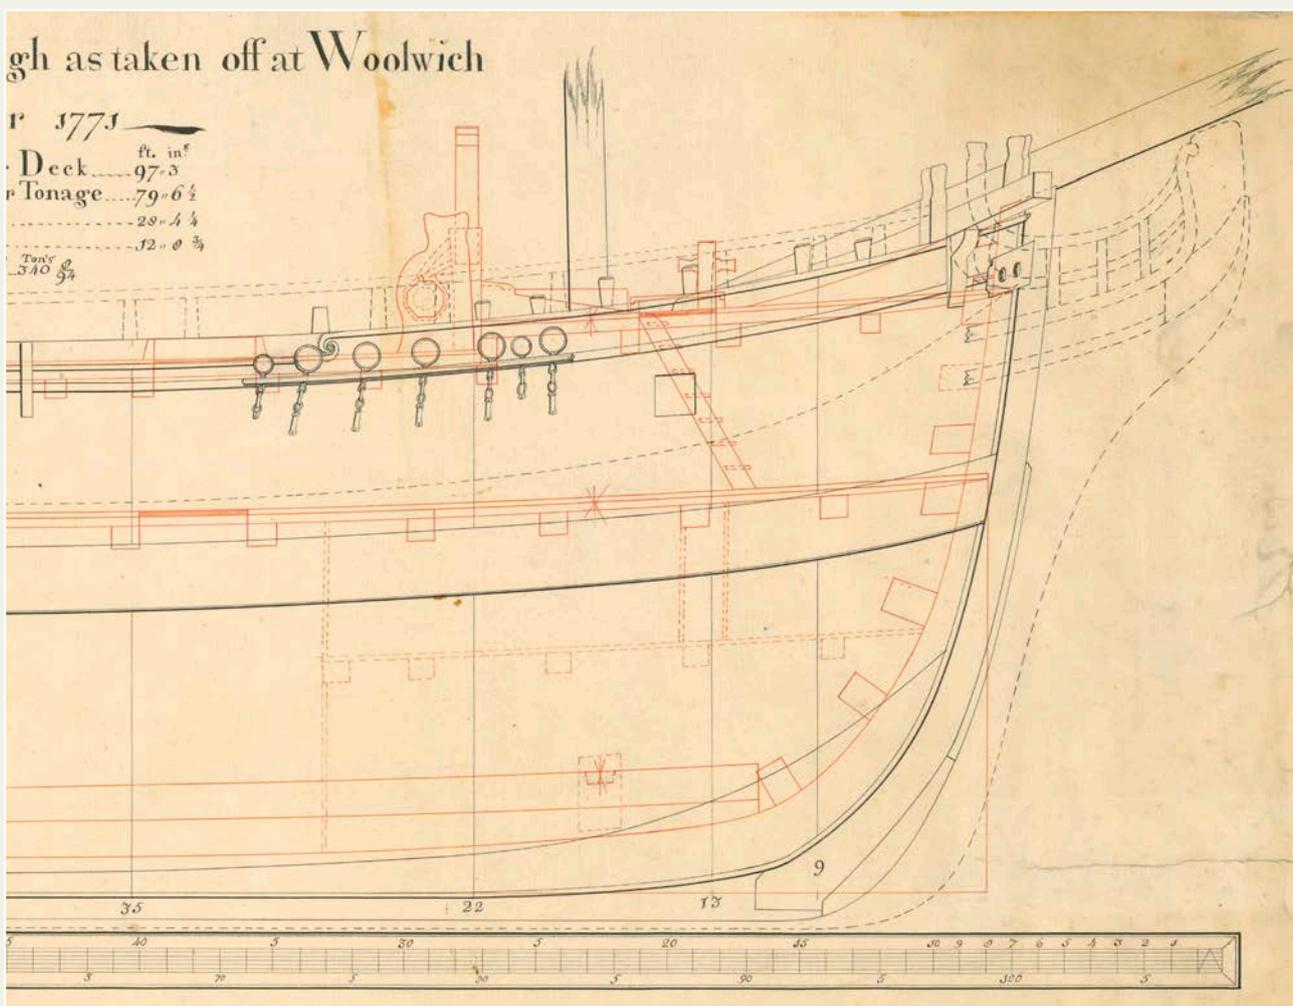
A survey of extant 18<sup>th</sup>-century ship plans held in the collections of the National Maritime Museum, Greenwich revealed draughts for 40 individual vessels, ranging from *Albion* (built 1763; NMM J2579) to *Chichester* (built 1785; NMM J5188). Only one of these sets of plans displayed a keel-stem scarph like that observed on RI 2394. That vessel, *Marquis of Rockingham* (built 1770), was another Whitby collier built by Thomas Fishburn, and was later commissioned by the Royal Navy and renamed HMS *Raleigh*. It was renamed again – this time HMS *Adventure* – and used by James Cook on his second voyage of exploration between 1772 and 1775 (Figure 32).

Figure 32. Extract from the body plans of His Majesty's Sloop *Raleigh* as taken off at Woolwich in November 1771. Image: Royal Museums Greenwich 19483.
