# Locating HM Bark *Endeavour*

Archaeological identification  
of shipwreck site RI 2394 in  
Newport Harbor, Rhode Island, USA

**Kieran Hosty**  
**James Hunter**

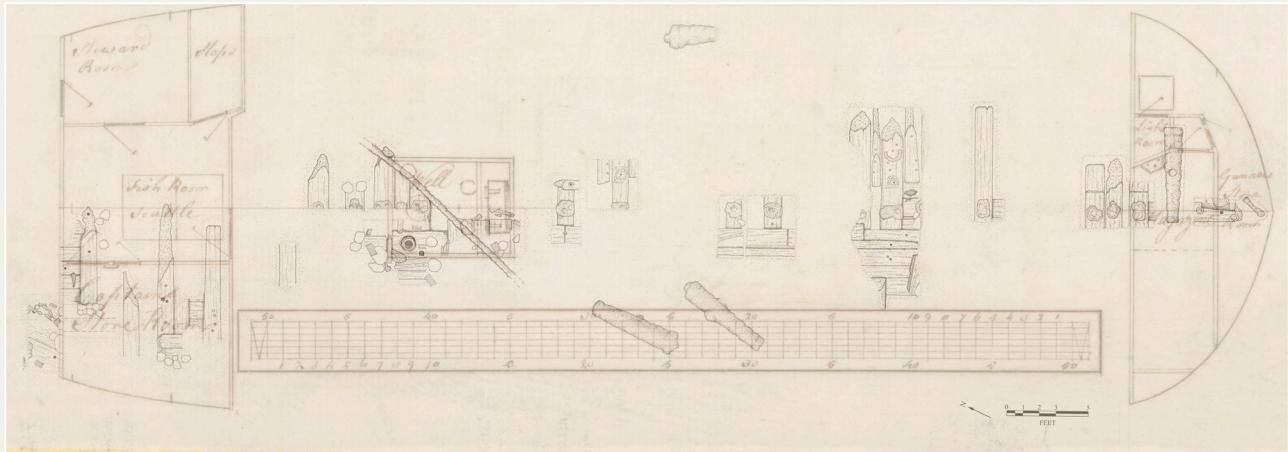
Figure 9. 2019–21 site plan overlaid with *Endeavour*'s 1768 survey draught, showing relative positions of site features such as the pump well compared with those on the archival plan. Image: Royal Museums Greenwich; James Hunter/ANMM.

Architectural elements associated with RI 2394's pump well, some of which remain *in situ*, were documented during the 2020 investigations (see Figure 9). These include the apron that formed the floor of the well, two fragmented partitions that formed one of the well's corners and an associated corner post. Two disarticulated stanchions that supported the partitions were observed lying on, or immediately adjacent to, the apron. A single mortise is located on the upper surface of the apron near the pump tube stump and likely accommodated one of these support stanchions.

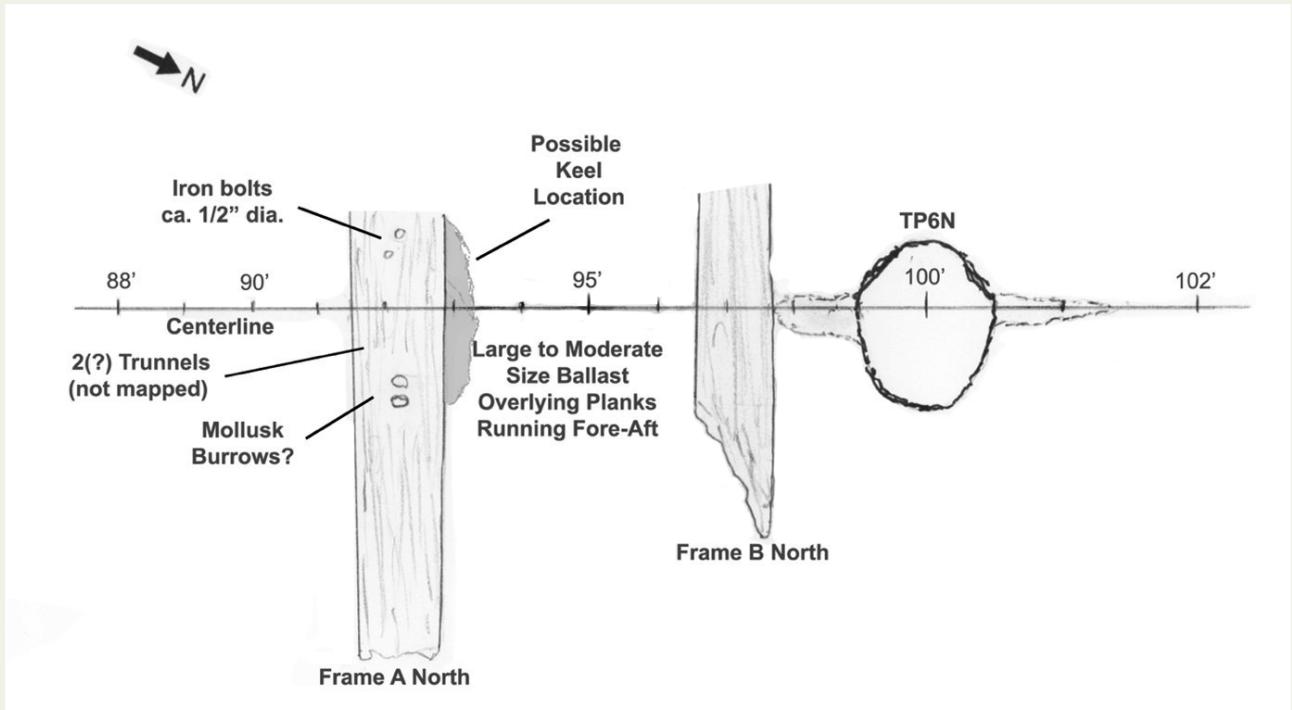
Several planks run fore and aft through TP6N on a roughly north-south orientation and are located at a depth of approximately 1 foot (0.3 metres) below grade. Those encountered beneath Frame A North were identified as runs of hull planking that had become disarticulated from the frame. Additional planks were encountered in TP6N, and some are believed to be contiguous with the hull planking beneath Frame A North. All are approximately 1 foot (0.3 metres) below grade. Their relatively shallow burial depth, as well as that of the two frames, suggests hull preservation is very poor in this part of the site. This

Figure 10. Area of archaeological investigation on RI 2394 during October 2020 (John D. Broadwater).

Figure 10 shows the two athwartship frames relative to TP6N. The upper sided surface of Frame A North features two large holes. These were located just east of the centreline and initially thought to be empty keel bolt holes. However, closer examination revealed the holes are not quite circular, do not contain adhering ferrous concretion and were likely made by marine molluscs. To the west of the centreline, the upper sided surface of the same timber features remnants of what appear to be two small iron bolts (approximately  $\frac{1}{2}$ -inch or 1.3-centimetre diameter). These fasteners are too small to be keel bolts and were instead likely used to affix hull or ceiling planking in conjunction with at least two treenails found protruding from the frame's lower sided face. The treenails were cut flush with the timber's upper sided face and may have been wedged. Spacing between the frames is significantly greater than that observed elsewhere on RI 2394 and suggests additional intermediate frames are missing. This in turn provides additional evidence of hull deterioration at the site's northern end. Because the team could not locate the keel in TP6N, a small exploratory test pit was excavated along the northern moulded face of Frame A North.

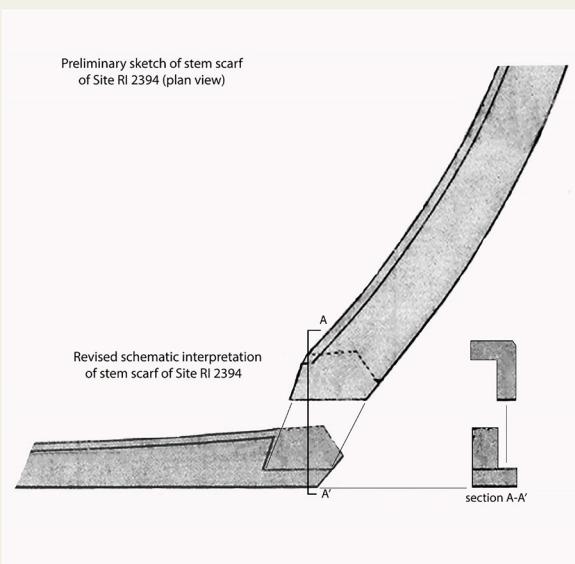
The survival of the keel-stem scarph – a highly diagnostic feature – is important for two reasons. First, it permitted the project team to obtain a key measurement from the stem end of the keel to the projected location of the mainmast, a value of approximately 49.8 feet (15.17 metres). Second, it provided details of the scarph itself, which appears to be a rare form of stem attachment known as a 'half-lap' joint (Broadwater and Daniel 2021: 7–10) (Figure 15).

**Figure 15.** Reconstruction of RI 2394's keel-stem scarf (John D. Broadwater).

During the mid-to-late 18<sup>th</sup> century, British shipwrights established accepted methods for joining the keel to the stem. However, RI 2394's keel-stem scarph is markedly different from the 'table' and 'box' scarphs typically employed during this period. When RI 2394's keel-stem scarph (Figure 15) is compared with the scarph shown in the Admiralty plans of *Endeavour* (Figure 22), there is no question they match exactly in both form and dimensions. As illustrated in Figure 23, Marquardt (1995: 49) depicts the same scarph (#16) and shows it braced with a horseshoe plate (#15). A similar scarph design was also used during construction of the *Endeavour* replica during the early 1990s. This vessel is now in the ANMM collection (Figures 24 and 25). A C-shaped concretion of 5 × 5.4 inches (metres) was recovered from the bow end of the keel, which may represent a horseshoe plate, but a definitive identification has not been completed (Abbass and Lynch 2024: 30).

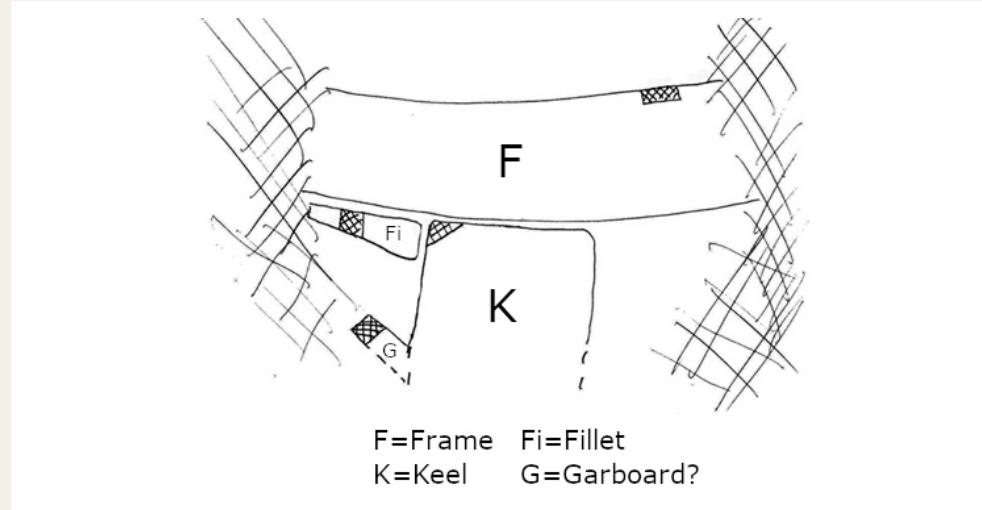
**Figure 27.** Locations where wood samples were recovered from TP3-S, view facing north (John D. Broadwater).

In September 2021, wood samples were recovered from four hull members in Test Pit 3-South (TP3-S): the keel, a floor timber, a fillet, and possible garboard strake (Figure 27). When a possible repair in the form of an unusual keel scarph was located in TP3-S, another sample was recovered from the keel in Test Pit 4-South (TP4-S) in an effort to identify possible use of exotic timbers in repairs to the keel (Broadwater and Daniel 2021: 13).

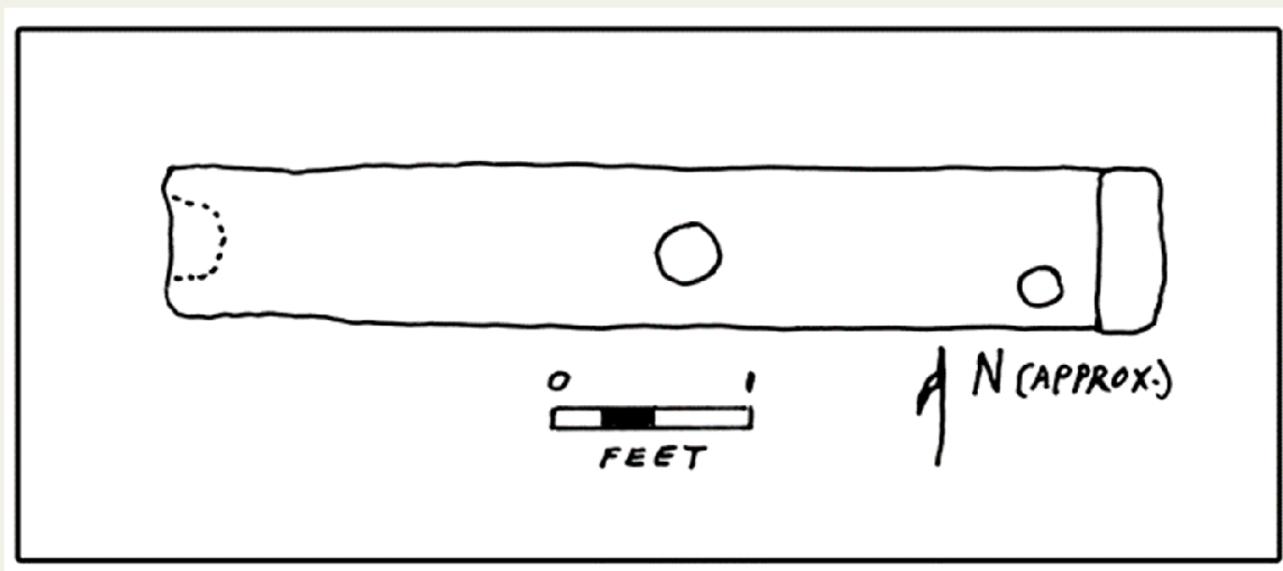
Figure 28: Sketch of Cannon 4 (John D. Broadwater).

During the September 2021 investigations, team members inspected Cannon 4, which is located at the 30.4-foot (9.3-metre) mark on the baseline. Hand fanning revealed the cannon is positioned in a predominantly flat and level orientation on the seabed beneath a thin layer of sediment. The field sketch below (Figure 28) shows the cannon is lying on its side with one trunnion facing upward and the muzzle facing west (towards the shipwreck site's starboard side). An unidentified flat, cylindrical metal object is concreted to the cannon near its breech. The muzzle opening is largely unobstructed, but the bore becomes progressively more choked with iron concretion towards the breech, and this precluded accurate measurement of its internal diameter.

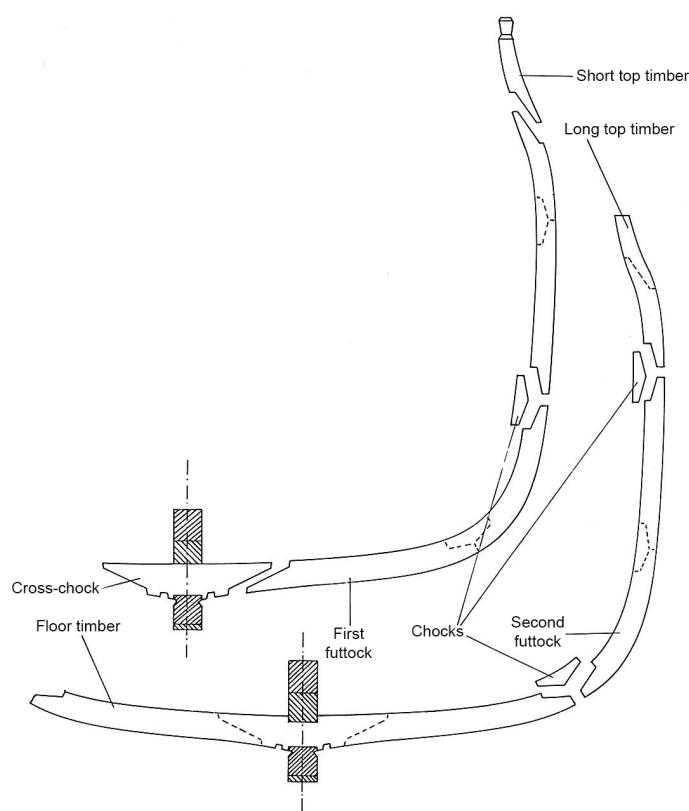
**Figure 31.** Proposed *Endeavour* framing schematic adapted from Marquardt (1995: 51).

Marquardt also illustrated what Broadwater (2020: 12) believes is an uncommon method of constructing ship's frames. He drew frames formed from bolting a short timber (called a 'cross-chock') over the keel. The cross-chock was then scarphed to two longer timber arms that he termed floor timbers (Figure 31). The frames are drawn by Marquardt as compound frames – an arrangement of floors and futtocks fastened in such a manner that they form double (or compound) frames. This pattern does not appear to match RI 2394's frames, which show first futtocks offset from the keel in a more common configuration for 18<sup>th</sup>-century merchant vessels (Morris et al. 1995: 127–9). If cross-chocks were used in *Endeavour*'s framing arrangement, it would be relatively easy archaeologically to uncover a selection of floors to check for the tell-tale seams that indicate the presence of cross-chocks.

If Marquardt's drawings are correct, the width across the upper face of each cross-chock averages approximately 7 feet 2 inches (2.18 metres). However, at least one floor (F15) in the wreck site's forward section was uncovered to its outboard heel and no evidence of a cross-chock seam was noted. If RI 2394 is the shipwreck of *Lord Sandwich*, then this suggests Marquardt's theory that cross-chocks were used in *Endeavour*'s construction is in error. It is worth noting some of the vessel's frames were likely replaced over the course of its life and those replacements may have followed a different construction pattern (or no pattern at all), so the presence or absence of cross-chocks would not resolve the question of the wreck site's identity.

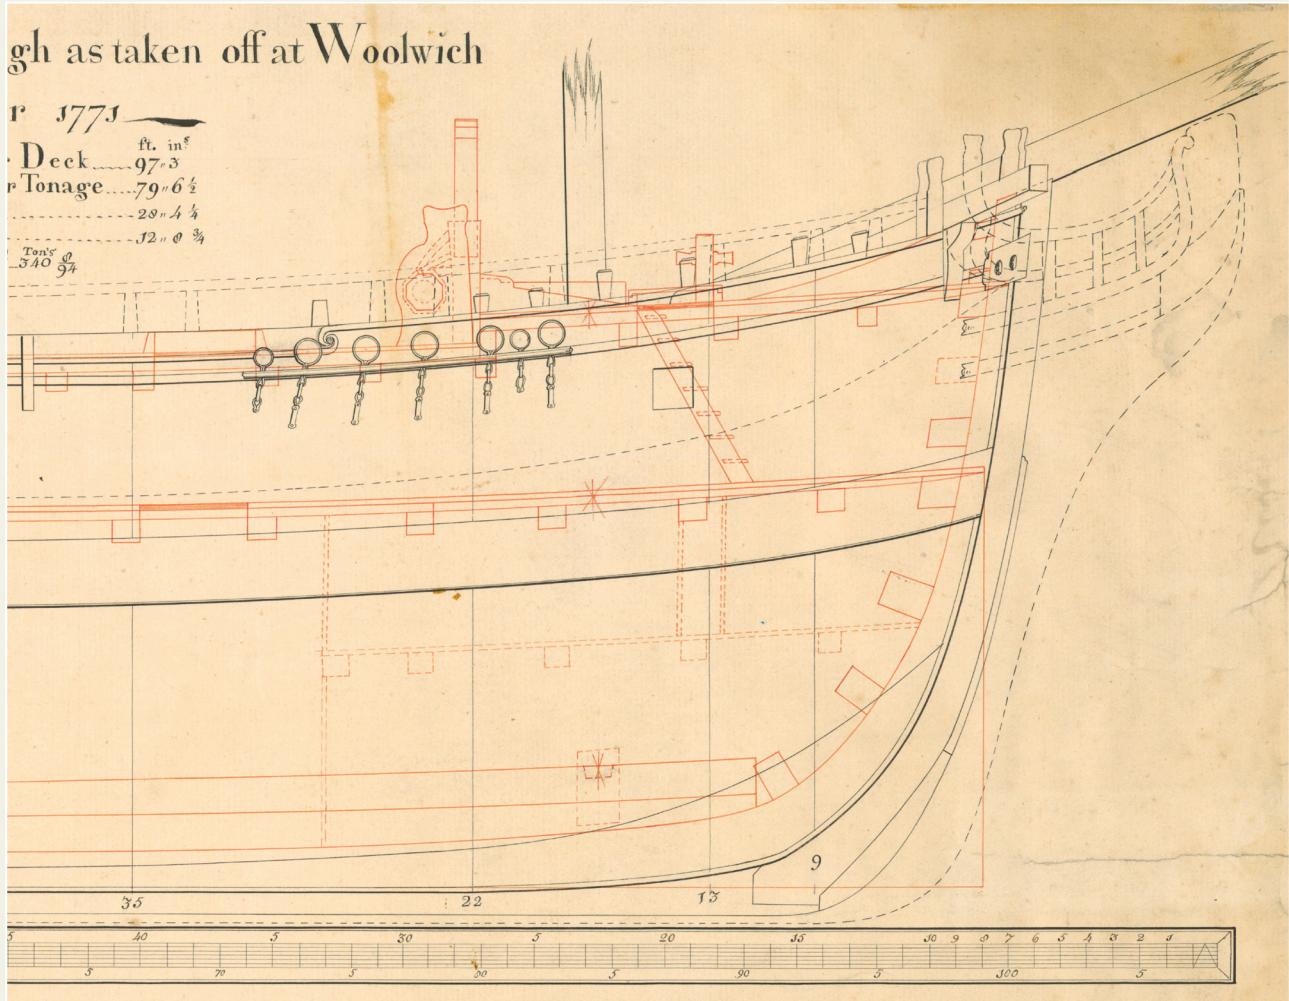
Figure 32. Extract from the body plans of His Majesty's Sloop Raleigh as taken off at Woolwich in November 1771. Image: Royal Museums Greenwich 19483.

A survey of extant 18<sup>th</sup>-century ship plans held in the collections of the National Maritime Museum, Greenwich revealed draughts for 40 individual vessels, ranging from *Albion* (built 1763; NMM J2579) to *Chichester* (built 1785; NMM J5188). Only one of these sets of plans displayed a keel-stem scarph like that observed on RI 2394. That vessel, *Marquis of Rockingham* (built 1770), was another Whitby collier built by Thomas Fishburn, and was later commissioned by the Royal Navy and renamed HMS *Raleigh*. It was renamed again – this time HMS *Adventure* – and used by James Cook on his second voyage of exploration between 1772 and 1775 (Figure 32).
